## Evaluation of Building Performance in Use - A Case Study of the Seager Distillery Development

# Evaluation of building performance in use – a case study of the Seager Distillery development

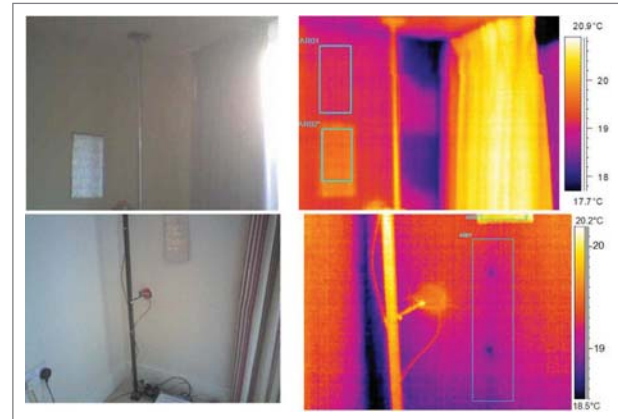
The reported Thermal Index generally suggested actual U-values are in-line with design expectations. Some cold spots were identified, which highlighted potential areas for future improvement. Examples include: (i) colder areas at the top of “boxed-in” sections, perhaps covering section of pipe work, with air leakage problems, (ii) cold bridging from large dabs behind the plaster board, and (iii) some evidence of cold bridging due to penetration of stud-wall fixings. Figure 5 shows images of the latter two examples.

Figure 5: Thermography images showing (top) cold bridging (dark-blue patches) from dabs on plasterboard and (bottom) from penetration of stud-wall fixings.

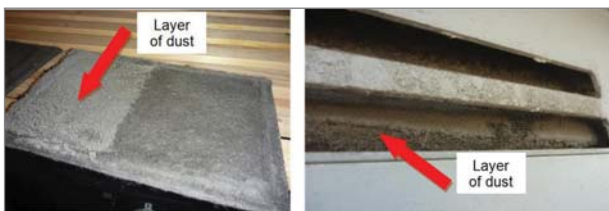
In general, the location where the MVHR units were installed made access difficult, being part-constricted by soffit in the airing cupboard, which would require removing to access the MVHR units. A visual inspection of the interior of one of the MVHR units revealed the following, for which photos in Figure 7 illustrate the findings:

- The filters were dirty, particularly the extract air filters. This is likely due to the units being installed and commissioned during on-going construction work and, thus, capturing dust. The occupants appeared unclear as to what maintenance was necessary and who was responsible. Indeed, this is representative of a wider concern from residents that they had not received instruction on the use of their ventilation and heating systems. Impeded access could have further contributed to lack of filter cleaning/change;
- The external supply grilles were found to be covered with dust. The location of some of the external grilles does not allow easy access for cleaning.

Figure 7: Dirty extract filter (half cleaned for comparison) and clogged up external inlet grille.
