Evaluation of Building Performance in Use - A Case Study of the Seager Distillery Development

Evaluation of building performance in use – a case study of the Seager Distillery development

A two-year post-occupancy performance evaluation has been undertaken of the apartments within Galliard Homes' Seager Distillery redevelopment site in London. The Seager Distillery site is typical of the many new high-density developments in London, reflecting the tightening standards on energy use and pressure on land use. This paper presents the energy and environmental performance of three apartments studied in detail, including the assessment of the performance of the building fabric, MVHR units and the communal heating system.

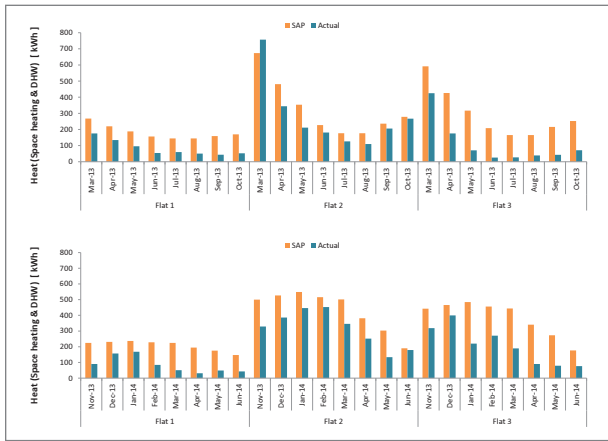
SAP over-predicted the heat consumption. The actual heat load would tend to be reduced by both better actual air tightness and observed ventilation rates being less than assumed by the SAP assessment. Furthermore, the apartments are thought to benefit from (unmeasured) heat gains arising from the distribution heat losses from the communal heating system (see Section 4.3).

Figure 8: SAP and actual heating energy use for the three apartments for March 2013 to the end of June 2014.

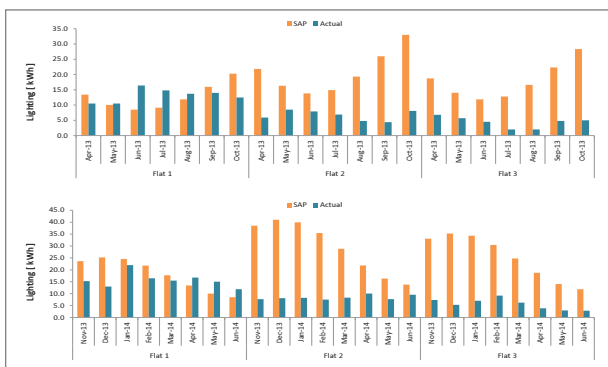
Figure 10: SAP and actual lighting energy use for the three apartments for March 2013 to the end of June 2014.

The electricity use for stand-alone lighting was not separately measured to reconcile this lower-than-predicted consumption of fixed lighting. This reduced the need, and thus energy consumption, for ceiling lights which were on the lighting circuit. There is no evidence in this study to suggest that the reduced energy use for artificial lighting was linked to provision of good daylight in the apartments, which was not investigated in the study. Finally, it is also noted that 100% low energy lighting was installed in the apartments, which is greater than that assumed in SAP and would tend to further reduce the actual energy use.
