**THE PURPOSE BUILT POST OFFICE BUILDINGS
OF
THE OFFICE OF PUBLIC WORKS
IN LEINSTER
FROM 1870 TO 1947**

This thesis is submitted to University College Dublin in fulfillment of the requirements of the Degree of Master of Urban and Building Conservation

by Máire Crean

March 2007

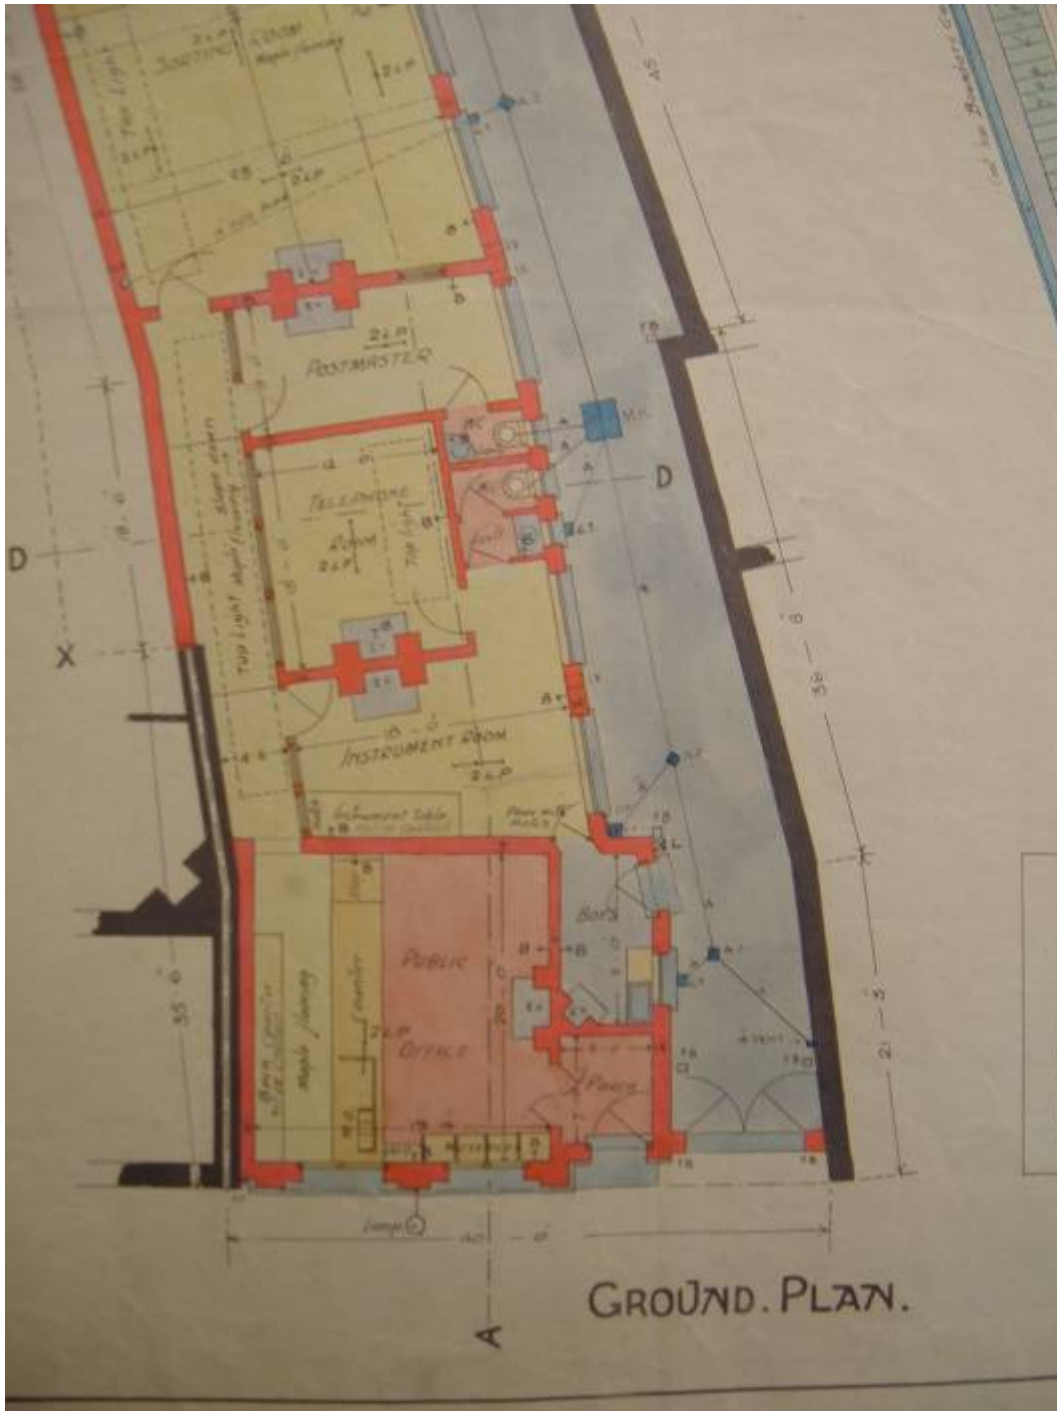
Figure 5/32 – Navan P.O., c.1906,; Sorting Office Arrangement¹⁶⁴

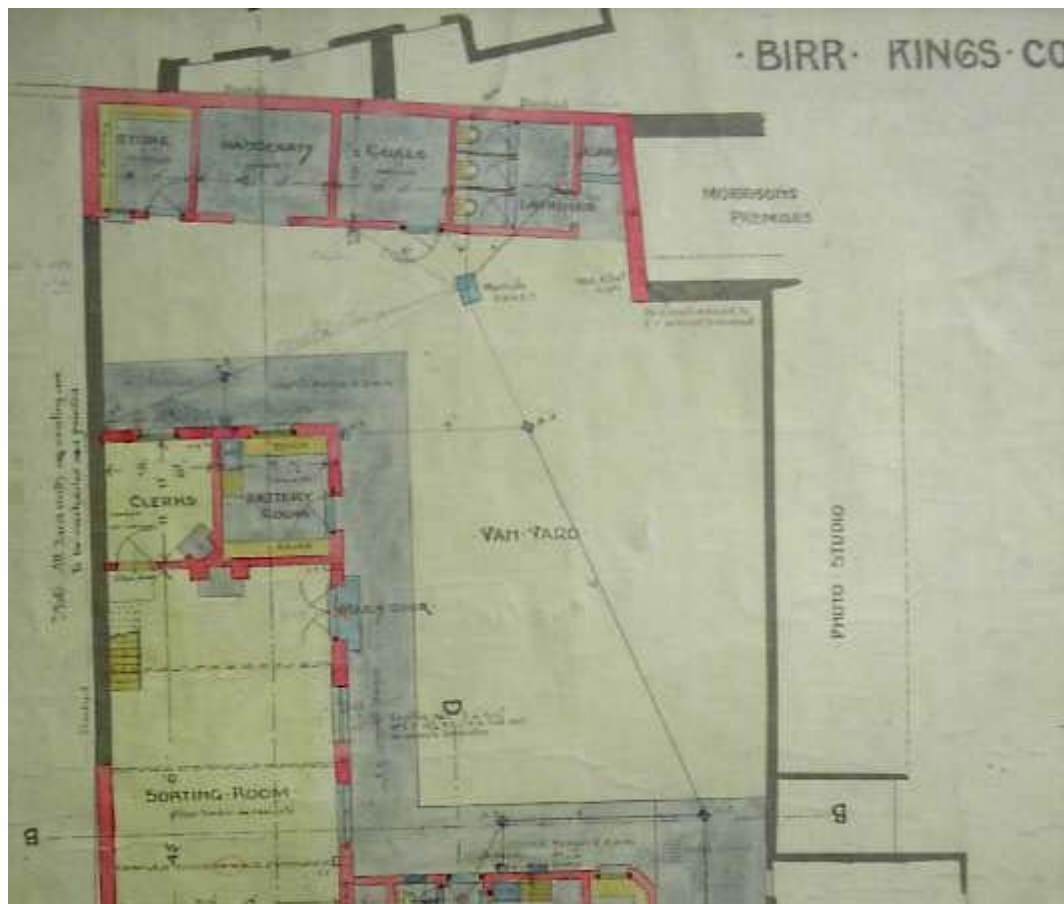
Figure 5/34 – Birr P.O., c.1907; External Yard Arrangement ¹⁶⁸

The external yard was located to the rear or side of the postal office in all the cases examined. The yard was used for the parking of post office carts, bicycles and vehicles. On the 1897 drawing for Birr P.O. it indicates the yard as a Van Yard, Figure 5/28. This reference would be to early post office vehicles such as hand carts being referred to as vans. The word van is a slight misnomer as today a van refers to a motorised vehicle, the first motorised vehicle being attributed to the 1876 Mercedes Benz Patent¹⁶⁷. There is no evidence to indicate that Birr Post Office had motorised vans at this time.

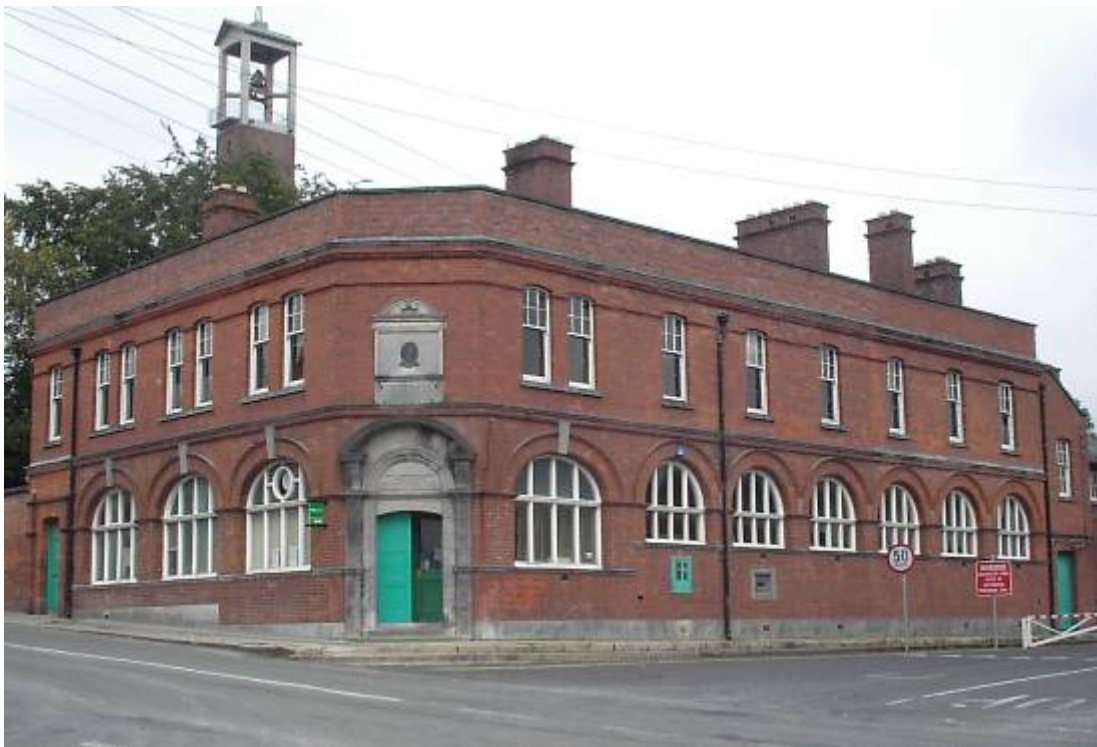
Figure 5/31 – Curragh Camp P.O., c.1900; Brick Post Office; Photo Author, 2006

The external finish of the buildings comes under three main headings, stone facade, rendered facade and brick façade. In some instances the brick finished buildings also had stone relief as in Curragh Camp Post Office, Figure 5/31 with its stone entrance door surround, stone sill and keystones to Ground Floor windows. Sligo Post Office, Figure 5/32, is a mixture of stone and brick with central section in stone accommodating the entrance and side panels. There is brick relief to the remainder of the ground floor and throughout the first floor.

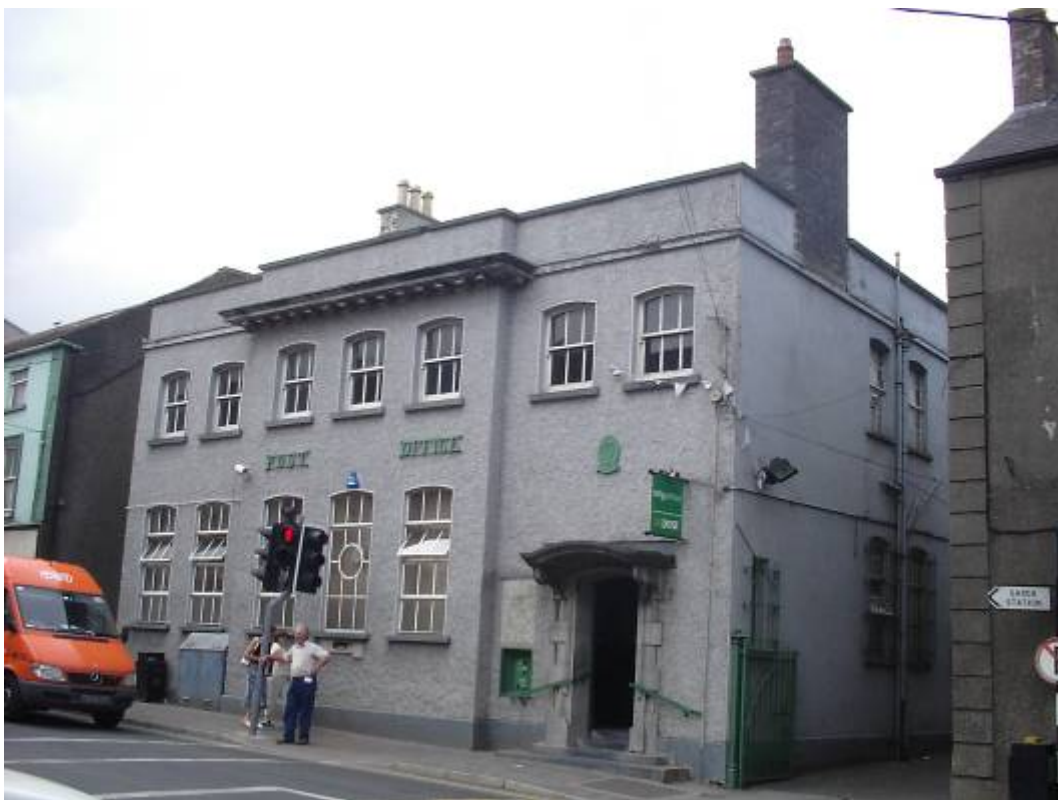
Figure 5/33 – Athy P.O., c.1911; Rendered Post Office; Photo, Author, 2006

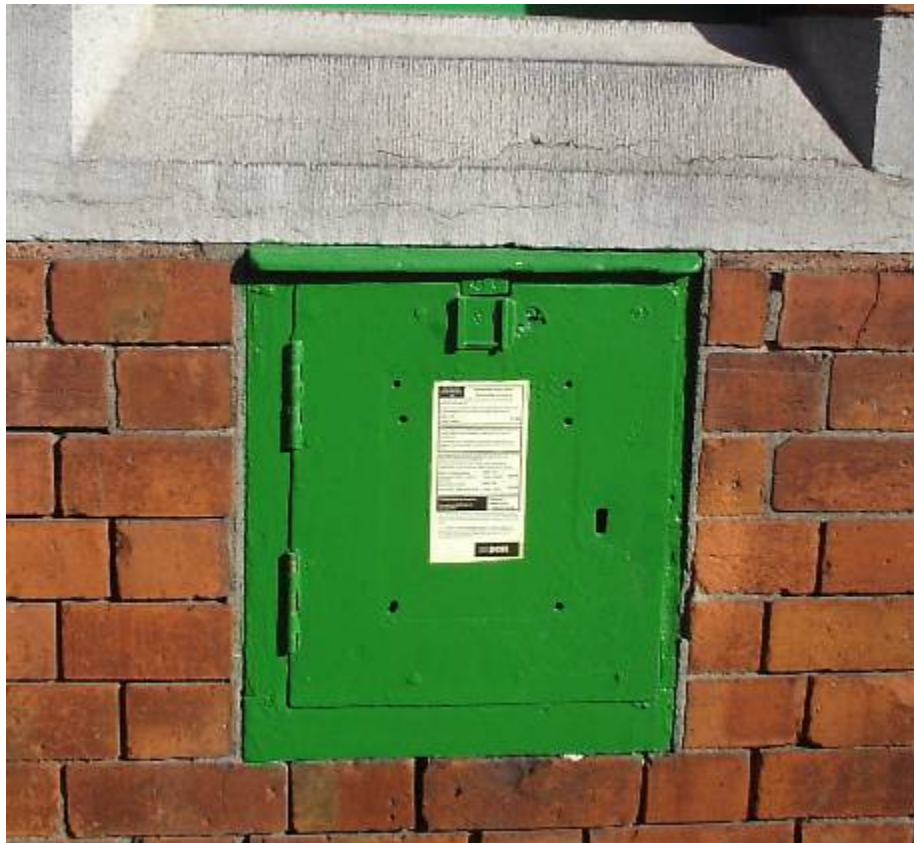
Figure 5/54 – Ballsbridge P.O., c. 1915; – Receiver Box; Photo, Author, 2006

The receiver or letter box was either located within the Public Area or behind the counter in the Clerks Area of the Public Office, depending on the public counter layout. The public used it to deliver letters to the post office and access for the public was from outside or inside the building. It could be opened and emptied from both inside and outside the building, Figure 5/54. The receiver or letter slot was located, in some postal offices, within one of the window opes which would have a section of glass omitted and replaced with a brass plate with the letter slot Figure 5/55. Some postal offices had the letter slot located in the wall. In some cases there were two or more letter slots. In most cases these receivers have been modified or removed completely.

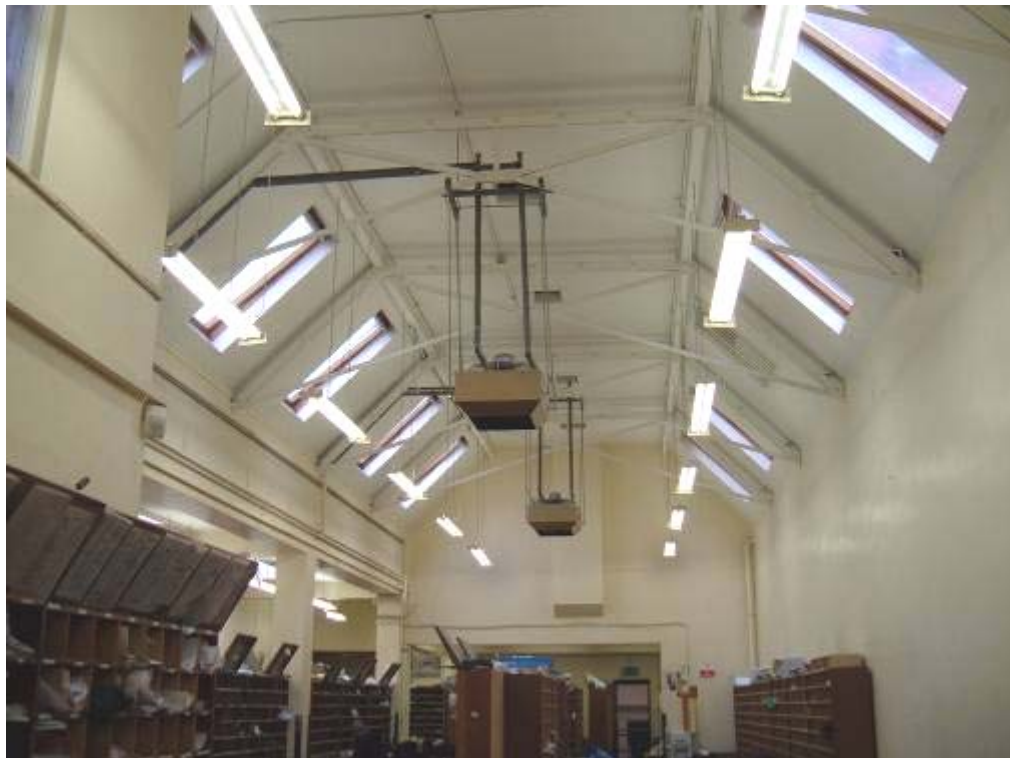
Figure 6/48 – James's Street Post Office; Sorting Room, Original Roof Structure, Photo; Author, 2006

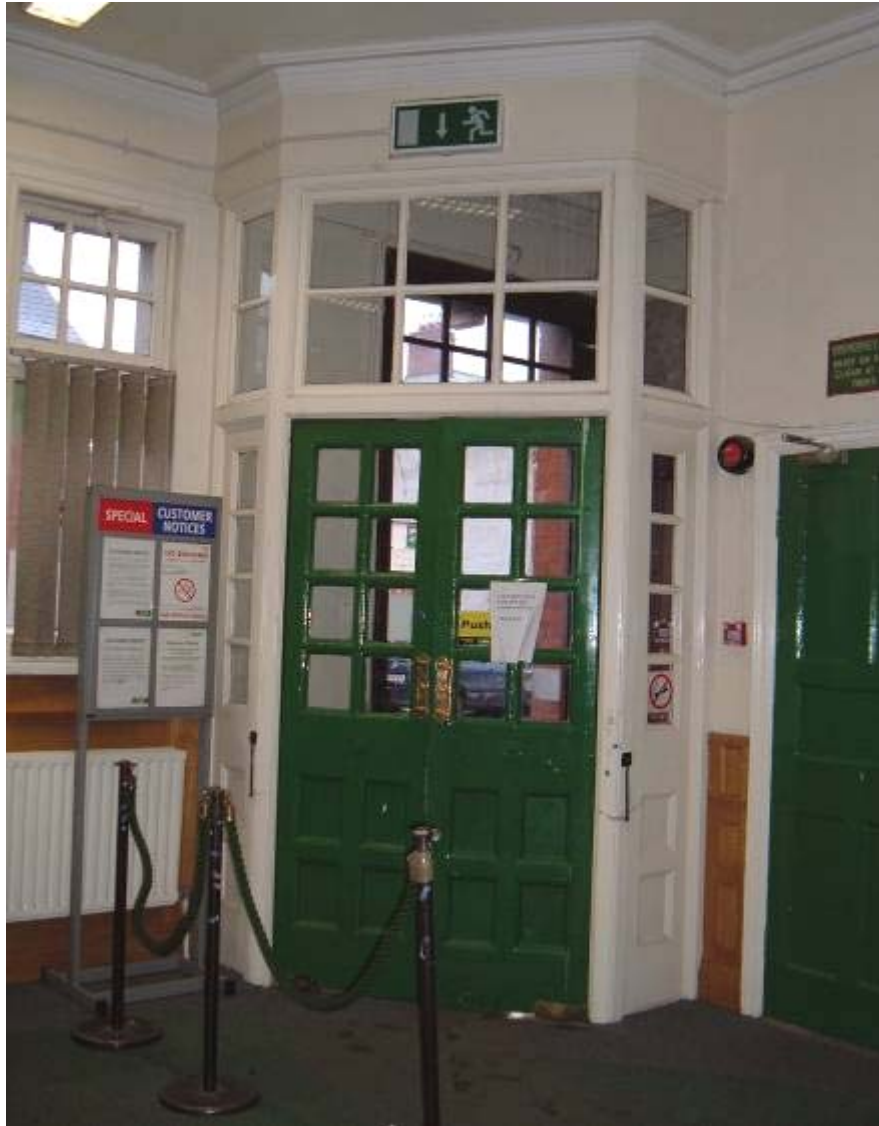
Figure 6/49 – Kells P.O., 1902; Original Glazed Screen to Public Office; Photo, Author 2007

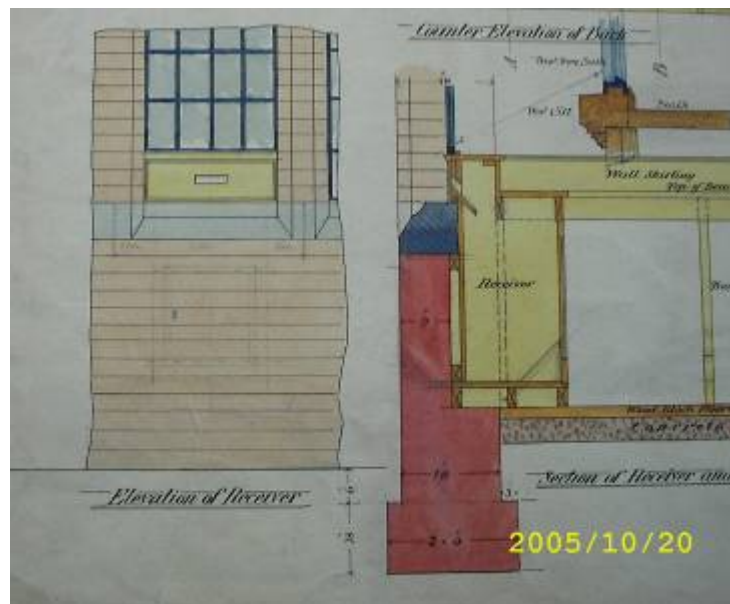
Figure 7/65 – Ballsbridge P.O., c. 1915; Original Receiver Box Drawing

The Letter/Receiver box is located in its original position, Figures 7/10 and 7/12. Curiously a faint outline of a wall mounted receiver box can be seen on the original drawing and a period wall mounted receiver box was fitted, although there is no date to confirm when, Figure 7/13. The original letter box slot has been replaced with one with a larger slot, Figure 7/14.

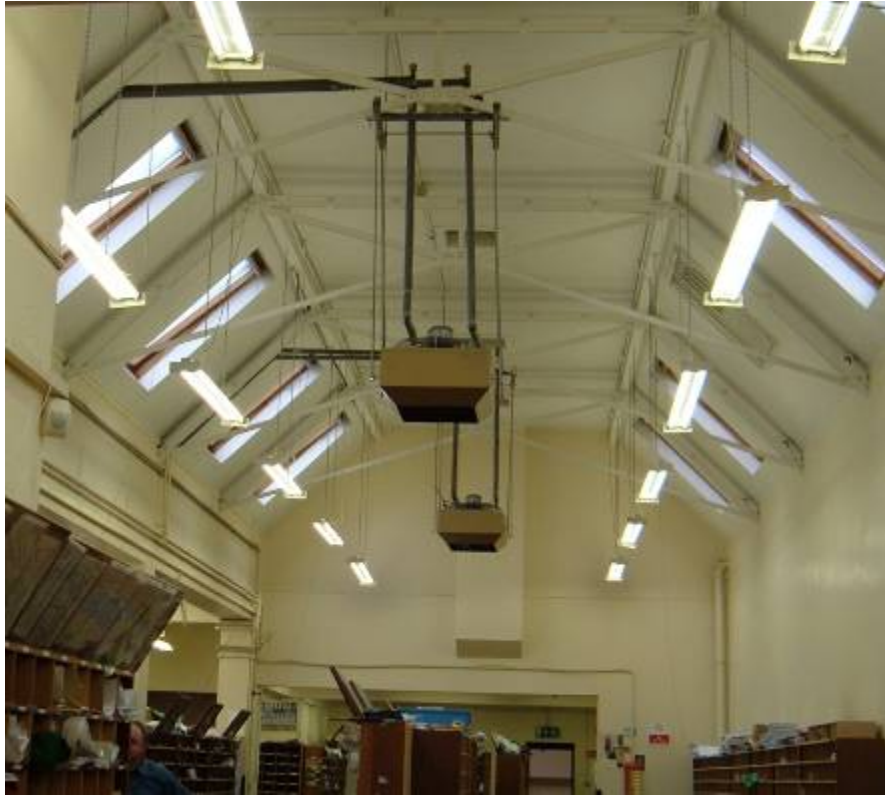
Figure 7/39 – James's Street Former P.O.; Sorting Office Roof Structure; Photo, Author, 2006

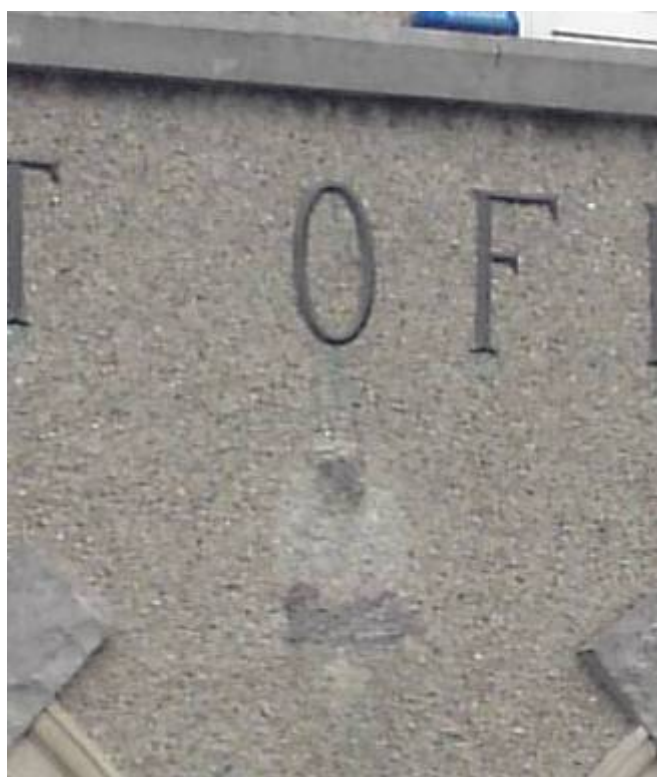
Figure 7/87 – Westport P.O., c. 1900; Repair work on Front Façade; Photo, Author, 2007
