Rainwater Harvesting Pilot Project Report

McCarton, L., O'Hogain, S., Reid, A., McIntyre, N., Pender, J.: Rainwater Harvesting Pilot Project Report. National Rural Water Monitoring Committee, 2009.

Rainwater Harvesting Pilot Project

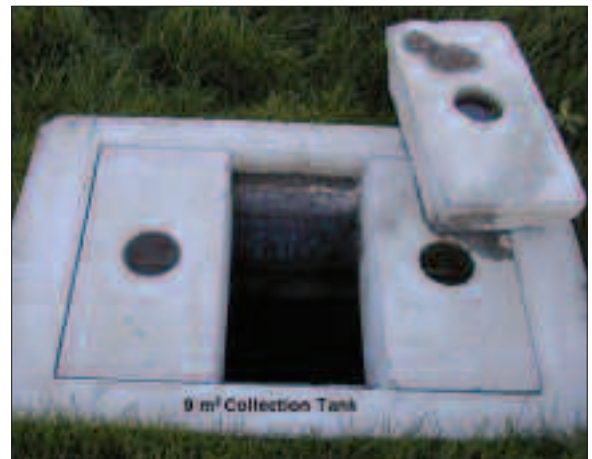
Fig. 2.3 Underground rainwater harvesting 9m³ storage tank.

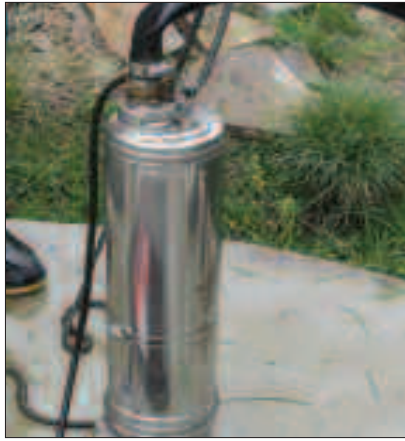
Fig. 2.4 Submersible pump installed in underground rainwater storage tank.

All connections to the rainwater drainage system were sealed to prevent contamination from surface water. A separate plumbing supply was installed from the attic to the toilets. A submersible Multigo pump placed in the collection tank in the garden pumped the collected rainwater to the rainwater header tank in the attic. The pump's floating filter inlet lay just below the water level, preventing any floating debris entering the pump. The pump had a safety mechanism that prevented switching on if the water level in the tank was below a certain level. This protected the pump and prevented any settled material being disturbed, thus clogging the pump inlet or entering the rainwater header tank.

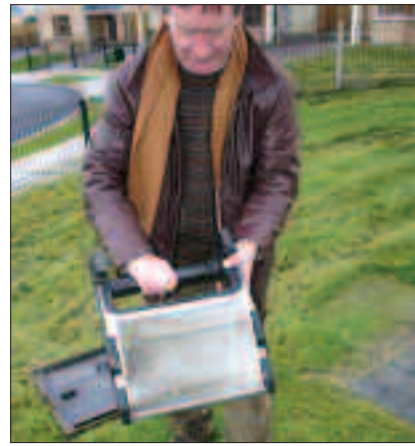
Fig. 2.5 Inline filter installed prior to rainwater entry to tank.

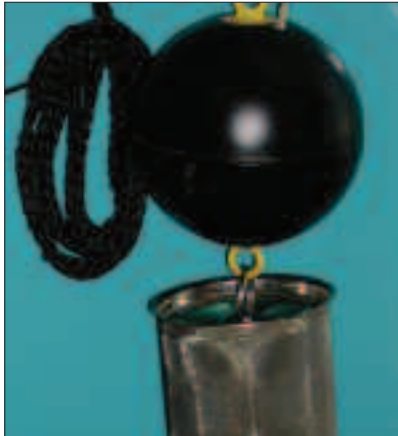
Fig. 2.6 Floating suction filter installed on submersible pump.

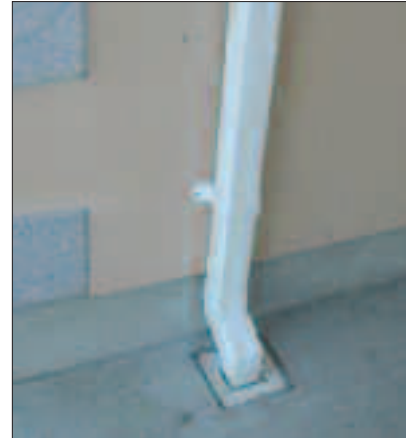
Fig. 2.7 Sealed downpipe to rainwater catchment system.

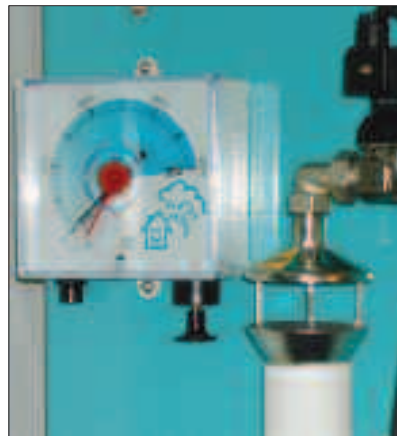
Fig. 2.8 Pressure meter showing level of rainwater in storage tank.

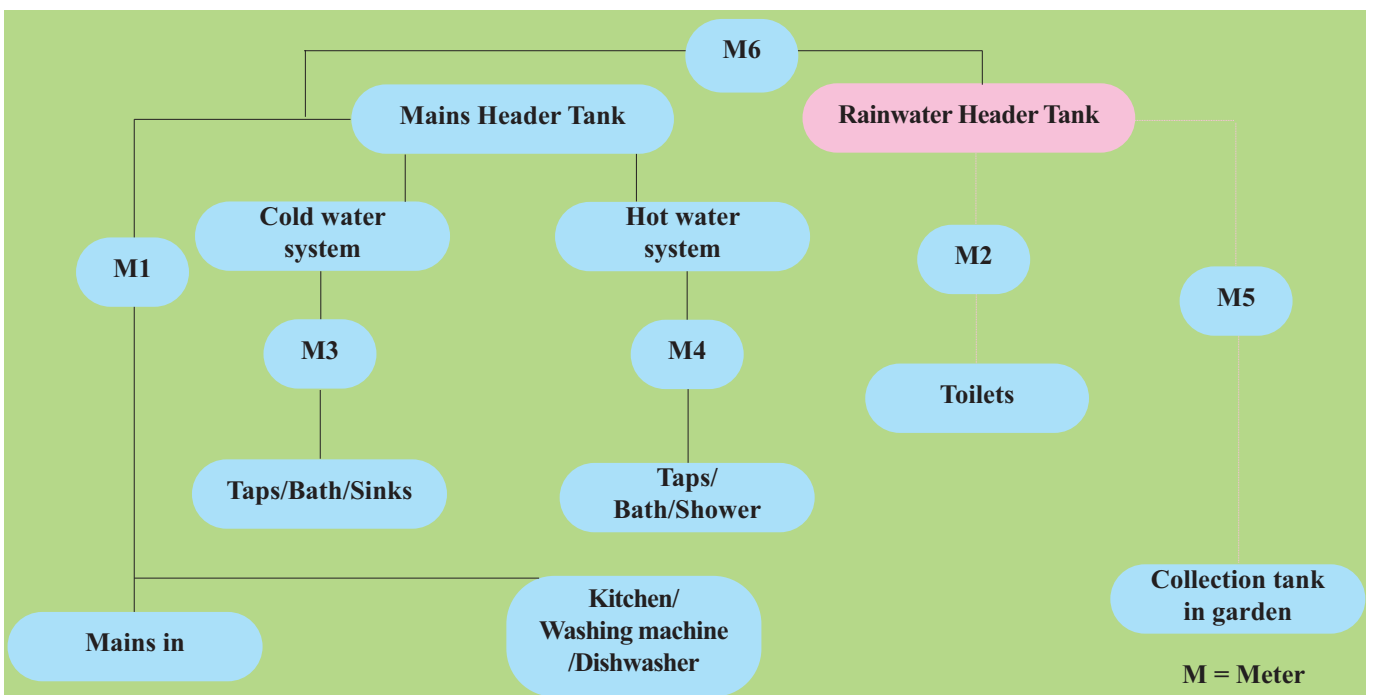
The metering system installed in all four houses in Phase 1 consisted of four meters (Bonyto Klasse C 1.5m³/h type). M1 was placed under the kitchen sink on the mains pipe to the house. This measured total mains water use. Meters M2, M3 and M4 were located in the hot press (airing cupboard), measuring toilets, cold water demand and hot water demand respectively (Figs 2.11 & 2.12). As stated above, M5 measured rainwater flow to the storage tank from the collection tank in the garden, while M6 measured the mains top-up to the rainwater storage tank. This mains water top-up facility ensured that sufficient water was available for toilet flushing during periods of dry weather. If there was insufficient rainwater in the collection tank, the mains top-up was switched on via the water management system.

Fig.2.10 Metering schematic for initial rainwater harvesting house.

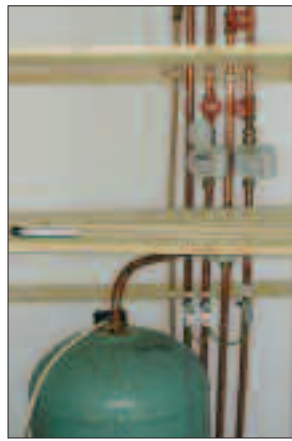
Fig. 2.11 & 2.12 Water meters in the hot press.

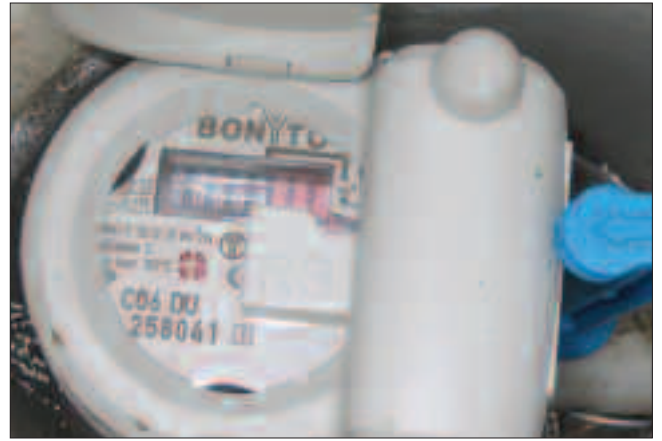
Meters measuring the mains into the house were situated in the path outside (Fig 2.13).

Fig. 2.13 Meter with attached transmitter located externally.

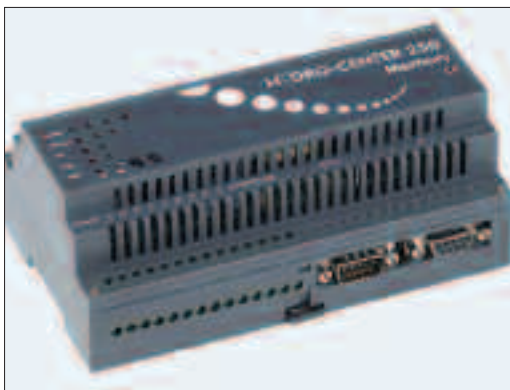
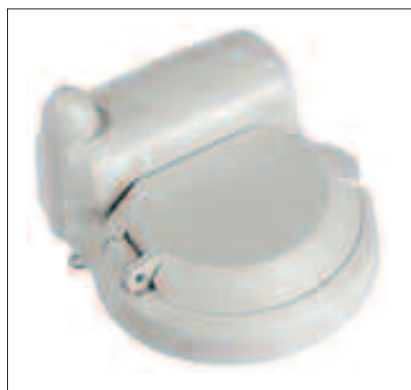
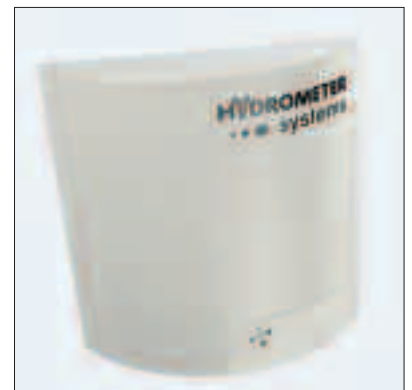
Fig. 2.14 Hydro-Centre, radio transmitter and transceiver.

The instrumentation used to collect and store meter readings is shown in Fig 2.14. The transceiver picked up the signal transmitted by the radio transmitter attached to the meter and sent it to the Hydro-Centre for storage. This stored data was then downloaded via a telephone line and computer programme for analysis.

To minimise disruption to the householders, a remote monitoring system was installed in the houses. This consisted of Hydrometer's Hydro-Centre. Flow meters were fitted with a radio transmitter, allowing meter data to be transmitted to the Hydro-Centre's data logger for storage. Each meter's reading was transmitted to and stored by the Hydro-Centre 4 times per day: at 00:00, 06:00, 12:00 and 18:00. The Hydro-Centre had mobile phone SIM card technology facilitating the remote downloading of stored data via telephone and Hydrometer's software package, Hydro-Centre 2.35. Due to site conditions, one Hydro-Centre was incapable of picking up the transmitted meter readings from all 4 houses. Therefore, two Hydro-Centres were employed: one was set up in one of the control houses, the second in the RWH house.

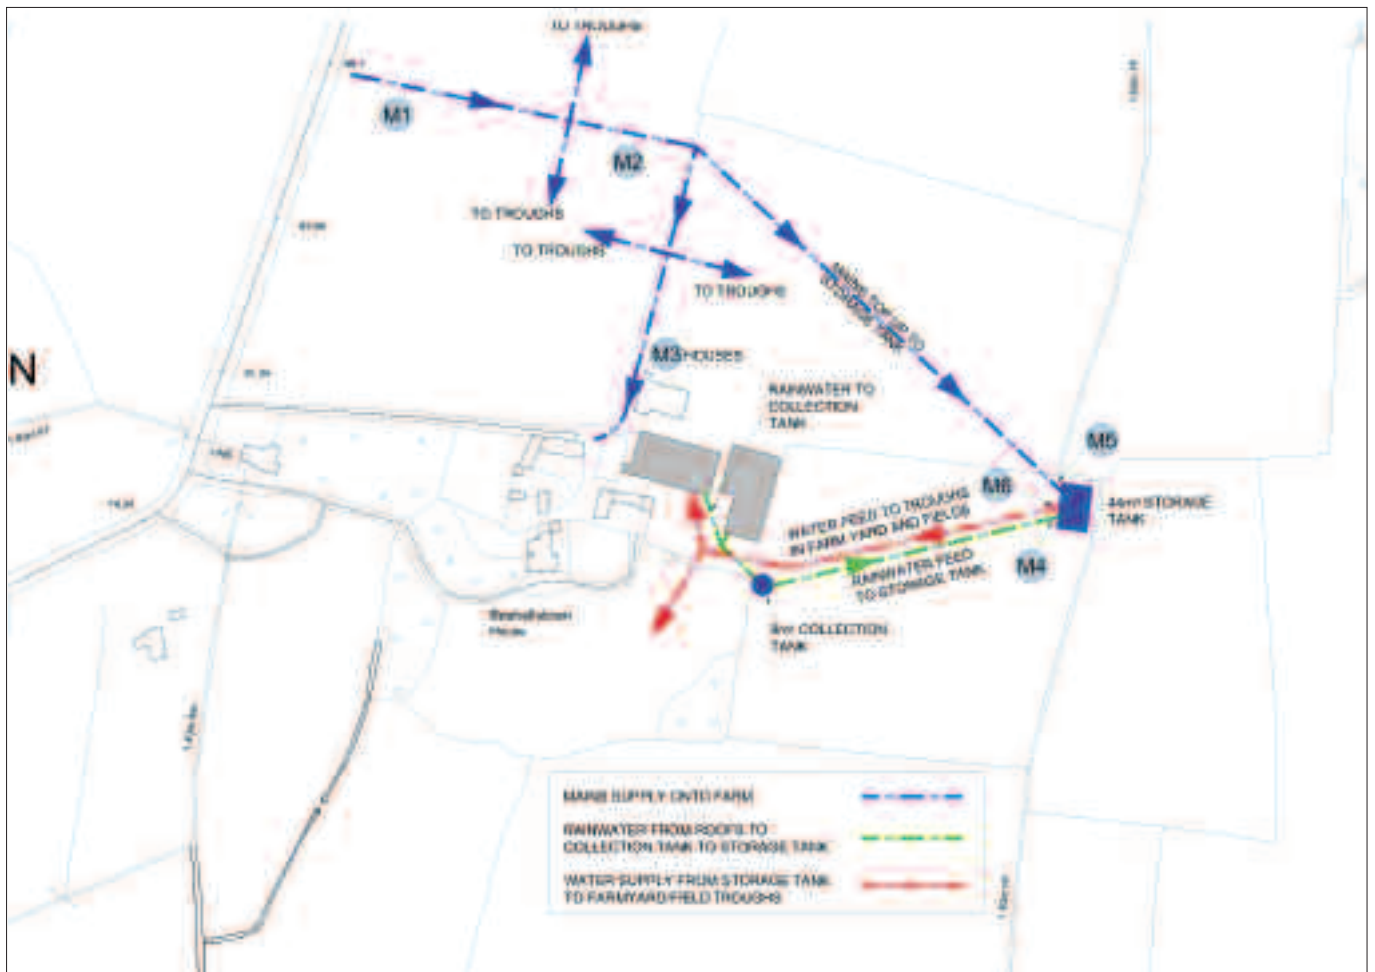
Rainwater from two sheds/barns was drained by gravity to an underground pre-cast 9m³ concrete collection tank. A 200mm high perforated stainless steel plate, overlapped, and of diameter 75mm, was placed in the downpipe gutter, as a filter. The collection tank was fitted with a pump and float switch, and the overflow pipe was connected to an adjacent field drain. The harvested rainwater was pumped via a 25mm rising pipe to two 22m³ pre-cast concrete reservoir tanks located on an adjacent elevated site. A mains top-up connection ensured water supply to the reservoir during periods of low rainfall. The harvested rainwater was distributed, via a 25mm pipe, by gravity to supply drinking troughs for cattle on the farm.

Fig. 3.1 Rainwater supply network.

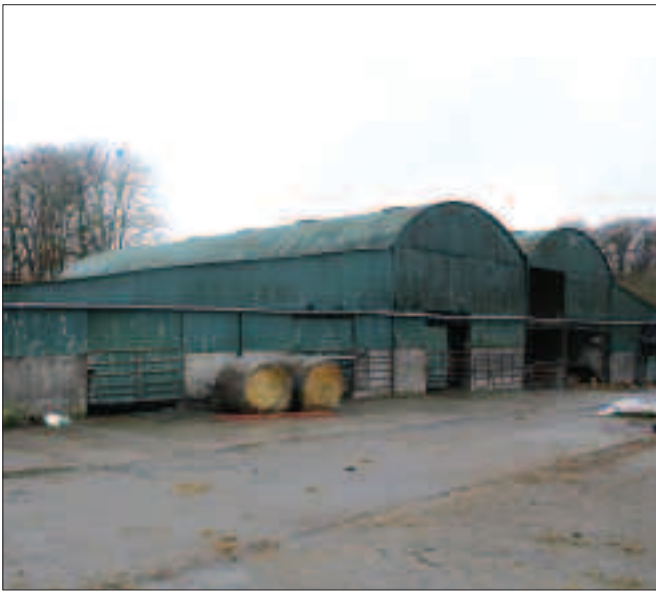
Rainwater drains from the roof catchment to an underground collection tank nearby (Figs. 3.2 & 3.3). From this tank a submersible pump pumps the water up to the storage tanks.

Fig. 3.2 Roof catchment.

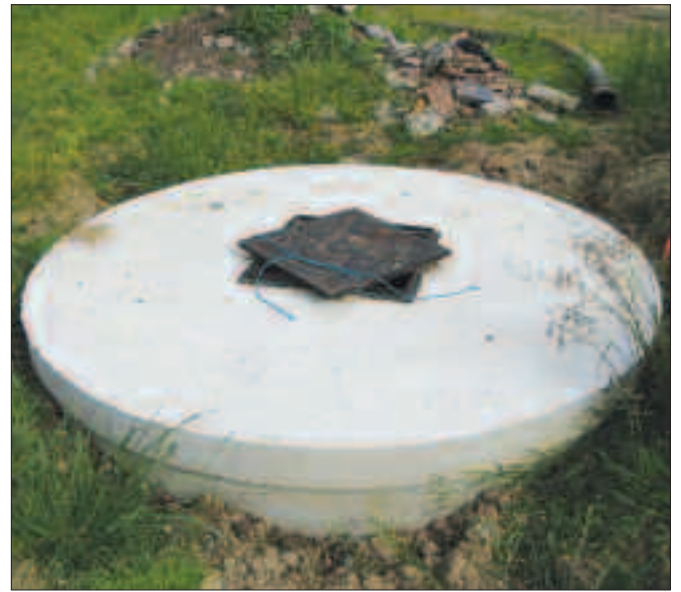
Fig. 3.3 Underground pumping tank.

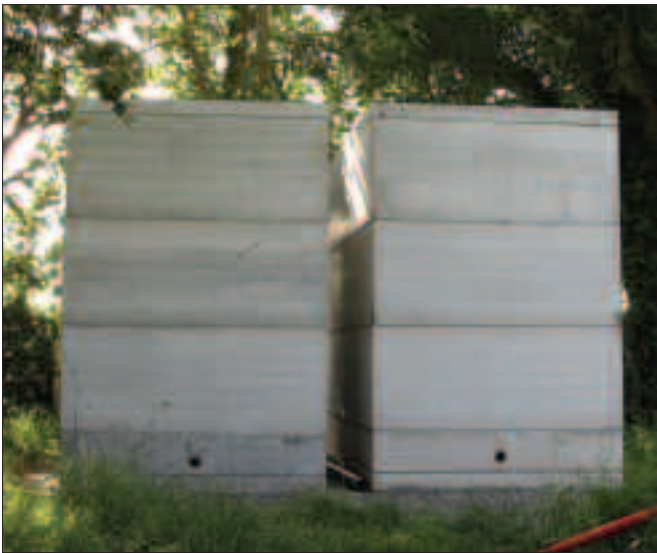
There was a facility for top-up by mains water in times of low rainfall. This was controlled by a ballcock system. If the water fell below a set level, the mains controlling ballcock was switched on. Fig. 3.7 shows the inlet for the mains pipe, the second pipe is for the rainwater, where the ball cock controlling rainwater flow is set at much higher level, allowing for maximum rainwater storage.

Fig. 3.5 Rainwater storage reservoir.

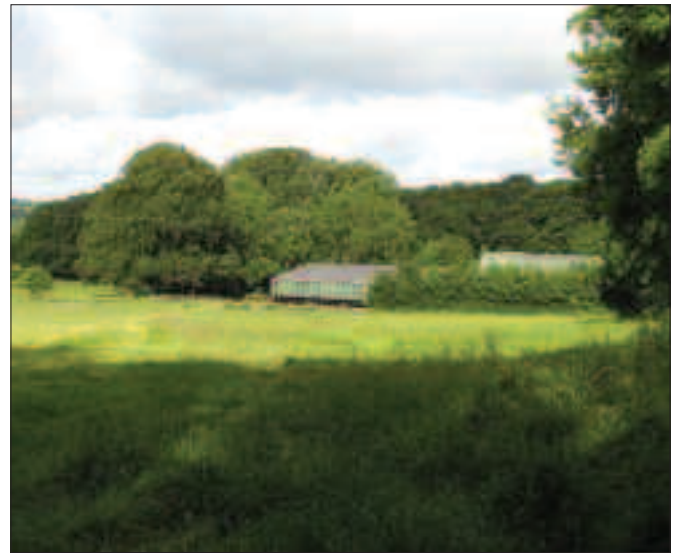
Fig. 3.6 Rainwater supply to drinking troughs by gravity system from storage reservoir.

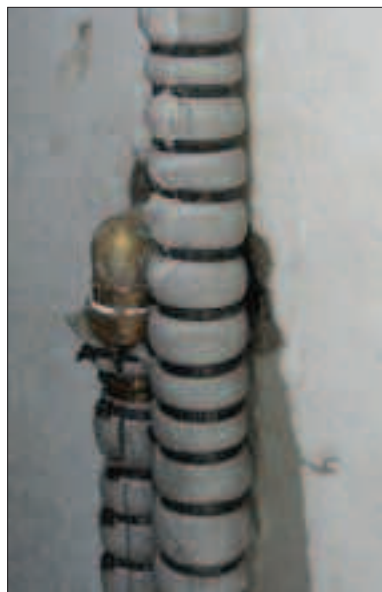
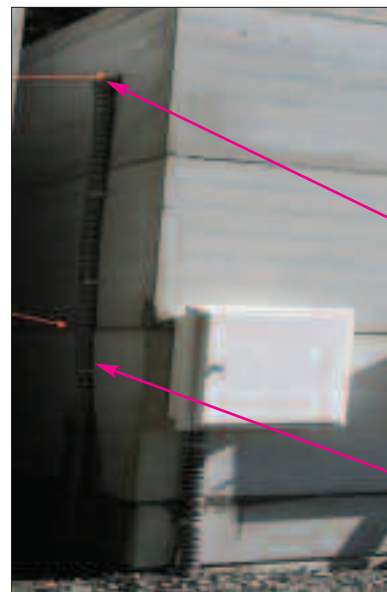
Rainwater level

Mains top-up point

Fig. 3.7a & b Mains water top-up system.

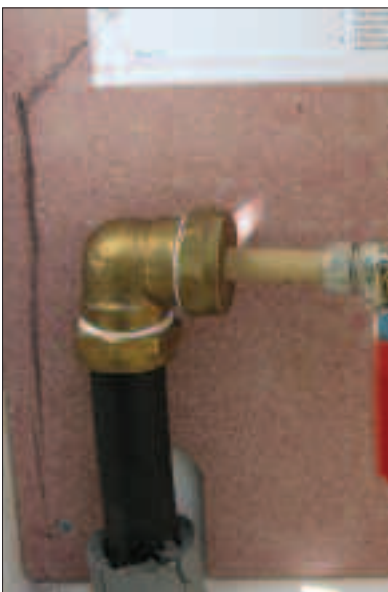
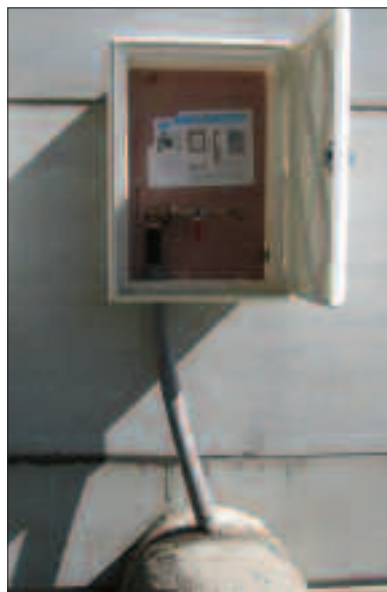
Fig. 3.8a&b Rainwater reservoir water quality sampling points.

On the side of one of the tanks were sampling points (Fig. 3.8a & b) from where the quality of the water going into the storage tank and leaving the tanks going to the cattle troughs could be analysed. Both chemical and microbiological tests were performed on the water. As at the Carlow site, weather data was collected (Fig. 3.9). See Appendix for monthly rainfall data.

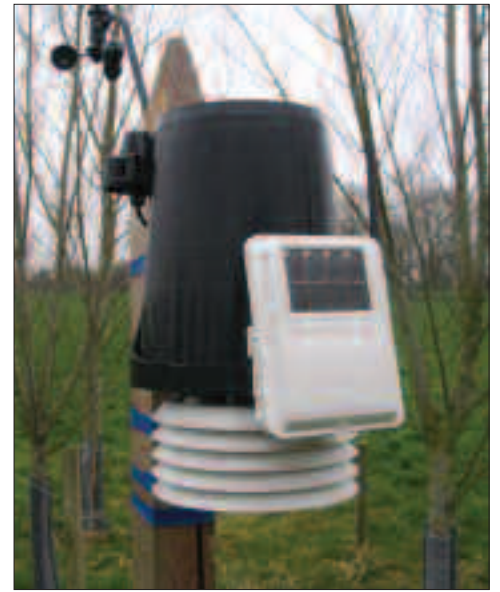
Fig. 3.9 Weather station at Clonalvy.

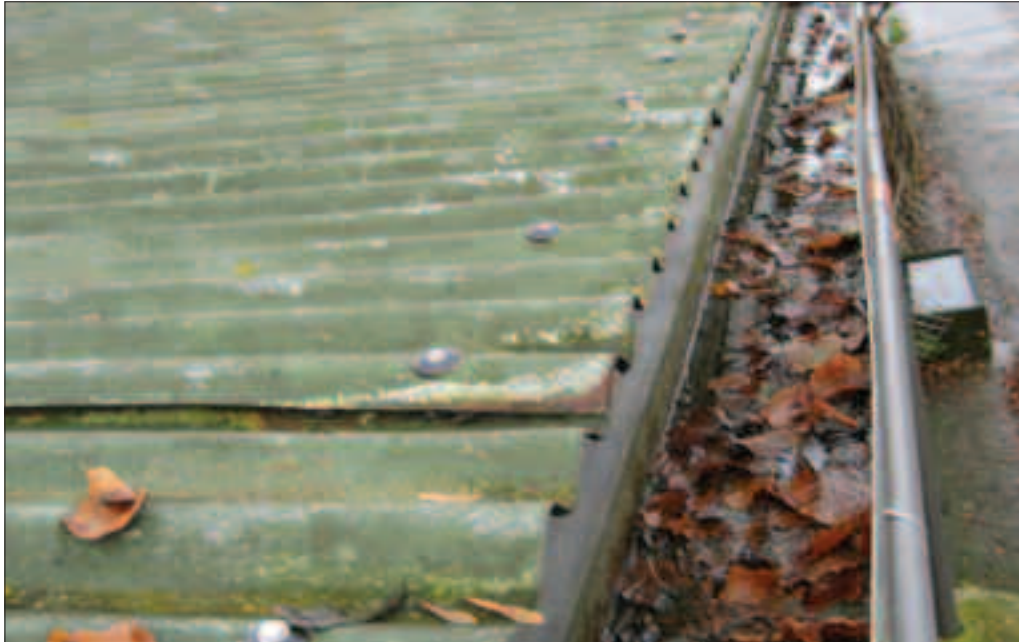
Fig. 3.10 Build up of leaves in gutter leading to failure of custom made filter.

Due to the unsatisfactory performance of elements of the original installation, it was decided to alter components of the Rainwater Harvesting system. A Lindab leafbeater™ and a BRAE™ filter were installed on the three downpipes conducting the rainwater, via the underground pipe work, to the collection tank. The leafbeater was installed prior to the BRAE filter. The design of the leafbeater is such that it allows for the removal of larger solids, while the fine filter on the BRAE traps the finer particles. Installation of the filters required cutting the downpipes. This allowed a reduction in the pressure of the water in the pipe work. The leafbeater is self cleansing while the BRAE filter requires periodic cleaning of a removable mesh. The fine filter on the pump in the collection tank was also replaced. Armstrong Junctions (AJs) covering the underground pipe work in the farmyard were sealed, using a silicon sealant. A data logger system was also installed with flow monitoring to assess water usage.

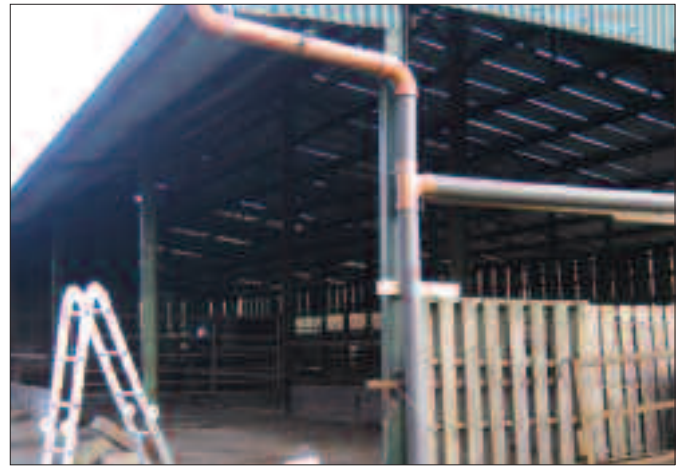
Fig. 3.12 Installation of regime 2.

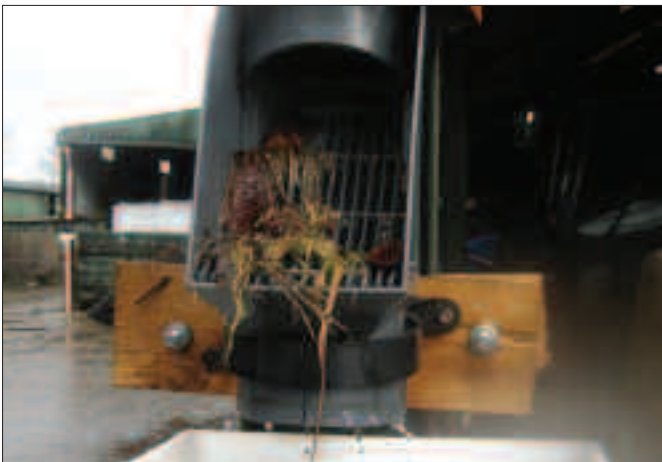
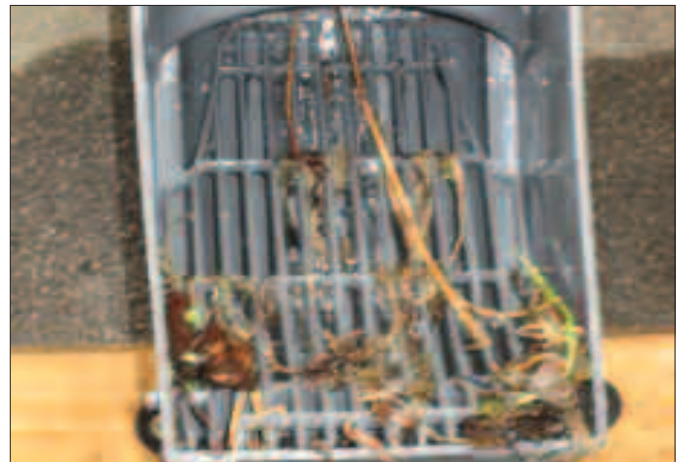
Fig. 3.13 and Fig. 3.14 A Lindab leafbeater™ and a BRAE™ filter installed.

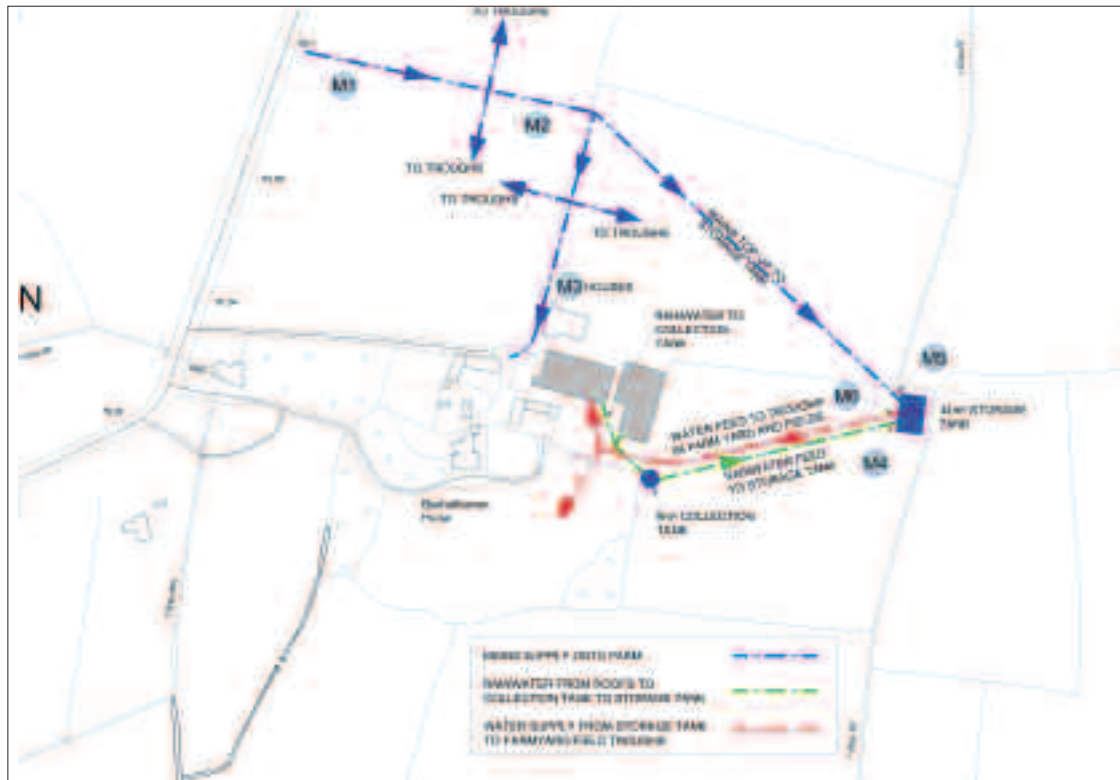
- M1 measured all municipal water supply to the farm.
- M2 measured municipal supply to the farm, minus water supplied to troughs between M1 and M2.
- M3 measured the municipal water to the three houses on the farm.
- M4 measured the rainwater feed from the 9m³ collection tank to the 44m³ storage tank.
- M5 measured the municipal water supplied as to up in periods of low rainfall to the 44m³ storage tank.
- M6 measured the water fed from the storage tank to the cattle troughs connected to the RWH system. This measurement (M6) was exclusively harvested rainwater in periods of rainfall.

Fig. 3.15 Showing location of flow meters (Background Map Source: OS Map No. 2648).

The meters used were Bonyto Klasse C 1.5m³/h type. Each meter was connected to an Endress + Hauser MinilogB data logger. Meter readings were recorded and stored by the data logger at 4-hourly intervals. This stored data was downloaded via a laptop and the Endress + Hauser software ReadWin 2000. To monitor local weather patterns, a Vantage PRO2™ Weather Station from Davis Instruments was installed on the farm. Using the software package Weatherlink, the weather data stored by the station's data logger was downloaded once every 6 weeks.

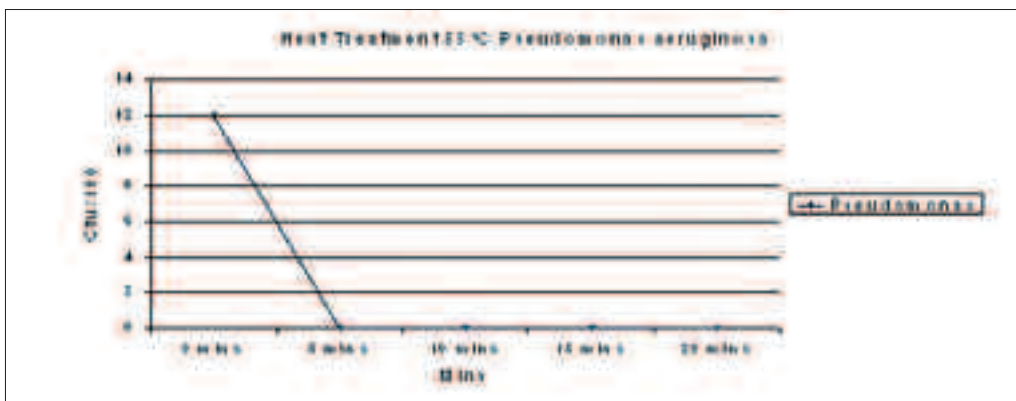
Fig. 4.3 *Pseudomonas aeruginosa* results for Heat Treatment Experiments at 55°C.

Pseudomonas aeruginosa (12 cfu/100ml) was detected at Time 0 minutes. As with TVCs, no *Pseudomonas aeruginosa* was detected at 5, 10, 15 or 20 minutes (Fig.4.3). Faecal Coliforms (36 cfu/100ml) were detected at Time 0 minutes. After incubation, no Faecal Coliforms were detected at 5, 10, 15 or 20 minutes (Fig.4.4).

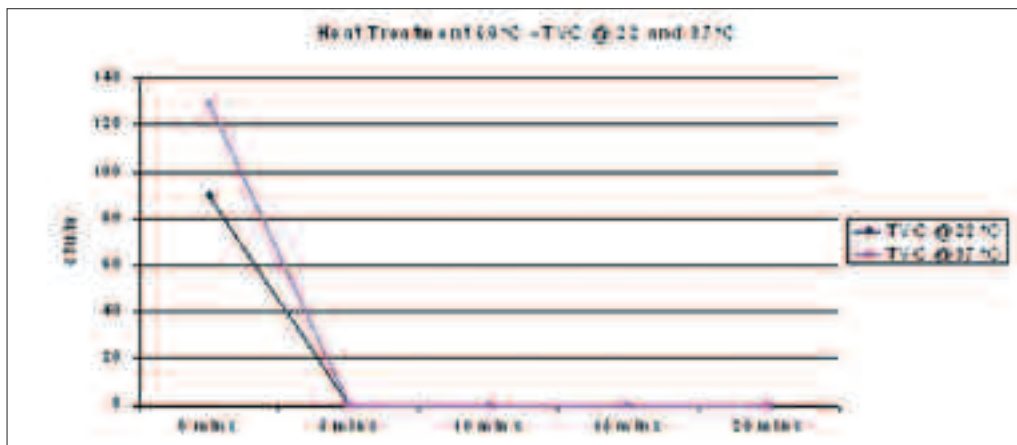
Fig. 4.6 Coliform TVC @ 22 and 37°C results for Heat Treatment Experiments at 60°C.

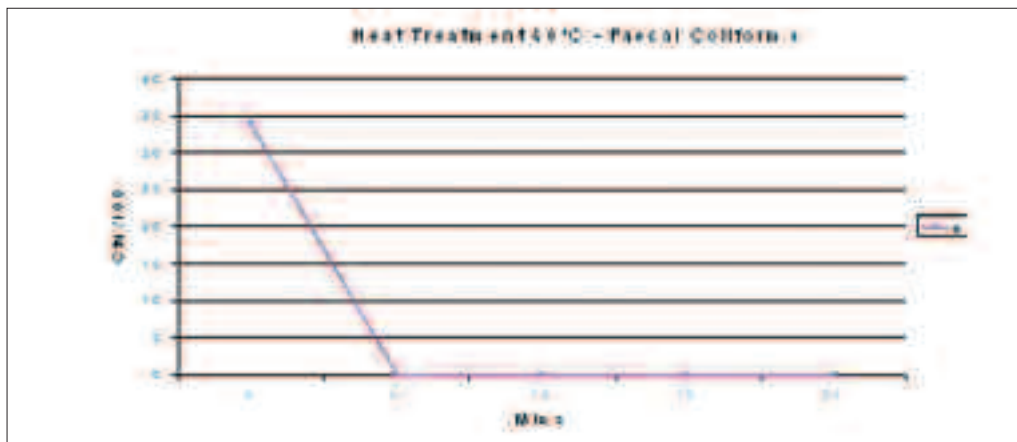
Faecal Coliforms were also detected at Time 0. 34 cfu/100ml was detected. Similarly to TVC's and *Pseudomonas* spp, no Faecal Coliforms was detected at 5, 10, 15 or 20 minutes (Fig. 7.8).

Fig. 4.8 Faecal Coliform results for Heat Treatment Experiments at 60°C.
