Microwave Self-healing Technology as Airfield Porous Asphalt Friction Course Repair and Maintenance System

Amir Tabakovic

Tabakovic, et al. (2019) Microwave Self-healing Technology as Airfield Porous Asphalt Friction Course Repair and Maintenance System'. *Case Studies in Construction Materials*, <https://doi.org/10.1016/j.cscm.2019.e00233>

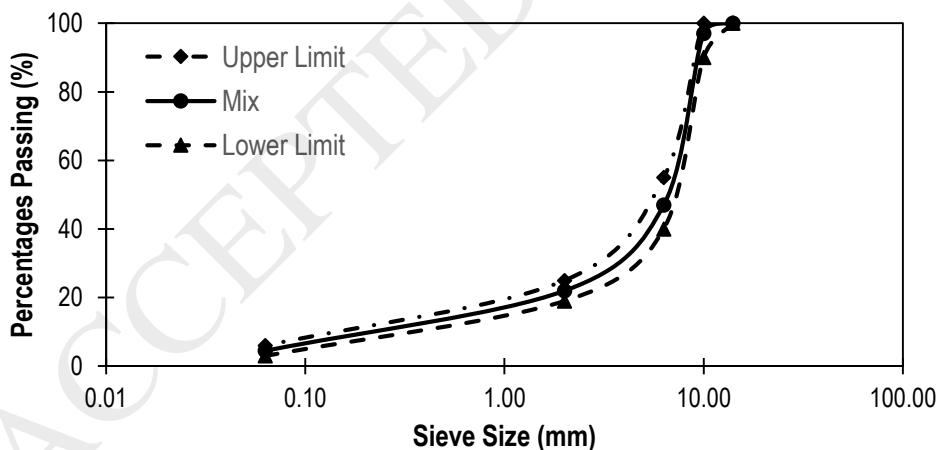
The Porous Friction Course (PFC) mix was prepared in accordance with MOD Specification 040. The aggregate was a high skid resistance Silurian greywacke from Northern Ireland. The filler was a combination of crushed Carboniferous limestone filler and hydrated lime to BS EN 459-1. The bitumen was a 160/220 pen as specified by MOD 040. Figure 1 shows the mix grading curve.

Figure 1. PFC grading envelope (MOD Specification 040).

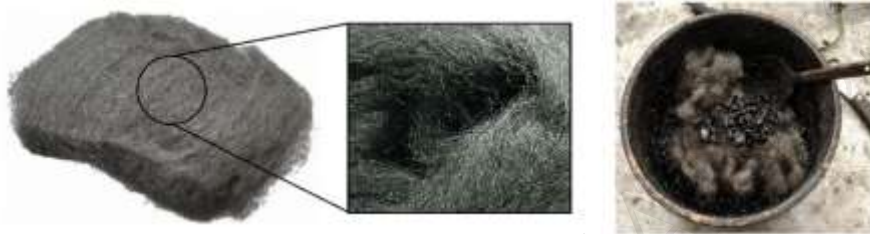
The steel fibre used was Grade 3 coarse-grained Trollull Steel Wool. Figure 2 illustrates the steel wool fibre used. The fibre diameter was 90 μ m. The fibres were cut using scissors to approximately 10mm in length.

Figure 2 Trollull Grade 3 steel wool.

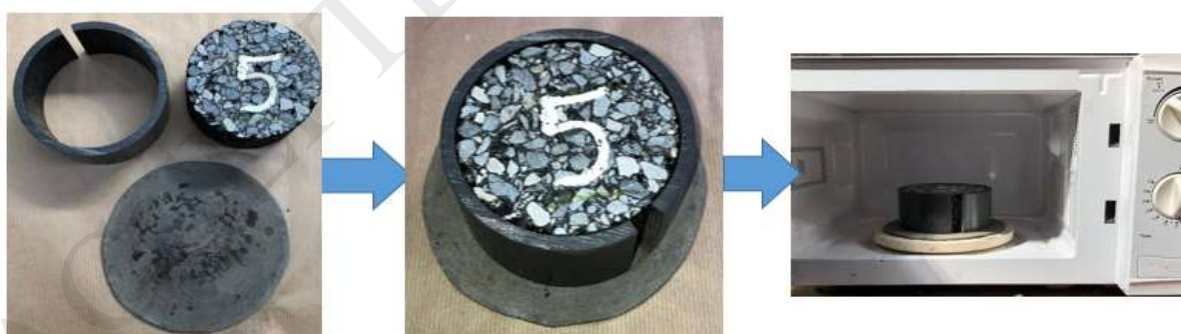
Figure 3. Microwave healing test system set up.

Figure 3 illustrates the main elements of the test programme. The microwave oven used was a Tesco Solo, Model No: MM08 with 700W power output. The defrost setting of 300 watts for 3 minutes was found to be the optimum healing condition for the PFC mix. Some sparks were visible during the first healing cycle probably caused by some of the fibres not being fully coated with bitumen. No sparks were observed for the second healing cycle. This is different to that found in literature where the test specimens are healed by heating for 40 seconds on the highest microwave power setting of 600 watts. The study summarised in this paper observed that at this laboratory microwave setting intense sparks

1. Specimens are first tested for non-destructive ITSM at 10°C and destructive ITS at -5°C.
2. After completion of the ITS testing the two halves of the test specimen are recombined. It is then placed into a specially designed cylindrical plastic collar with 100mm internal diameter and conditioned for 1 hour at an ambient temperature of 20±3°C.
3. The plastic collar and recombined cracked specimen is then placed in a micro-wave oven and heated for 3 minutes using the Defrost setting at 300 watts.
4. The plastic collar is removed and the specimen is left undisturbed to cool to room temperature 20±3°C during which the healing process takes place.
5. This testing and healing procedure is repeated twice.

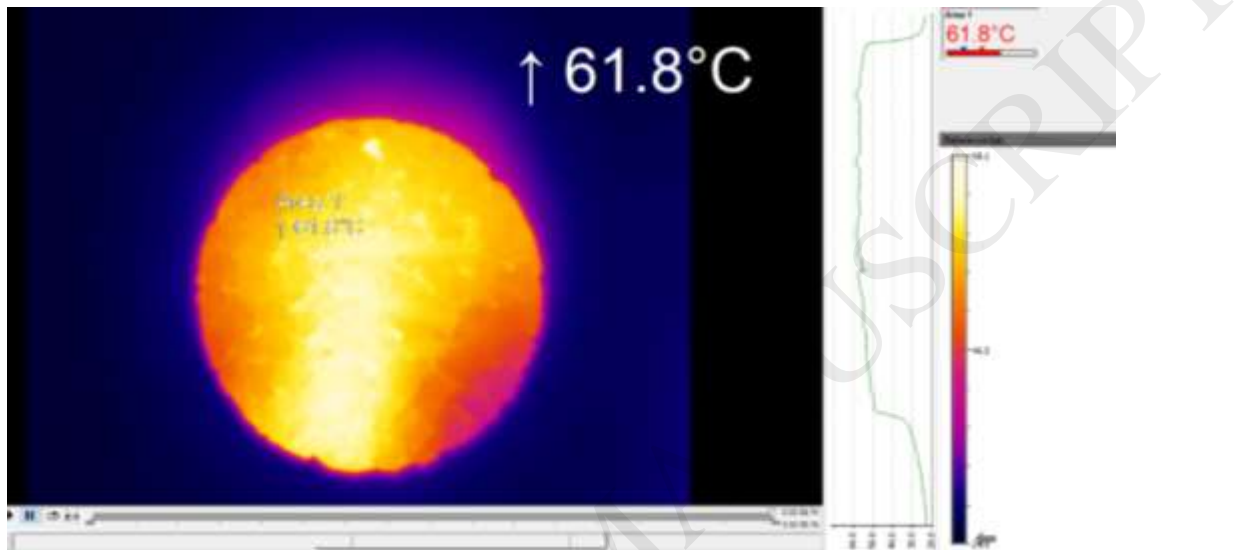
Thermal imaging was carried out to observe heat distribution throughout the test sample due to the microwave based healing process. This used a Micro Epsilon ThermoIMAGER TIM 400. Recording began immediately after the plastic collar was removed from the micro-wave heated specimen. Figure 4 shows a thermal image of a test specimen 60 seconds after microwave healing. The image shows temperature distribution across the surface of the test specimen. The average temperature is 61.8°C ranging from 56°C at the edges of the test specimen to 66°C at its centre. Figure 4 shows that this elevated temperature is relatively evenly distributed across the surface suggesting good steel fibre distribution throughout test specimen and in turn good asphalt mix healing.

Figure 4. Example PFC test specimen thermal image 60 seconds after removal from microwave.

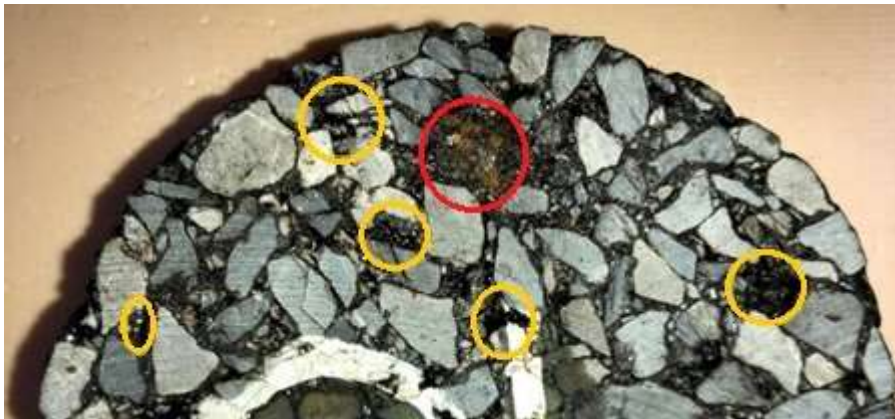
Figure 10 shows an example of steel fibre clustering and subsequent steel fibre oxidation in one of the test specimens. The yellow circles show localised areas of bitumen binder damage due to the excessive heating of steel fibre clusters. The red circle depicts an oxidized steel fibre cluster. Larger steel fibre clusters were recorded as having a heat spike of up to 400°C. Temperatures of this magnitude are above the flash point of the bitumen i.e. approximately 250°C, and would cause it to instantly vaporize. This is what likely caused the flashes and black fumes that were emitted from the 15% PFC mix during

microwave heating. This may have weakened the test specimen structure leading to its poorer test data.

Figure 10 PFC specimen #16 showing localised issues of oxidation and binder damage.

The PFC mix containing 15% fibres did not perform as well as the 5% and 10% PFC mixes. This is probably due to the clustering of steel fibres subsequently superheating the bitumen beyond its flash point.

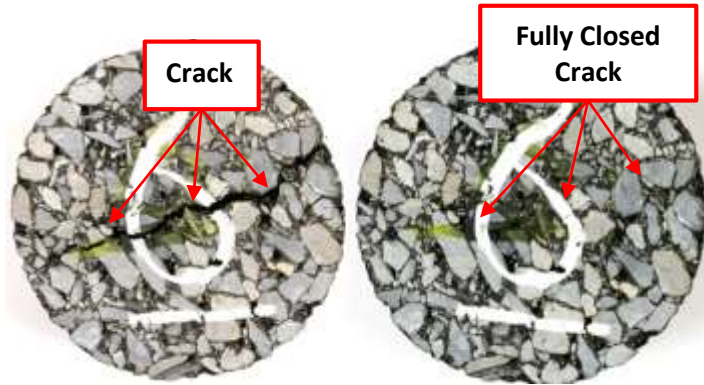
The PFC test specimens with 5% steel fibres increased stiffness value after the healing cycles. Figure 12 shows PFC sample #6 containing 5% steel fibres before and after healing cycle 2. Compared to Figure 11, the crack is completely healed. The increase in heat has probably reduced binder viscosity allowing it to flow not only into the visible cracks but also into other microcracks within the specimen. This agrees with the major healing mechanism of induction healing being capillary flow [23] and diffusion of the asphalt binder at high temperatures. Figure 13 shows PFC sample #15 which contains 15% steel fibres. The crack is fully repaired.

Figure 12. PFC specimen #6 with 5% steel fibre: Left: before healing and Right: after healing with fully repaired crack.

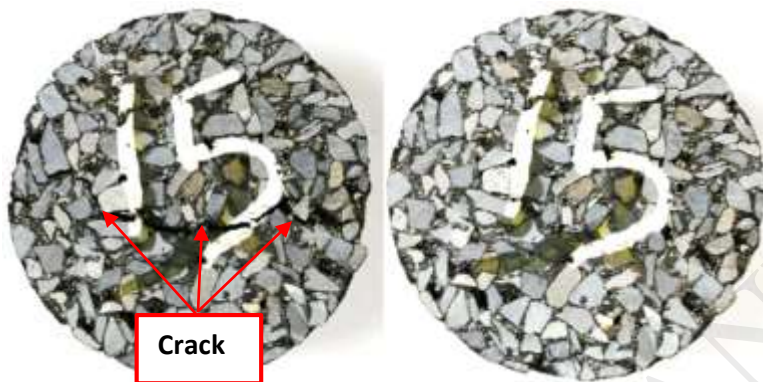
Figure 13. PFC specimen #15 with 15% steel fibre: Left: before healing and Right: after healing with fully repaired crack.
