## Northside Partnership "Healthy Community" Pilot Area Walkability Audit

## NORTHSIDE PARTNERSHIP "HEALTHY COMMUNITIES" PILOT AREA WALKABILITY AUDIT

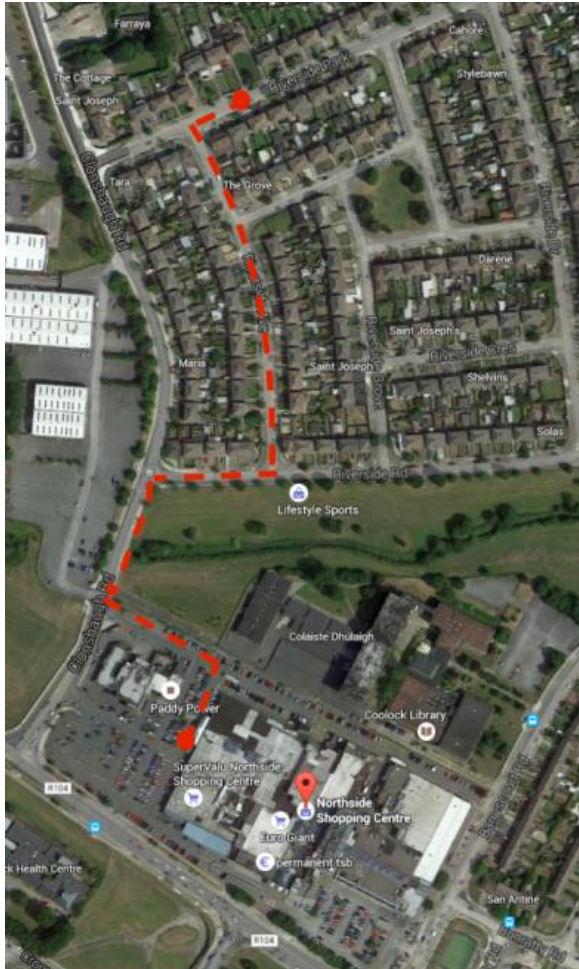
Figure 4: Aerial view of route 1

The first route is from Riverside Park to the Northside Shopping Centre. The Northside Shopping Centre is a busy focal point for the area, consisting of two anchor stores (Dunnes Stores and SuperValu), clothes shops, pharmacies, cafés and a public swimming pool, which is operated by Dublin City Council. It is adjacent to Coolock Library and Colaiste Dhulaigh (a second level school and a college of further education), further increasing the footfall in the area.

The chosen route runs from a housing estate north of the shopping centre and is approximately 600m in length. The route is very typical of the wider residential environment and is of key importance because Northside Shopping Centre is the main retail facility in the area. A number of factors that impact on pedestrian comfort were identified:

The permeability index gave a figure of 1.46. This indicates that the route is relatively direct; however, as mentioned above, providing access through the park would increase pedestrian mobility.

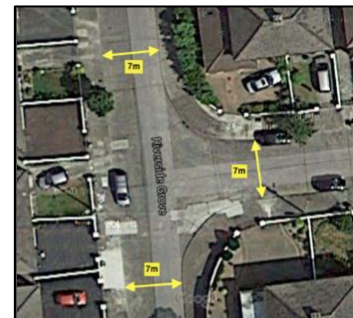
Figure 5: Carriageway width on Riverside Grove

- The carriageway width (approx. 7-8m) and corner radii (approx. 9m) allow cars to travel at high speeds and create long crossing distances for pedestrians (see figures 5 & 6).
- There is a roundabout at one of the junctions (see Figure 6), which does very little to restrict car movement, thus posing more of a problem for pedestrian mobility.
- The patchy, uneven surface characterises most of the route is generally unattractive and also could potentially cause people to fall and (see Figure 8).
- Litter is also problematic for certain parts of the route, particularly in the Stardust Memorial Park (see Figure 8). In the area audited, including the park, only one bin was identified. There is also a lack of seating, which could invite people to rest or be a focal point for social encounters.

- Infrastructure: wider footpaths; traffic-calming measures (tighter corner radii, chicanes and narrower carriageways); increased permeability (for example, more access through parks); and more pedestrian crossings.

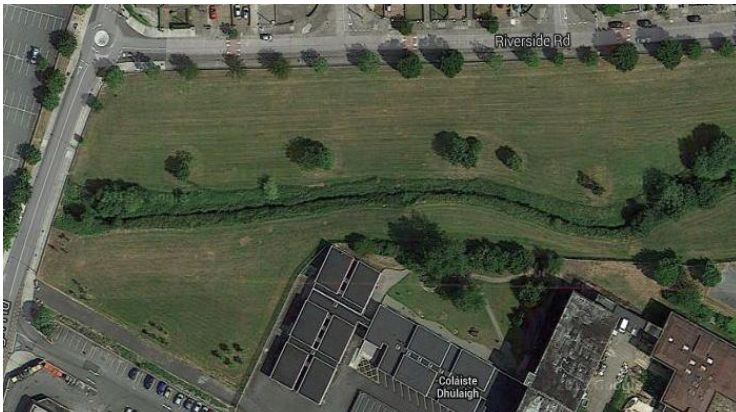
Figure 10: The Stardust Memorial Park

- Access through the park is restricted by a fence and a stream (the Santry River), which runs through (see Figures 10 & 11). This not only reduces the directness of the route but it also leaves the park underutilised, allowing for antisocial behaviour such as littering.

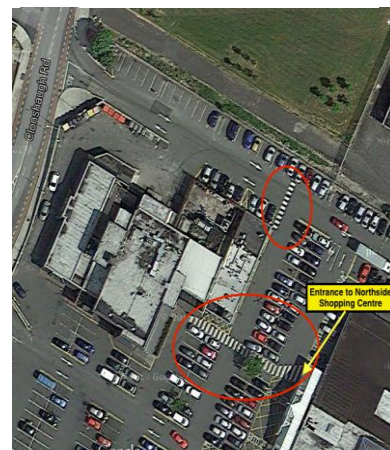
Figure 12: Car park in the Northside Shopping Centre

- The lack of designated footpaths or walkways in the shopping centre car park makes walking very difficult, potentially unsafe and certainly unappealing, particularly during busy times.

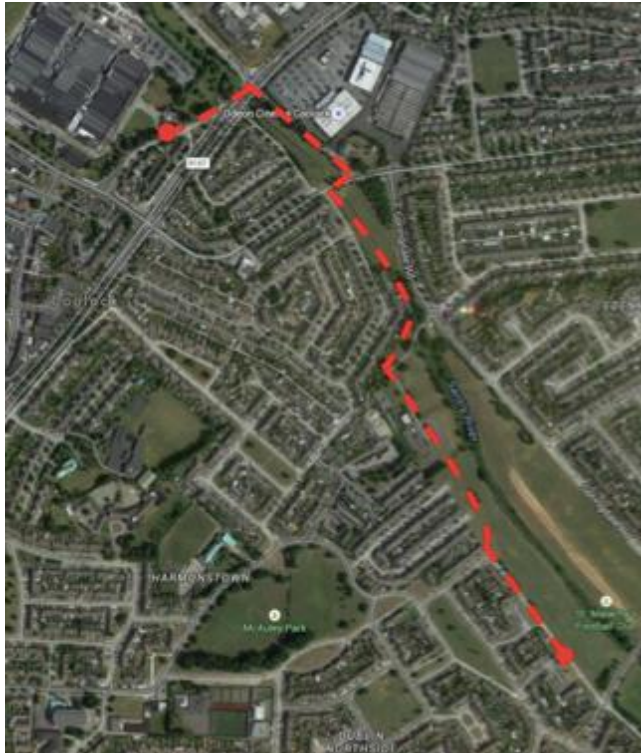
Figure 13: Aerial view of route 2

The second destination is the Cadbury Factory, which employs 450 people, many of whom live locally. The assessed route leads from Lein Park, a housing estate, to the Cadbury Factory site entrance and is over 1000m in length. This is a commonly used route on a desire line to a major employer. Significantly, it also forms part of a designated Greenway and strategic cycle route in the Dublin City Council Development Plan [9]:

The PRD for this route is 1.3, which is considered low, suggesting that directness should not be a major issue for this route, which in turn supports the idea of the Santry River Park as a natural greenway. Nonetheless, as can be seen above, crossing major roads reduces the amenity of the route.

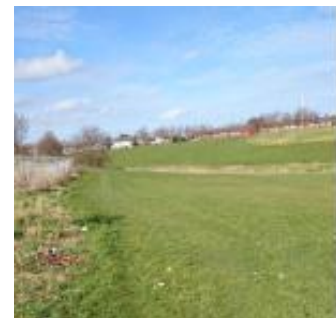
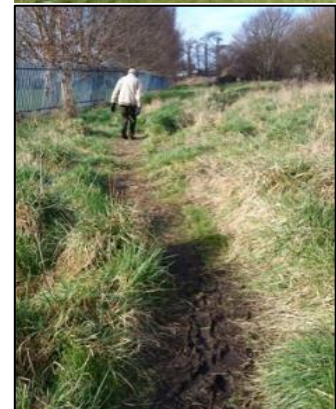
Figures 14 & 15: Informal trail through Santry River Park

- There is no footpath from the beginning of the route, though an informal walking route can be seen through the grass (see Figures 13 & 14). This is problematic as this path is slippery and uneven.
- Moving through the park, there is a strong perception of anti-social behaviour based on the presence of litter. This is aggravated by poor lighting and overgrown vegetation, which inhibits passive surveillance of the area.
- The absence of a footpath continues until the route meets Glenwood Road, where there is narrow paving (less than 1m in width).
- In addition, there is no cycle path, resulting in cyclists and pedestrians sharing the same footpath.

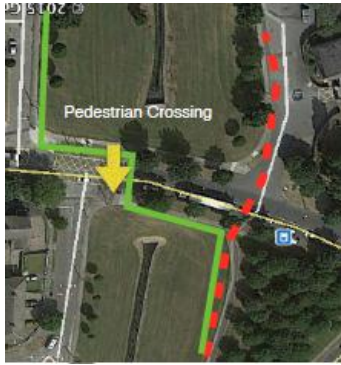
Figure 18: Crossing at the Tonleage Road

- The footpath widens and the route becomes more attractive as it transects the Santry River Park. The absence of seating and street furniture in the park was noted.
- Another problem arises when the route passes across the Tonleage Road; the most direct route does not have a pedestrian crossing – it is 37m to the left (see figures 18 & 19). This results in pedestrians choosing to cross the road without the use of signals.

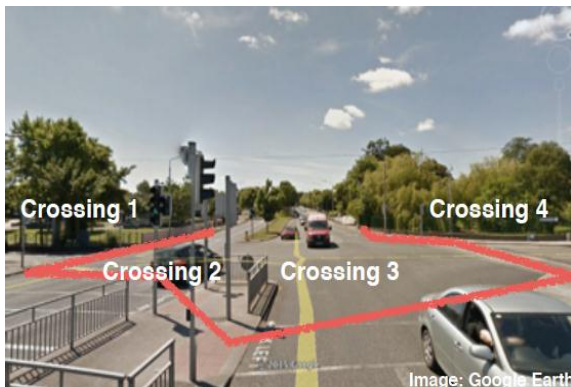
Figure 20: Multiple crossings at the Malahide Road

- Approaching the Cadbury Factory, pedestrians are required go through 4 crossings to cross the Malahide Road (see Figures 20 & 21), increasing the waiting time by approximately 7 minutes.

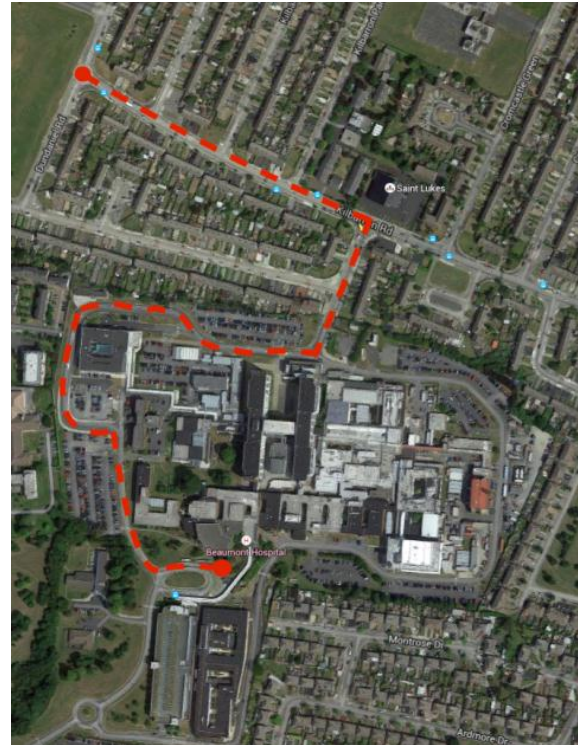
**Figure 22: Aerial View of Route 3**

The third route, which is approximately 510m in length, runs from the front entrance of Beaumont Hospital, through the hospital grounds and ends in a residential area.

The permeability index for this route was calculated as 2.06. This is a high PRD score, suggesting that the route is quite indirect. As can be seen in Figure 22, the surrounding housing estates consist of long blocks and the hospital itself is relatively impermeable. The poor quality of access to a national health facility has consequences for the mobility of employees, who may live locally, as well as those going there for health purposes. There is an almost planned level of disconnect between the hospital and its surrounding community, which is highly detrimental and contradicts accepted best practice.

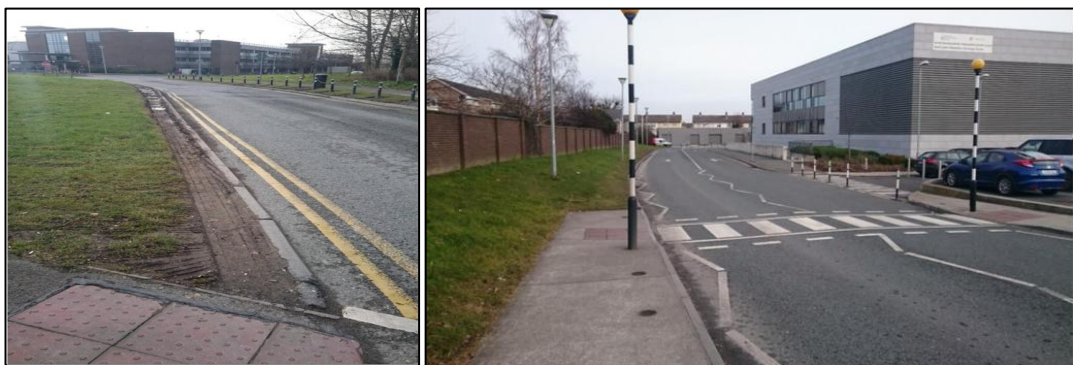
**Figure 23: (left) Lack of paving in Beaumont hospital**  
**Figure 24: (right) End of footpath in Beaumont Hospital**

- Narrow, or lack of, paving, which is particularly problematic as there are likely to be wheelchairs and people with mobility issues (see Figure 23).
- The paving comes to a stop and pedestrians are forced to cross over the street (see Figure 24).
- The uneven paving and street clutter pose a further barrier to walking, particularly for the elderly and people who are unsure on their feet.
- The presence of high walls and fences result in a lack of passive surveillance, which is not only unpleasant for walking but can also lead to making people feel unsafe.
- The surrounding housing estates are impermeable due to the presence of cul-de-sacs, which disconnect them from the hospital.
- Few safe pedestrian crossings coupled with wide corner radii, further reducing pedestrian safety.

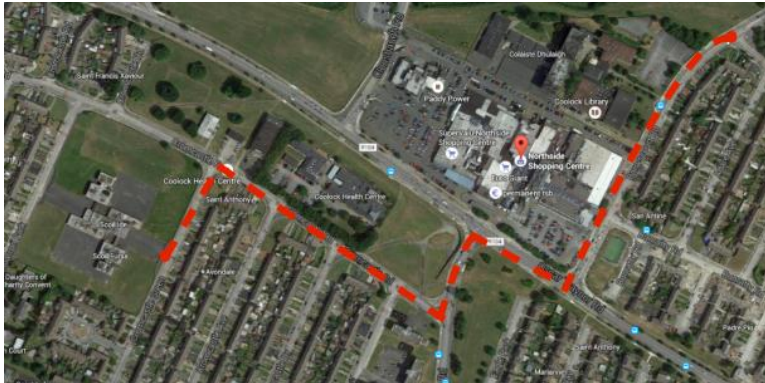
Figure 25: Aerial view of route 4

The fourth route has a distance of 780m and connects the entrance of Scoil Fhursa and Scoil Íde on Cromcastle Green with Adare Road and. These are two local primary schools located in a housing estate.

- Narrow and uneven footpaths, which continue for much of the route.
- Wide corner radii and a lack of clear pedestrian crossings make it very difficult for pedestrians to cross the street.

The PRD for this route is 1.4, suggesting that the route could be direct if made safe and amenable.

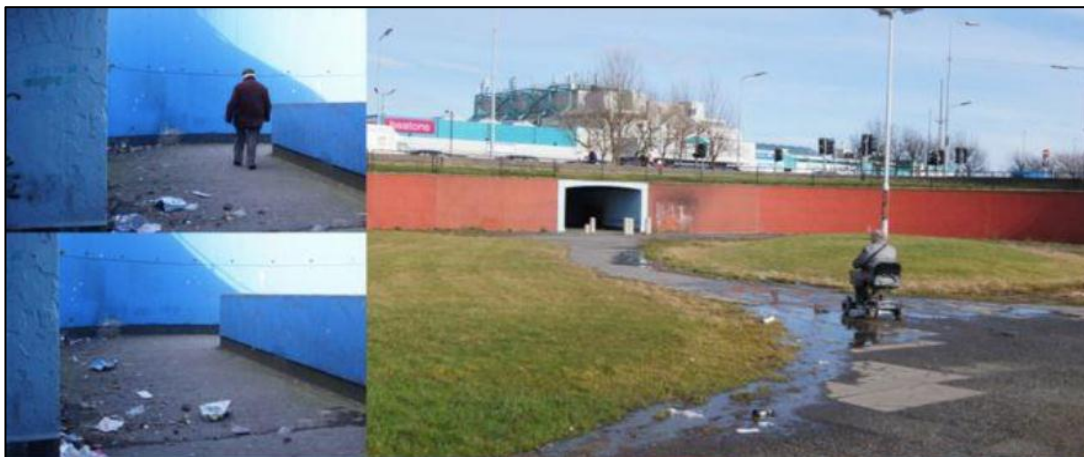
Figure 26: Litter and graffiti at the underpass at the Oscar Traynor Road

- A mini roundabout at the junction on Cromcastle Road, allowing motorised vehicles to move at high speed, posing a threat to pedestrians.
- The underpass beneath Oscar Traynor and Kilmore Road (see Figure 26) is far from a safe and amenable walking experience; high levels of litter, dog fouling, the stench of urine, broken glass, graffiti and a lack of lighting are not only unattractive but also increase the perception of anti-social behaviour. Local knowledge suggests that such perceptions are very justifiable [8]. This underpass was due to be removed as part of a redevelopment of the area which received planning permission in 2009 but which did not progress due to the downturn in the economy [10].

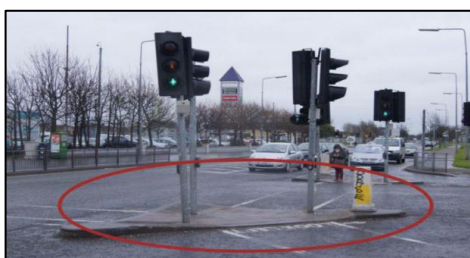
Figure 27: Multiple crossing and small median on the Oscar Traynor Road

- Multiple crossings to reach the other side of the street (see Figure 27). Moreover, the medians are quite small, which could lead to pedestrians standing on the road. The lack of safe pedestrian crossings and wide corner radii also continue for this part of the route.
