## Developing a Visitor Profile: The Hill of Tara for Hill of Tara Conservation Management Plan

# Tara Conservation Management Plan **Appendices**

**September 2022**

# **Tara Monument Catalogue & Condition Assessment**

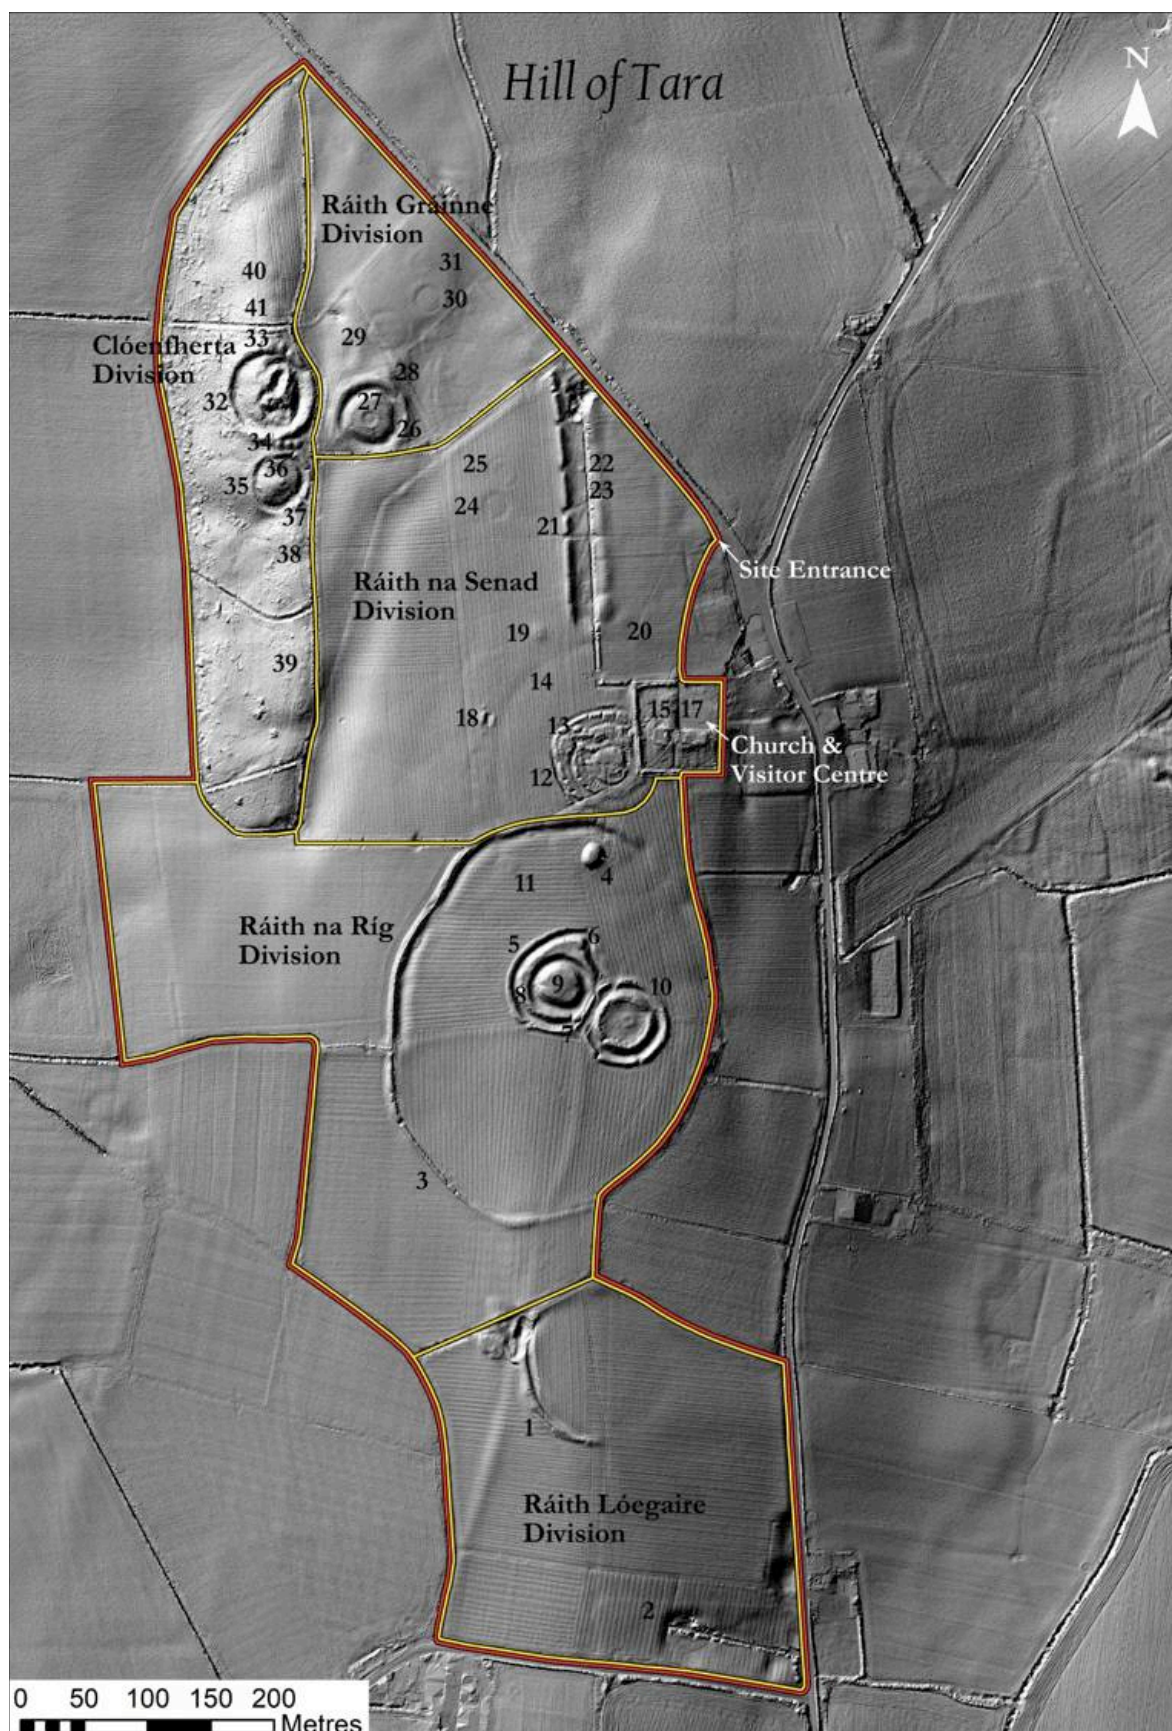
Fig. 1 Hillshaded lidar terrain model of Tara showing boundary of the State property (red), monument divisions (outlined in yellow) and numbered monuments in catalogue.

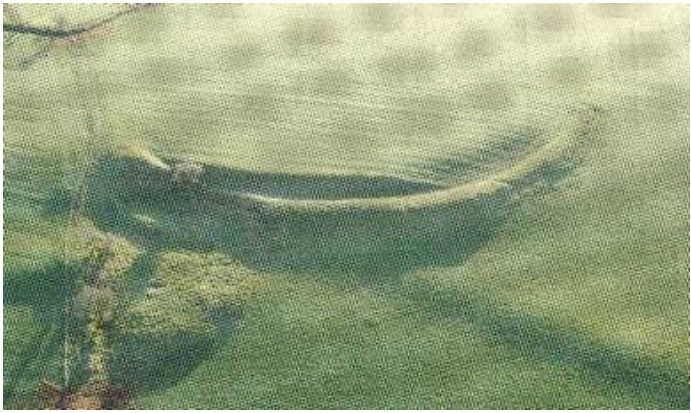
<p><b>Fig. 3</b> Aerial view of Ráith Lóegaire, from the W. Note gently-rounded profile of the remnant inner bank, on SW.</p>		<p><b>Illustrations</b> Figs 2–5</p> <p><b>References</b> Newman 1997, 47–52, 180, 317</p> <p><b>Dimensions</b> Max. diameter approx. 130m N/S by 122m E/W (excluding levelled bank on E); interior ground surface 2.2m high above bottom of ditch; outer bank 6.3m in max. width and 0.7m high above bottom of ditch</p>
<p><b>Description</b></p> <p>Situated at the southern end of the summit ridge, Ráith Lóegaire is a large, circular enclosure defined by two banks (B1 and B2) with an intervening ditch (<b>Figs 3 and 4</b>). The E part of the enclosure was levelled sometime before 1836, and only the W half – extending as far as a remnant field boundary (FB1) that once bisected the enclosure N/S – is visible today. Here the ramparts were built along a marked break in slope, where a former quarry (Q) has cut away part of the outer bank and accompanying ditch. The inner bank is best preserved on the SW, albeit much denuded by former cultivation which extended across the interior of the enclosure. On the NW and NE, the ramparts were incorporated into field boundaries (FB2 and FB3) that formed part of the earliest identifiable field system at Tara (Newman 1997). One of these boundaries (FB2) has been removed while the other (FB3) comprises the footings of a stone wall fronted by a post-and-wire fence and forms a boundary of the State property. A possible road or driveway (DW), which pre-dates the quarry, approaches the enclosure from the SW and continues northwards to the junction of the Forrad and Tech Cormaic, inside Ráith na Ríg. Traces of the levelled, E boundary of Ráith Lóegaire are visible on lidar imagery (arrowed on <b>Fig. 4</b>) and its full circumference was mapped by geophysical survey in 2002. This confirmed that the enclosure had an E-facing entrance and revealed significant new features in its interior, including a possible roundhouse. The investigations also identified several ring-ditches and other features in the immediate environs of the monument.</p>

<p><b>Physical condition</b></p> <p>Most parts of the enclosure have suffered considerable damage from past land use practices, with only the SW quadrant escaping the most severe impacts. In addition to the effects of agriculture and quarrying, there are signs of minor deterioration in the form of narrow gaps in the outer bank and erosion from animal traffic (evidenced on lidar imagery as a series of faint narrow tracks, generally trending NW/SE). Despite extensive loss and disturbance of the earthworks, however, geophysical survey has shown that significant below-surface features survive across the site.</p>		
<p><b>Maintenance issues</b></p> <p>Ráith Lóegaire attracts fewer visitors than other parts of the hill and there is minimal evidence of wear from pedestrian traffic. The surviving earthworks are difficult to interpret, and even locating them under the high grass can be a challenge (the nameplate from the existing signpost is missing). There are signs of erosion from sheep sheltering beside a lone hawthorn tree on the W-facing slope of the outer enclosure bank, an area previously impacted by quarrying (Fig. 5). As well as sheep and deep-rooting vegetation, there is also a potential risk of disturbance by burrowing animals. A no-drive zone is currently in operation over the entire area of the monument (tracks created by farm vehicles crossing the enclosure are visible on the 2007 lidar imagery). As FB3 forms a boundary of the State-owned lands, it needs to be maintained as a stock-proof fence.</p>

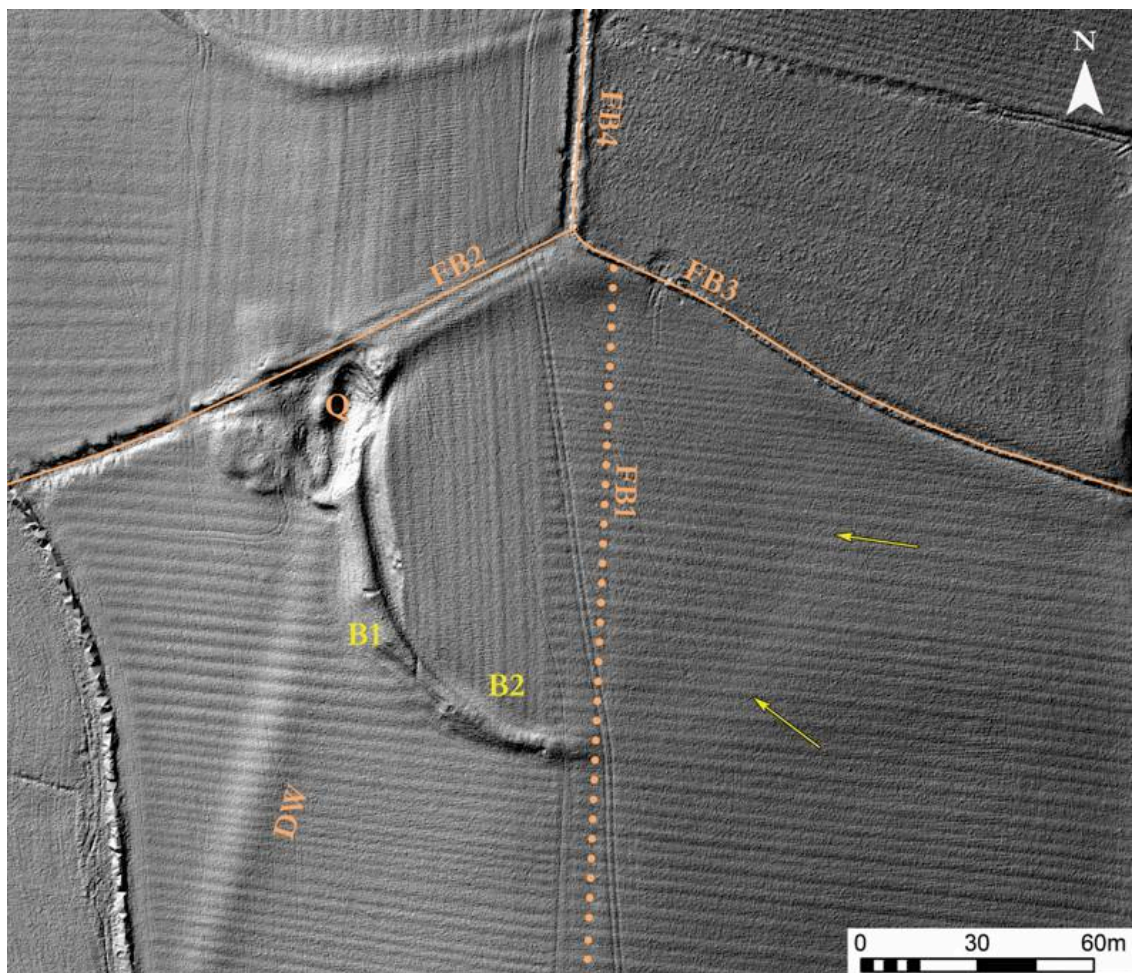
**Fig. 4** Lidar hillshade model of Ráith Lóegaire showing key archaeological (yellow) and historical (orange) features.

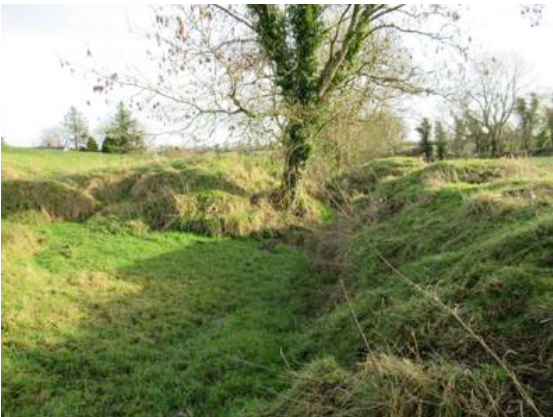
<p><b>Fig. 8</b> East-facing view of overgrown streambed and adjacent marshy hollow.</p> </div>

<p><b>Physical condition</b></p> <p>The water issuing from the spring is clear, but it occasionally dries out and becomes stagnant. The area surrounding the springhead is covered by high grass and littered with stones that have been dislodged by tree roots and pedestrian/animal traffic. The stream is overgrown and clogged with silt and dead vegetation.</p>		
<p><b>Maintenance issues</b></p> <p>Regular cleaning and maintenance works are required to improve the condition of the site.</p>		
<div>   <p><b>Fig. 7</b> Stone revetment and tree roots surrounding the spring (January 2019).</p>

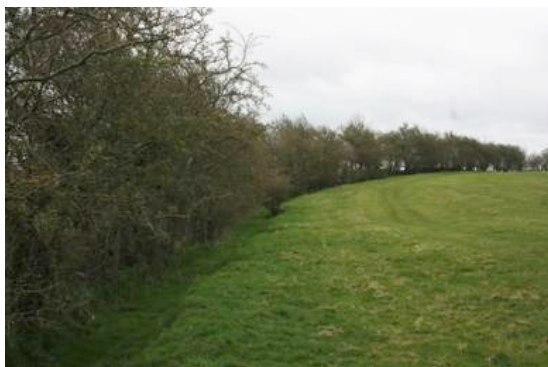
**Fig. 12** Curving tree-lined field boundary and modern ditch built along the western boundary of Ráith na Ríg, viewed from the north (April 2018). The field fence forms the boundary of the State property.

The principal threats to the enclosure and its internal monuments stem from tourism and recreational pressures and damage caused by livestock. It should be noted that it is not only the fabric and setting of upstanding earthworks that are at risk: a major concentration of archaeological features and deposits is known to lie just below the ground surface, which are also vulnerable to damage. Erosion from pedestrian traffic is mainly concentrated along specific routes linking the high-profile monuments. There is also significant footfall along the crest of the bank and around the inner circuit of Ráith na Ríg (the use of the latter area as a 'track' for fitness training is causing damage and is not compatible with the sensitive nature of the site). The level of erosion along these paths varies, from minor surface wear to more deeply incised tracks and erosion scars, particularly on the slopes of the earthworks. Mature hawthorn trees on the bank of Ráith na Ríg are causing disturbance to sub-surface archaeological layers and could cause more extensive damage to the earthwork if uprooted. Grazing and sheltering sheep are also contributing to localised erosion of the bank of Ráith na Ríg, while cattle in the adjacent fields to the E pose a significant threat to the already disturbed portion of the enclosure bank lying outside the State-owned lands. The field boundary running along the circuit of Ráith na Ríg (FB4) forms part of the E boundary of the State property and is re-enforced by a stock-proof fence which requires regular maintenance. The risk of damage from farm vehicles has been minimised by the imposition of a no-drive zone over the entire area of the monument.

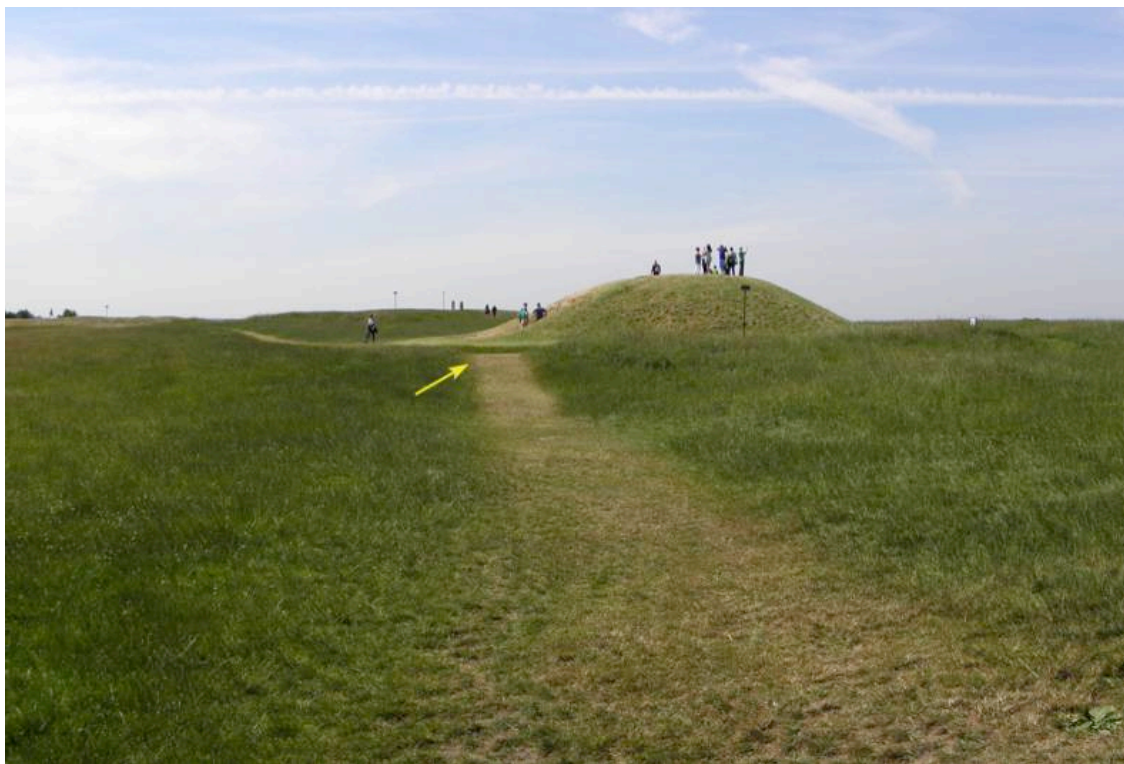
**Fig. 14** Concentrated footfall between the churchyard gate and the Mound of the Hostages is causing accelerated erosion of the already denuded bank of Ráith na Ríg (arrowed), as evidenced during a prolonged dry spell in June 2018. The impact of large numbers of people climbing on to the Mound of the Hostages is also exacerbated in very dry or wet conditions.

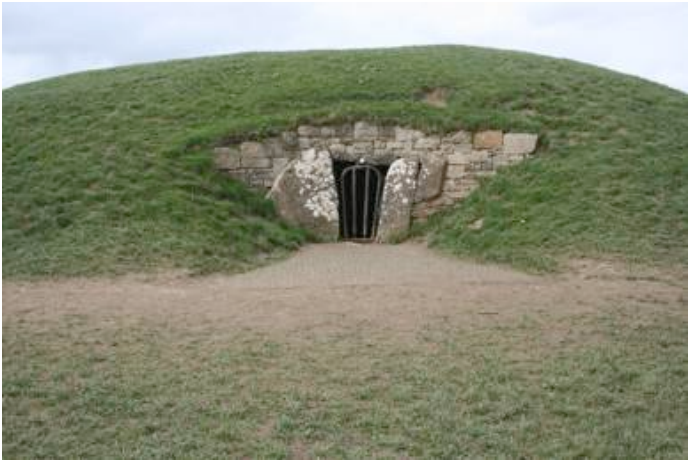
<p><b>Fig. 15</b> East-facing entrance to the passage tomb, showing turf reinforcement mesh extending from entrance to edge of mound and extensive erosion from pedestrian traffic (April 2018).</p>		<p><b>Illustrations</b>  Figs 9, 11, 14–19</p> <p><b>References</b>  O'Sullivan 2005; O'Sullivan et al. 2009; Newman 1997, 71–5, 145–9, 225–7, 318–19, 334</p> <p><b>Dimensions</b>  Mound approx. 2.75m high and 21.5m in diameter prior to excavation. Interior of passage approx. 3m long, 1.25m wide and 1.75m high.</p>
<p><b>Description</b></p> <p>Completed around 3100 BC, this Neolithic passage tomb was shown by excavation in the 1950s to have a long and complex history. Part of an earlier enclosure and other traces of activity were discovered beneath the monument, which appears to have been constructed in several phases. The tomb consists of a single stone-lined passage, about 3m in length, which is divided by sill-stones into three compartments and covered by a stone cairn and soil mantle (<b>Fig. 15</b>). The entrance, which is flanked by portal stones, faces ESE and a decorated upright stone (orthostat) is visible on the S side of the passage (<b>Fig. 16</b>). The remains of hundreds of individuals, most of them cremated, were placed in and around the tomb and in the overlying mound during the Neolithic and Early–Middle Bronze Age. Three main phases of burial activity have been identified, the latest dating to about 1700–1600 BC and represented by a young man, aged 14–15 years, whose unburnt body was placed in a grave dug into the mound. He wore a necklace of faience, amber, jet and bronze beads and had a bronze razor and an awl near his feet. The burials and rich assemblage of grave goods from the Mound of the Hostages (<b>Fig. 17</b>) provide an important window onto developments in funerary traditions, material culture, social organisation and exchange networks, both locally and with other regions of Europe, over a period of more than 1,500 years. The name of the monument suggests that kings exchanged hostages here in early historic times, a practice that likely had pre-Christian roots.</p>

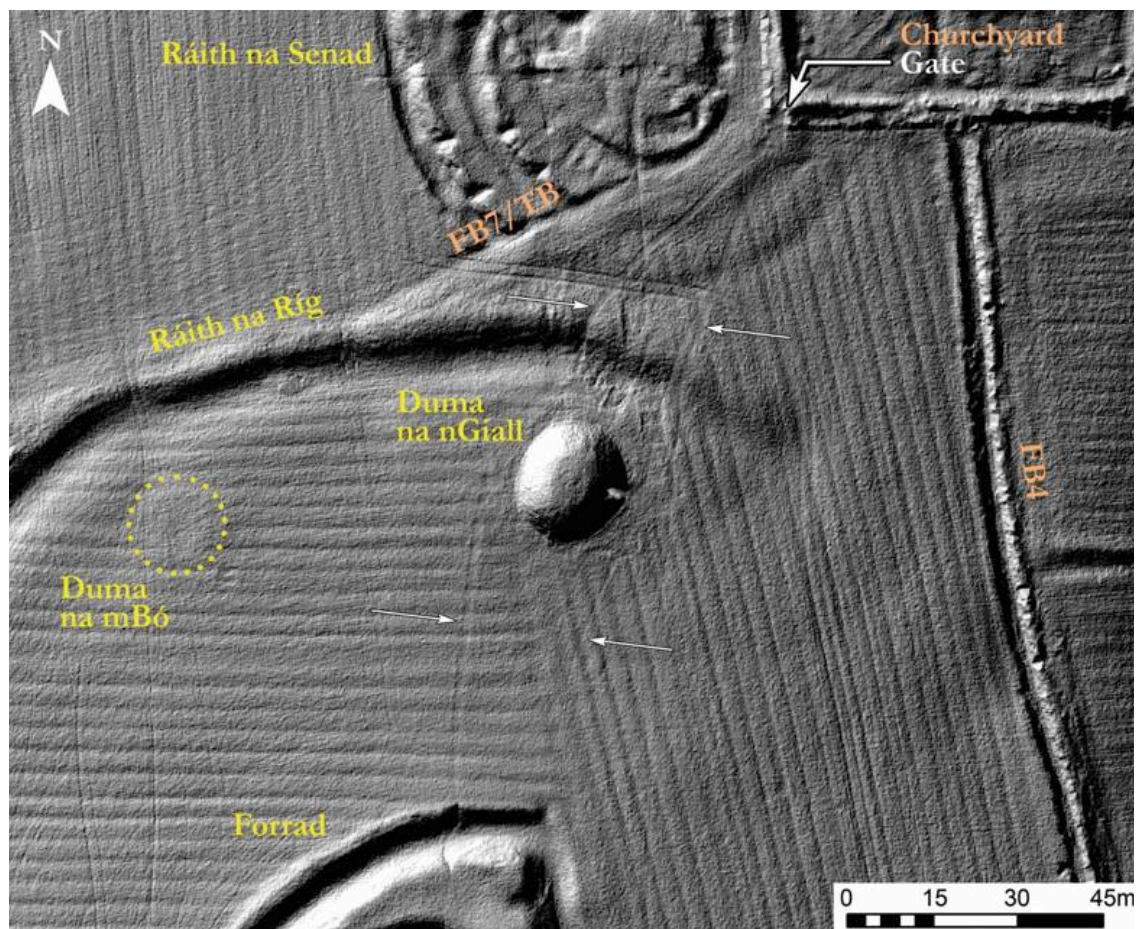
**Fig. 19** Lidar hillshade model of Duma na nGiall (Mound of the Hostages) and surrounding monuments, with the main pedestrian trackways leading from the churchyard to the passage tomb and the Forrad arrowed. Additional tracks created by pedestrians and sheep can be seen extending across Ráith na Ríg to the west. As well as causing localised damage to the archaeological monuments, traffic in front of the entrance to Duma na nGiall has removed all surface trace of the fossilised cultivation pattern.

Concentrated and sustained footfall between the churchyard, the Mound of the Hostages and the Forrad has created a network of earth-worn tracks that are causing damage to the earthworks they cross and risk exposing near-surface archaeological layers (**Fig. 19**). The Mound of the Hostages is highly vulnerable to attrition from visitors climbing on to it and there is also a potential safety risk arising from the height and angle of the slopes (**Fig. 14**). Inappropriate recreational use, such as sledding when the mound is covered in snow, is also a cause for concern. These types of activities are placing increased pressure on the monument and the resources required to maintain it in a stable condition. A turf reinforcement grid has been laid flush with the ground surface in front of the tomb entrance to help reduce surface erosion (see **Fig. 15**). The area is also regularly reseeded to promote grass cover; however, this has had limited effect due to the high level of soil compaction and wear from pedestrian traffic. Although not accessible to the public, the interior of the passage tomb is exposed to the elements and there is also a potential future risk of damage from burrowing/nesting animals. Local environmental conditions within the tomb and their effect on the exposed structural elements require detailed assessment as part of a broader condition monitoring programme.

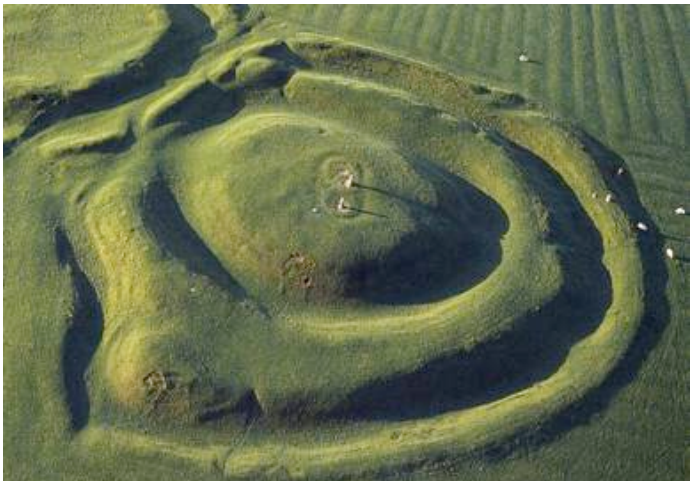
<p><b>Fig. 20</b> Aerial view of the Forrad, looking south. The largest of three mounds (no. 6) incorporated into the inner bank forms a prominent protrusion on the north side of the monument.</p>		<p><b>Illustrations</b> Figs 9, 11, 20–24</p> <p><b>References</b> Newman 1997, 77–83, 169–70, 227, 319–20</p> <p><b>Dimensions</b> Max. overall diameter 94m (NE/ SW); basal diameter of central mound 38m; max. height of mound above surrounding ditch 3.6m</p>
<p><b>Description</b></p> <p>The Forrad is a large, flat-topped mound encircled by a ditch and two external banks with an intervening ditch (<b>Fig. 20</b>). The monument as it appears today developed in several phases (Newman 1997) and traces of earlier structures on this spot have been revealed by geophysical survey. The central mound is thought to be a Bronze Age burial monument which later became a focus for royal assemblies and ceremonies. The inner of the two banks encircling the mound incorporates up to three smaller mounds (nos 6–8), which are clearly older than the bank and may also pre-date the central mound. The outer bank is believed to have been added many centuries later, by the builders of the adjoining ringfort, Tech Cormaic (no. 10). There are two stone monuments on the summit of the Forrad: the Lia Fáil (no. 9), the reputed inauguration stone of Tara, which originally stood near the Mound of the Hostages (no. 4); and a memorial commemorating the United Irishmen killed at the Battle of Tara on 26 May 1798, who are said to have been buried in a mass grave in the central mound. Both stones were erected on the Forrad in 1824.</p>

<p><b>Physical condition</b></p> <p>The monument is generally well preserved, with the main components surviving for the most part as impressive earthworks. A notable exception is the NE section of the outer bank, which has been almost completely erased by cultivation (<b>Fig. 21</b>). A V-shaped niche was cut into the bank on the SW, where it is abutted by a former field boundary, and the incorporation of the monument within this early field system also resulted in some modification of the bank on the S. There are several breaches in the banks on the E and SE resulting from long-term use of the junction between the Forrad and Tech Cormaic as a thoroughfare by pedestrians and farm animals. This route may have originated as an extension of the old road or droveway (DW) approaching from the S, which pre-dates the relict cultivation pattern inside Ráith na Ríg. Modern recreational use – and to a lesser extent, animal traffic – has increased the number of erosion paths and is placing additional pressure on vulnerable parts of the earthworks, in particular the steep-sided slopes and the gaps in the banks. On the N, concentrated footfall has carved a path across the banks and onto the mound summit which is steadily eroding the archaeological deposits (<b>Fig. 22</b>). Heavy footfall and extreme weather conditions also pose a threat to the stability of the earthworks, with slippage most likely to occur where the angle of slope is steepest (e.g. both faces of the inner bank and the NE side of the mound). Localised wear and disturbance in the form of erosion scars and trampling is also evident at various other locations around the monument (<b>Fig. 23</b>). Around the Lia Fáil and 1798 memorial on the mound summit, the ground surface is worn bare and is prone to waterlogging (<b>Fig. 24</b>). The depth and extent of ground disturbance resulting from the erection of these stones is not recorded.</p>

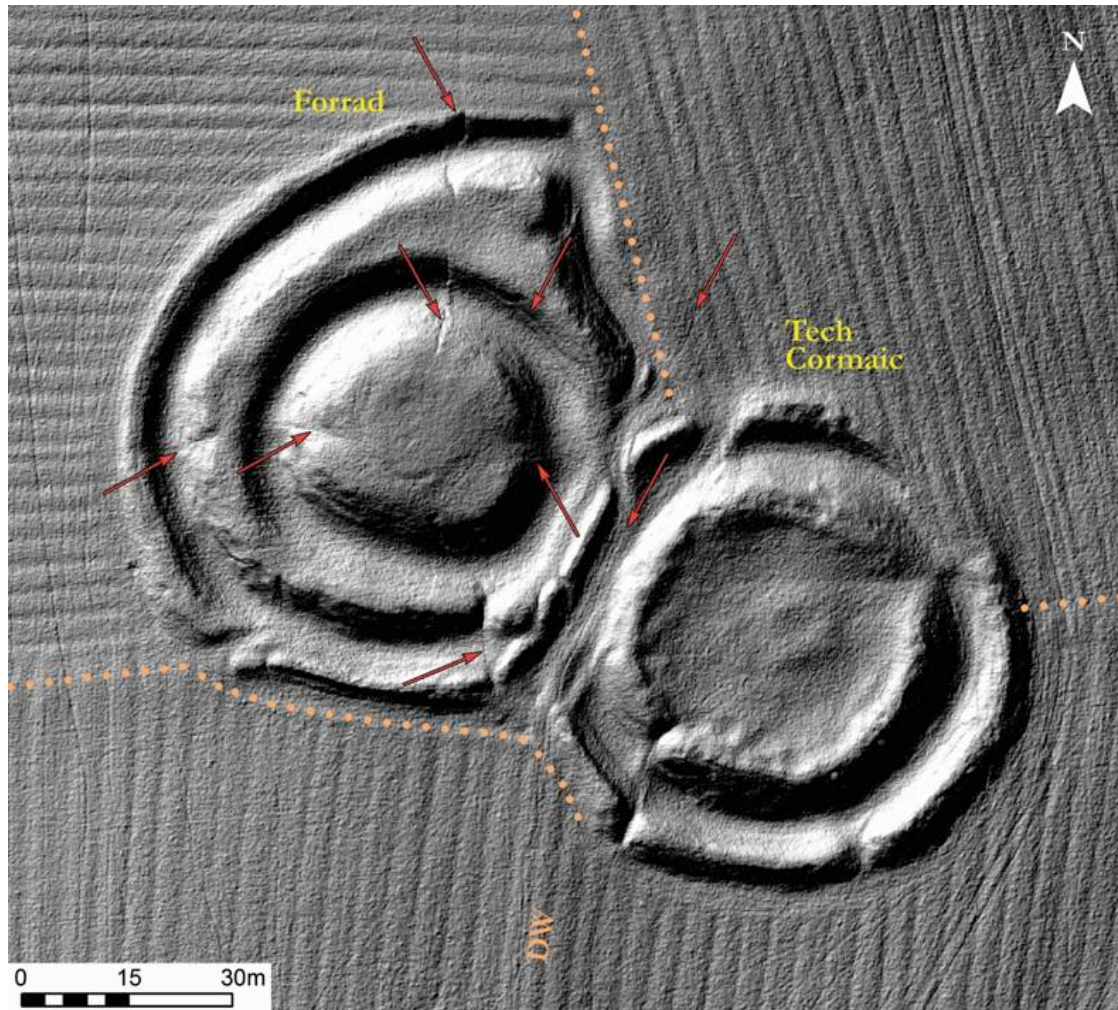
**Fig. 21** Lidar hillshade model of the Forrad, with arrows indicating the main erosion tracks over the earthworks. Additional pedestrian and animal tracks are visible to the west of the monument. The dotted lines mark the location of relict field divisions associated with former cultivation.

The key issues affecting the monument are damage caused by recreational use and the risks posed to the stability of the earthworks and visitor safety by the steepness of the slopes, particularly in wet or very dry conditions. Visitor pressure is mainly focused on N and E sides of the monument. The most extensive erosion path, on the N, is fenced off at regular intervals to allow for resting and reseeding (**Fig. 22**); however, the effects are short-lived and offer minimal protection to the exposed archaeological deposits. Other areas of the monument are also affected by surface erosion, including the summit of the central mound. Sheep may be a contributory factor, though sustained visitor traffic likely acts as a deterrent to regular grazing or sheltering.

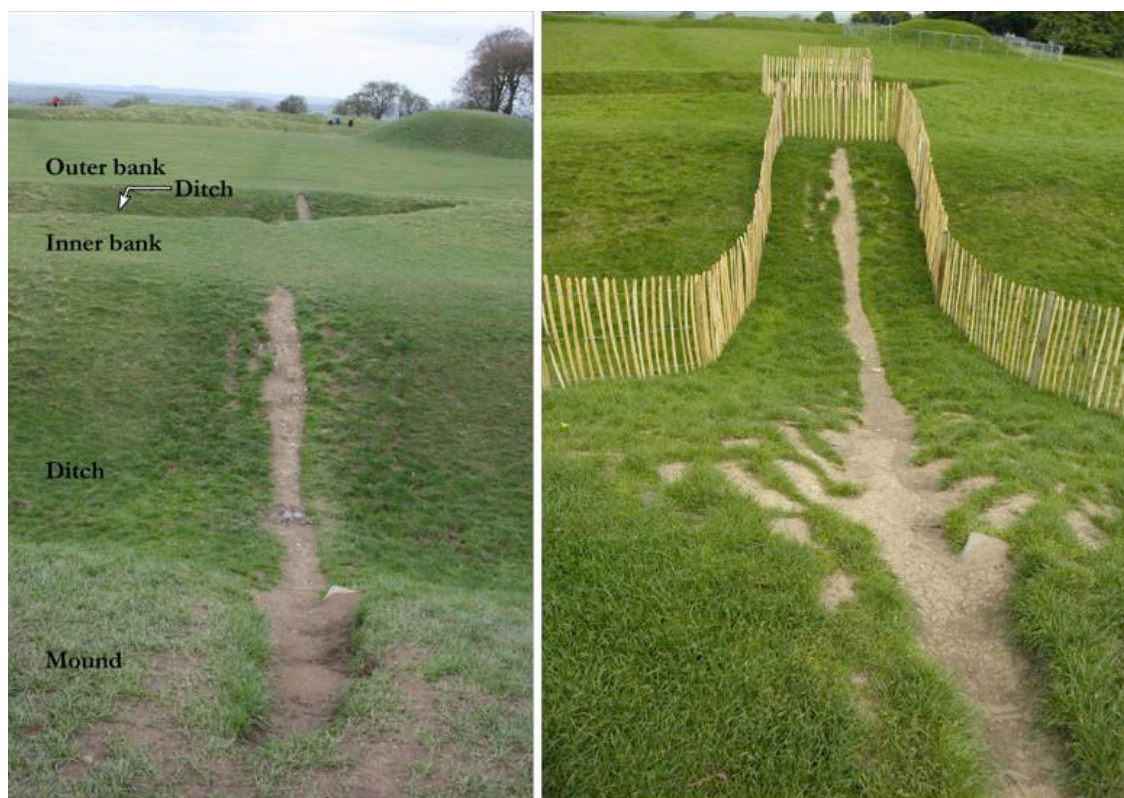
**Fig. 22** Incised path on north side of the Forrad, viewed from the central mound, showing accelerated erosion between April (left) and May (right) 2018, when the area was fenced off for reseeding. Damage resulting from pedestrian traffic is largely confined to the slopes of the earthworks, with the tops of the banks showing little evidence of wear.

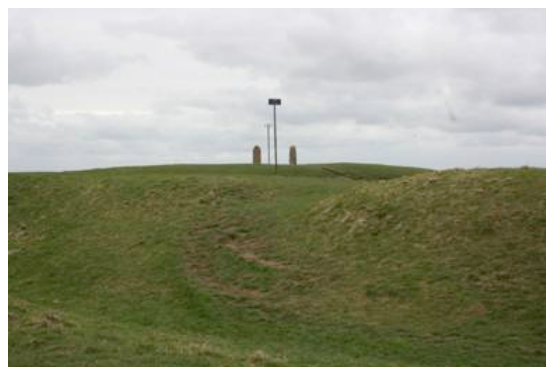
**Fig. 23** Surface erosion on the external face of the inner bank of the Forrad, on the northeast (April 2018).

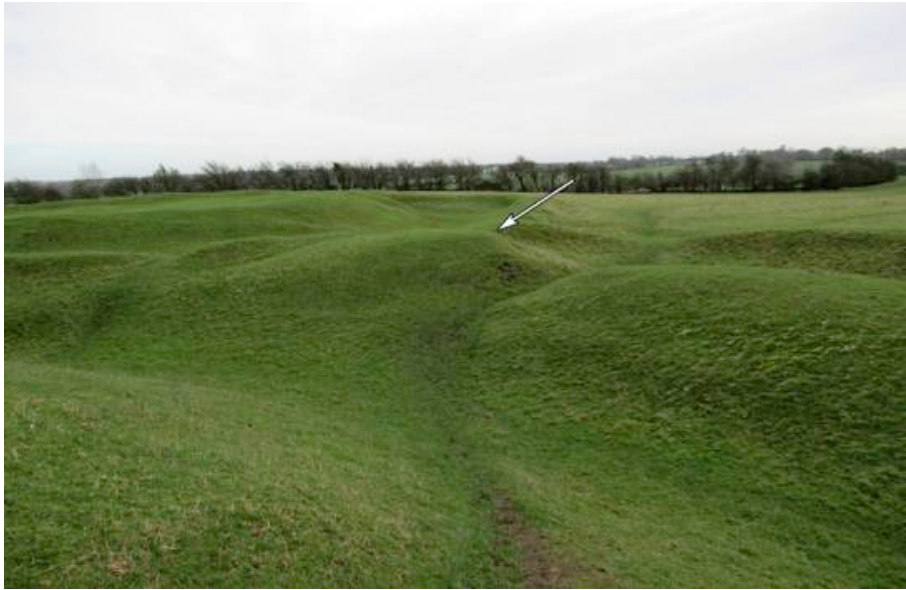
<p><b>Physical condition</b></p> <p>The mound is intact and is generally well preserved. However, traffic through the adjacent gap is causing attrition of the slope and base of the mound on the E side (see <b>Figs 21</b> and <b>28</b>).</p>		
<p><b>Maintenance issues</b></p> <p>The site is at risk of further erosion from pedestrian traffic and sheep.</p>

<p><b>Fig. 28</b> (Left) View of mound (arrowed) and surrounding earthworks, from the northwest, showing evidence of attrition from traffic through the gap between the mound and the inner bank of the Forrad (right) (January 2019).</p>

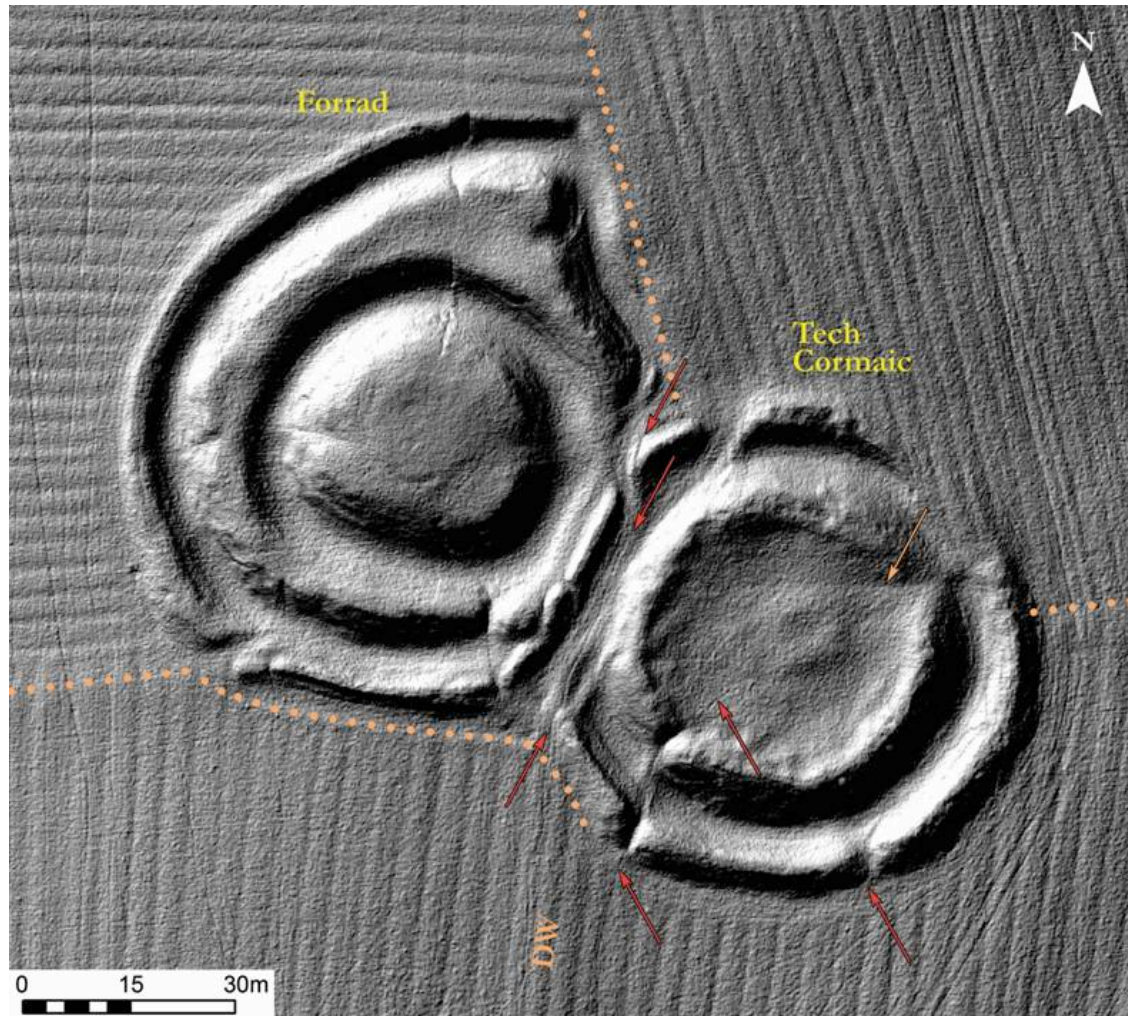
<p><b>Physical condition</b></p> <p>Apart from localised disturbance and erosion of the banks, the enclosure is in good overall condition. There are narrow gaps in the inner (SW) and outer (NW, SW, SE) banks and both have been partially flattened by cultivation on the NE. The field system associated with this phase of land use impinges on the enclosure and has resulted in some modification of the outer bank on the SW. These impacts mainly occurred between the 19th and mid-20th centuries and aerial photographs show no significant loss or deterioration of the earthworks since the mid-1970s. However, a number of incised paths have developed from sustained pedestrian and animal traffic through gaps in the banks and along the junction between Tech Cormaic and the Forrad (see <b>Fig. 34</b>). This junction links with an old road or driveway (DW) approaching from the S, which pre-dates the relict cultivation pattern inside Ráith na Ríg. The slopes of the banks also show evidence of damage and wear caused by sheep.</p>

**Fig. 34** Lidar hillshade model of Tech Cormaic, with arrows indicating the main erosion tracks over the earthworks. Farm vehicle tracks can also be seen skirting the southeast side of the enclosure. The dotted lines mark the location of relict field divisions associated with former cultivation. A linear depression running E/W across the enclosure (indicated by orange arrow) may form part of the same field system; however, this feature could also be archaeological in origin.

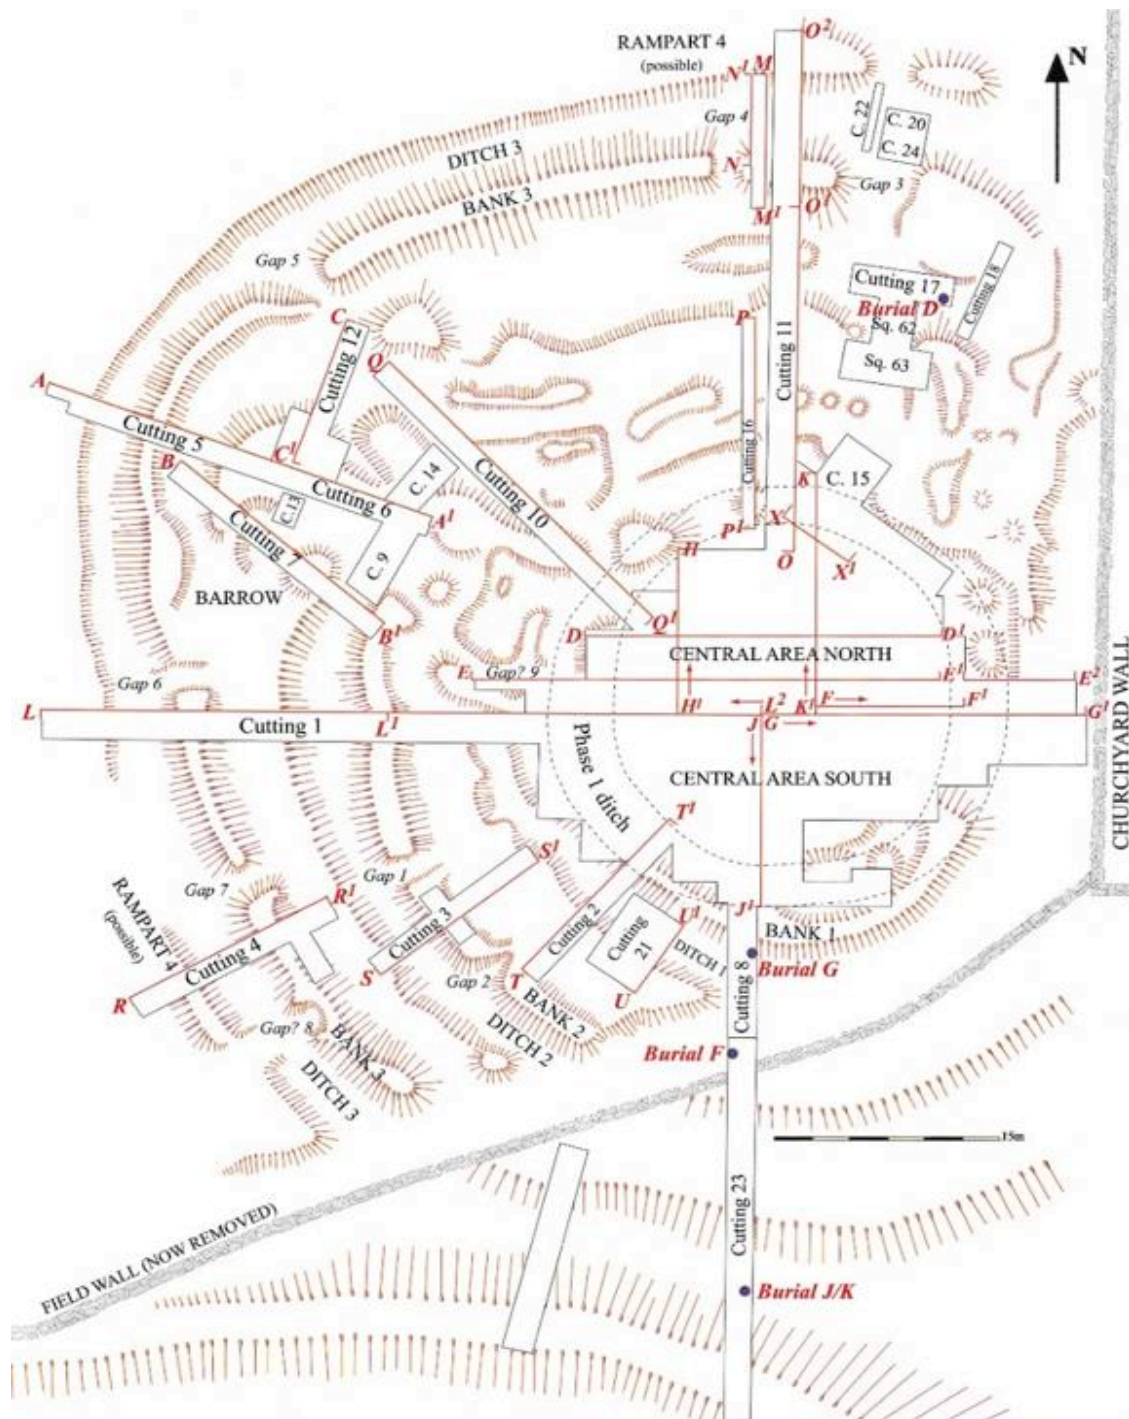
**Fig. 38** Pre-excitation plan of the Rath of the Synods, showing the location of the 1950s excavation cuttings (from Grogan 2008, fig. 1.4). The 'Phase 1 ditch' in the central area and barrow to the west both pre-date the multivallate earthworks.

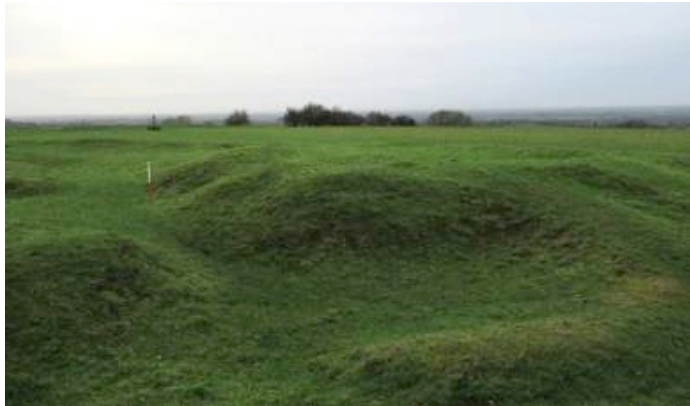
<p><b>Fig. 40</b> View of mound (centre) looking west from the ramparts of Rath of the Synods (January 2019).</p>		<p><b>Illustrations</b> Figs 36, 38–40</p> <p><b>References</b> Newman 1997, 92–6, 164, 166, 177, 321–2; excavation results and analysis: Grogan 2008, 37–42; O'Sullivan et al. 2009</p> <p><b>Dimensions</b> 16.5m in max. overall diameter; mound 12m in max. diameter; height of mound above old ground surface 1.25m; surrounding ditch up to 3m wide and 2m deep</p>
<p><b>Description</b></p> <p>A small, irregular mound incorporated into NW quadrant of the Rath of the Synods (no. 12), between the second and third ramparts (<b>Figs 39</b> and <b>40</b>). Excavations by S.P. Ó Riordáin in 1952–3 (see <b>Fig. 38</b>) revealed that the primary mound (phase 1) was constructed from stone and clayey material excavated from the surrounding ditch, which is V-shaped in profile and partly rock-cut. The mound contained five primary cremation burials and some animal bone; a single cremation deposit and a large quantity of animal bone from the ditch were also associated with this phase. The mound was subsequently remodelled (phase 2) by levelling off the top and spreading the material over and beyond the ditch on the W and N. A natural sod layer formed over the secondary mound and three further episodes of burial and modification were identified, the latest represented by the digging of Ditches 2 and 3 of the Rath of the Synods. The secondary burials consisted of four cremations (one in the barrow ditch) and a single crouched inhumation near centre of the mound. None of the burials from the barrow have been dated.</p>

<p><b>Physical condition</b></p> <p>The barrow is much disturbed but is in a stable condition. In 1899–1902 the British-Israelites cut a large pit, up to 1.8m deep, through the central western part of the mound, and on the E side the ditch was also cut into and all archaeological material removed. The surface of the barrow remains uneven and the backfilled 1950s excavation cuttings are still visible (see <b>Fig. 39</b>).</p>		
<p><b>Maintenance issues</b></p> <p>The monument is difficult to distinguish from the other earthworks at the Rath of the Synods and although not currently under threat, it is at increased risk of erosion from visitor and animal traffic.</p>

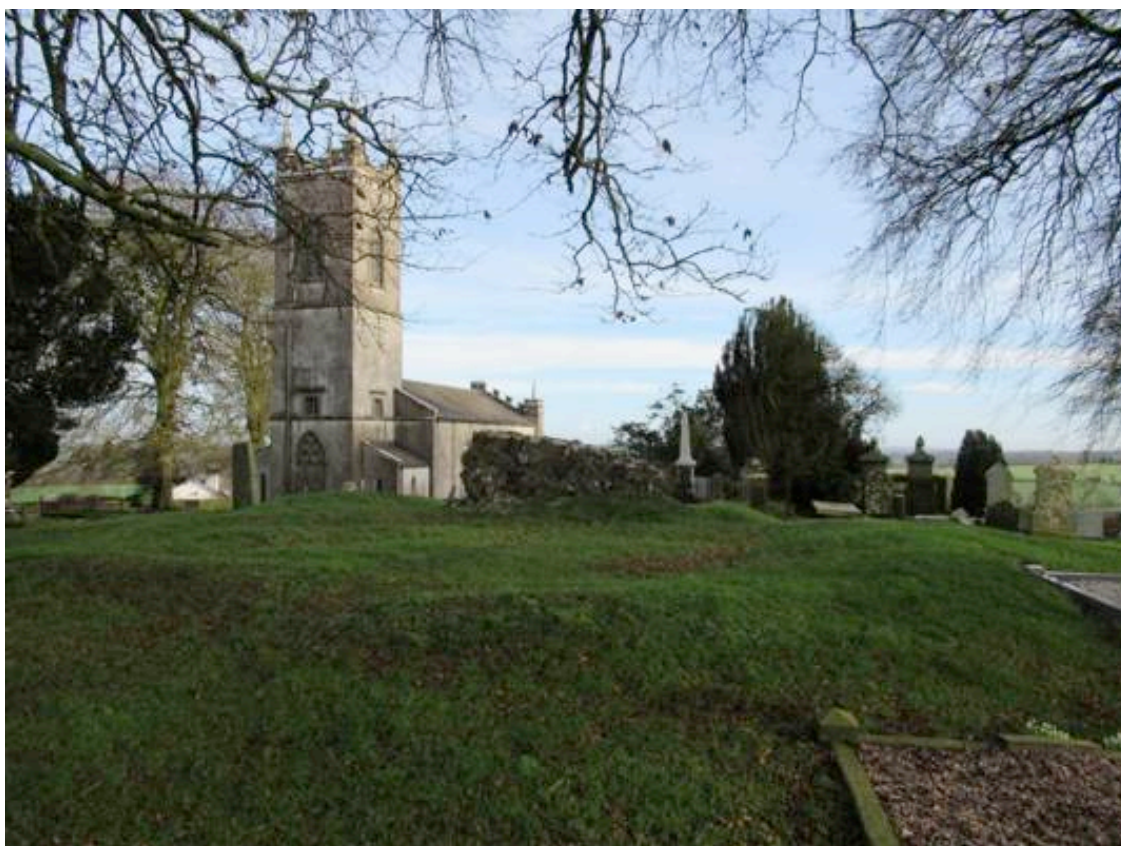
**Fig. 46** View of earthen banks and masonry remains on the site of the medieval residential tower, looking northeast towards St Patrick's church (January 2019).

The remains are highly vulnerable to damage from any form of ground disturbance, including grave-digging and the root systems of trees.

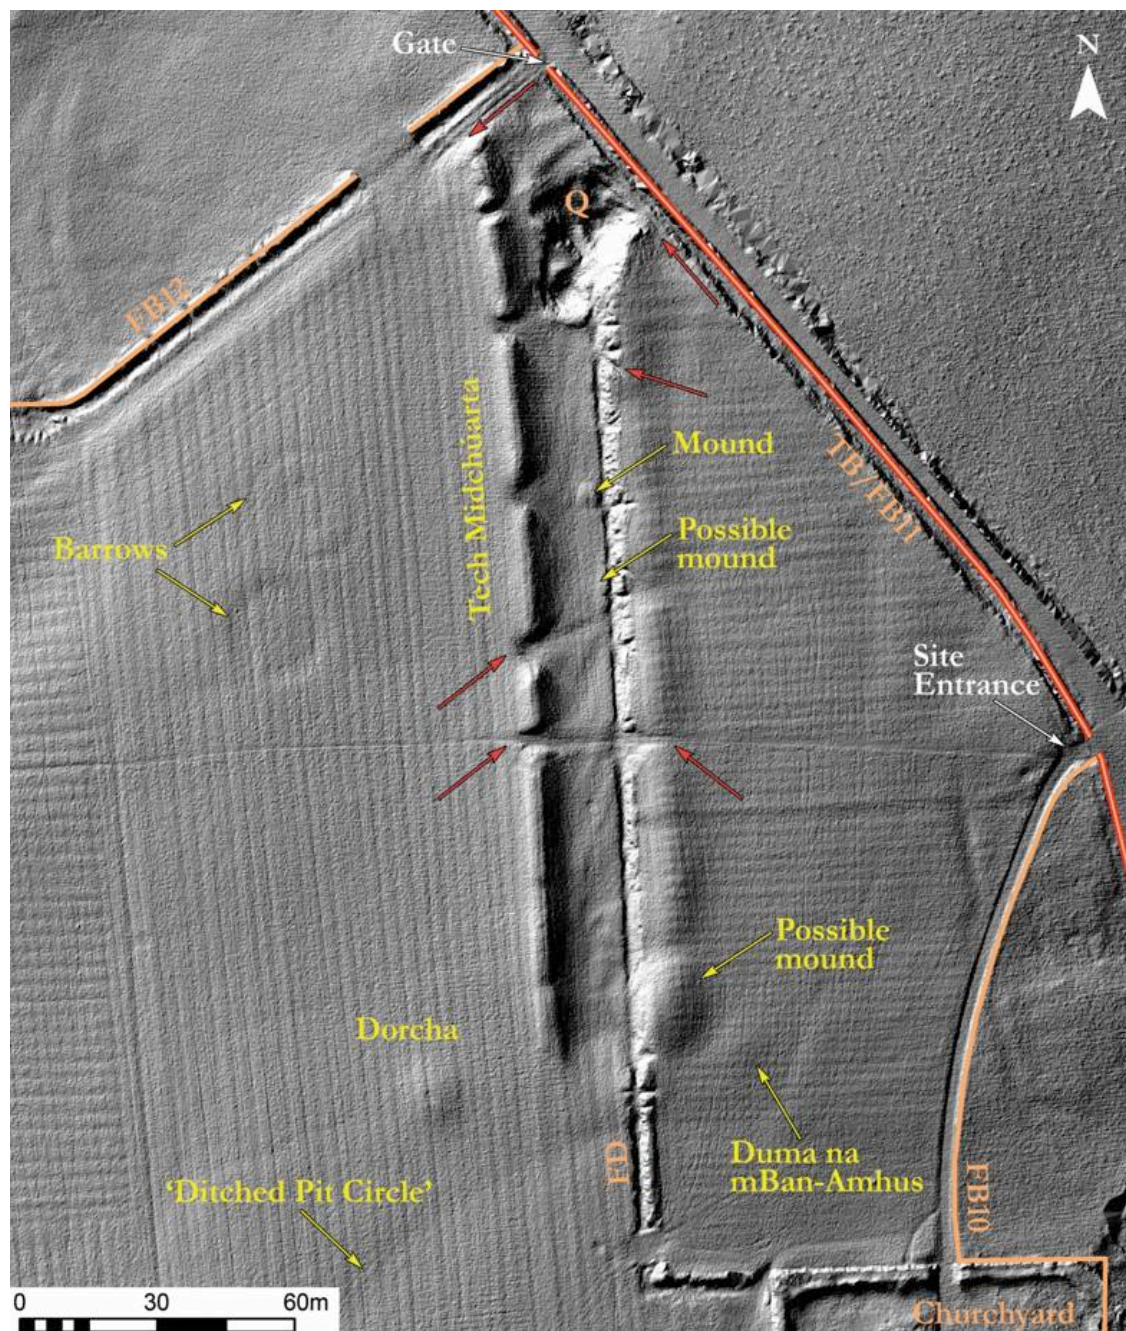
<p><b>Physical condition</b></p> <p>Although the upstanding earthworks remain impressive, the monument has suffered considerable disturbance in recent centuries. There are substantial old quarry pits (Q, Fig. 51) at the N end of the monument, which have caused damage to the E bank and extensive loss of deposits from the central area. The E bank has also been flattened and spread by ploughing and a field ditch (FD) cut into its base on the W side extends along the full length of the monument and a short distance beyond it on the S. The main source of modern deterioration is pedestrian traffic, which has caused localised erosion of the crests and slopes of the banks, particularly around some of the existing gaps. This is most evident along the path leading W from the main site entrance, which crosses the monument a short distance S of its midpoint (Fig. 52). Patches of bare ground, vehicle ruts, trampling and other signs of disturbance also occur along the route of another path that extends around the N end of the monument (Fig. 53).</p>

**Fig. 51** Lidar hillshade model of Tech Midchúarta and surrounding monuments. The main pedestrian paths across the earthworks are indicated by red arrows. One of the paths follows the townland boundary wall between Castletown Tara and Cabragh (TB/FB11), which flanks the local access road. The section of the wall extending south to the main site entrance, together with FB10, form part of the eastern boundary of the State lands. Traces of the former village of Tara are bisected by the path between the site entrance and the churchyard.

The substantial size and orientation of the monument, which runs perpendicular to the main approach from the site entrance, is placing certain sections of the earthworks under increased pressure from pedestrian traffic. The slopes, which are steep in places, and the access points through gaps in the banks, are most at risk of further erosion. Regular grazing and the cutting of small patches of gorse growing on the E bank and around the quarry may help to reinforce the ground surface and make it more resistant to wear. Two field boundaries and an access gate lie in close proximity to the N end of the monument, creating a pinch-point which is subject to sustained footfall from recreational users, as well as occasional farm vehicle traffic. These pressures are accelerating erosion of the ground surface and detract from the monument's

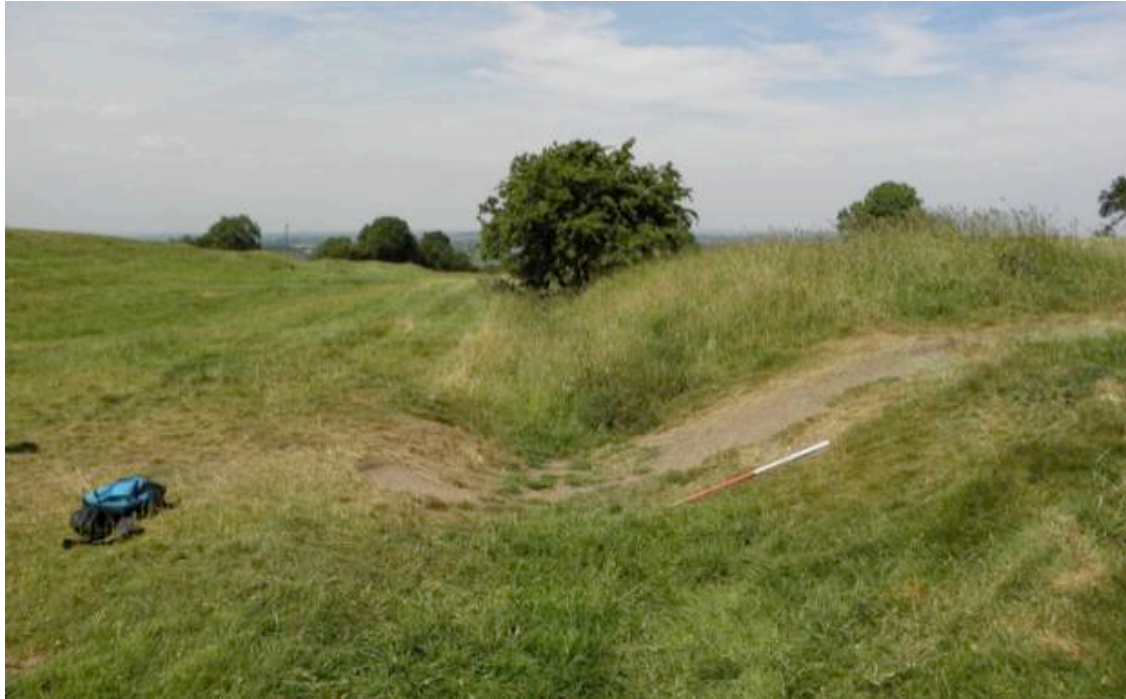
**Fig. 52** Erosion from pedestrian traffic across the eastern bank of Tech Midchúarta, looking north (June 2018).
