## Developing a Visitor Profile: The Hill of Tara for Hill of Tara Conservation Management Plan

# Tara Conservation Management Plan **Appendices**

**September 2022**

# **Tara Monument Catalogue & Condition Assessment**

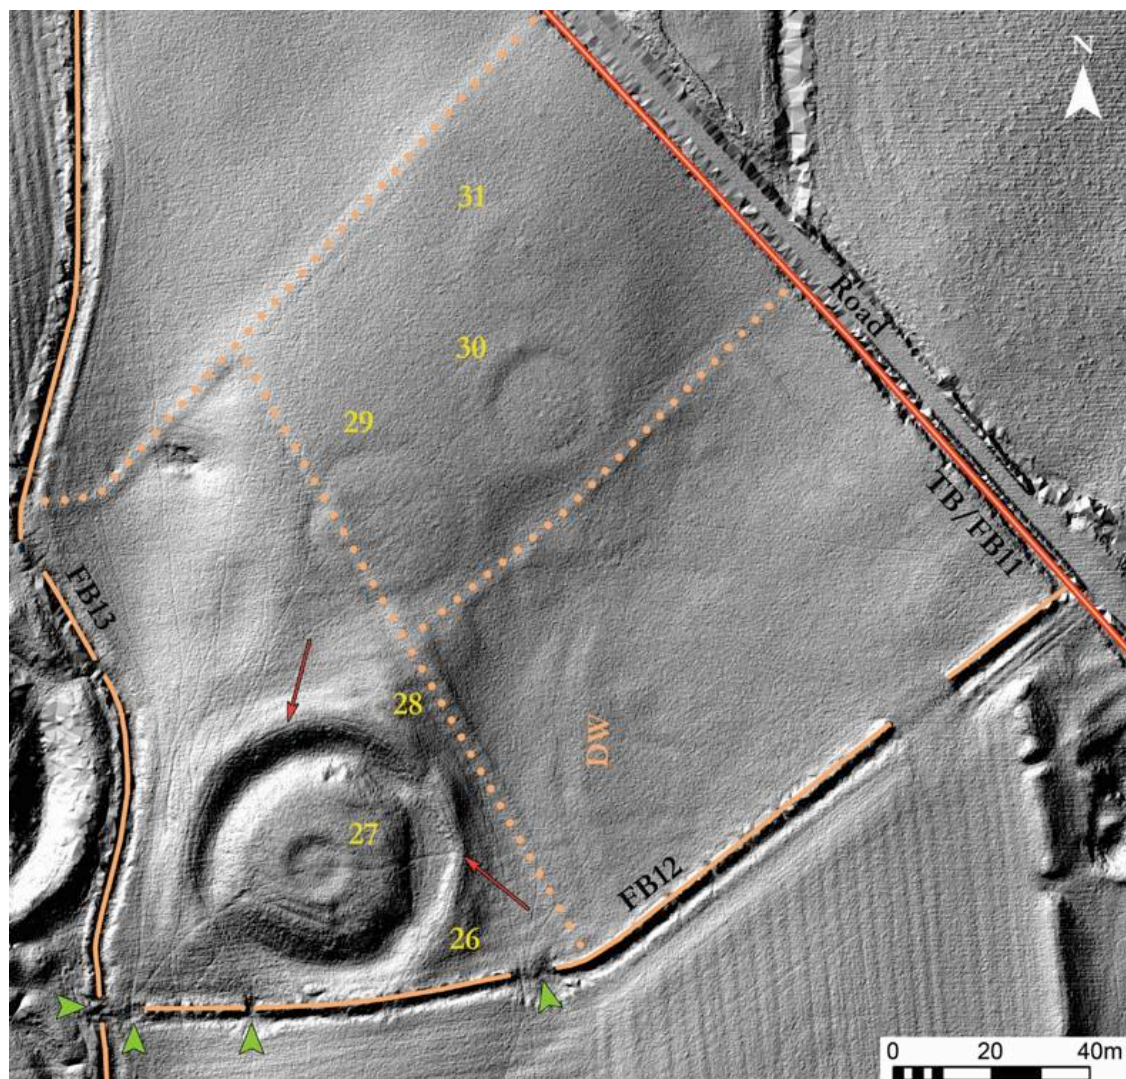
<p><b>Physical condition</b></p> <p>Ráith Gráinne is arguably the best-preserved earthen monument at Tara, having been less severely impacted by historic interventions than other high-profile earthworks (<b>Fig. 60</b>). Nonetheless, cultivation as well as disturbance from an adjacent field boundary (FB12) that encroaches on the monument have caused attrition of the bank and the mound on the S and SW. There is also a small hollow in the upper N edge of the mound and signs of wear on the external slopes of the bank. Apart from a small depression on the NE, however, the bank is uninterrupted. The monument and its immediate environs are traversed by a network of narrow incised tracks resulting from pedestrian and animal traffic. The two most established pedestrian routes extend E/W across the centre of the monument and in a circuit around the top of the bank.</p>		
<p><b>Maintenance issues</b></p> <p>Although the site attracts fewer visitors than other high-profile monuments, there is a risk of accelerated erosion (soil loss) along established paths which could impact vulnerable archaeological deposits, particularly in the area of the summit barrow. The steep-sided slopes are also vulnerable to attrition and potential slippage from pedestrian and animal traffic and can be dangerous in wet conditions. Access by sheep is mainly through a series of gaps in the dilapidated field boundary (FB12) to the S, which in this area comprises an earth-and-stone bank and hedgerow, fronted by a ditch on the N. Repair of the field bank would help divert animal traffic away from the monument. In addition, the root systems of trees in the adjacent hedgerow may be encroaching on the already denuded bank of Ráith Gráinne and sensitive management of this field boundary is necessary to avoid or minimise potential impacts on the monument.</p>

**Fig. 60** Lidar hillshade model of Ráith Gráinne and surrounding monuments. Arrows mark the main pedestrian paths (red) and access gaps used by sheep (green), while relict field boundaries are indicated by dotted lines.

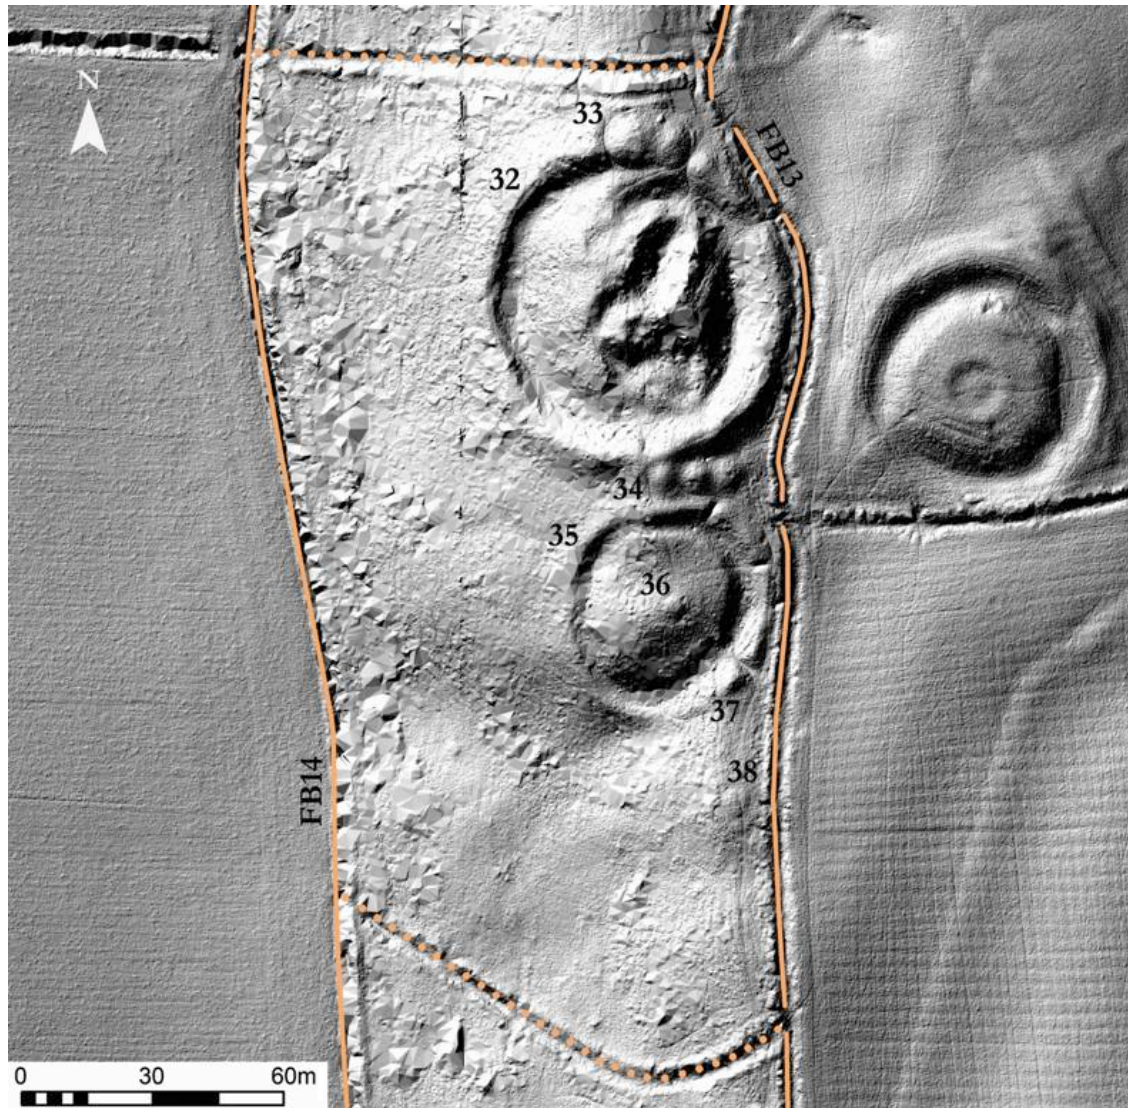
**Fig. 68** Lidar hillshade model of the Clóenfherta and surrounding monuments. Relict field boundaries are indicated by dotted lines. FB14 forms part of the western boundary of the State property.

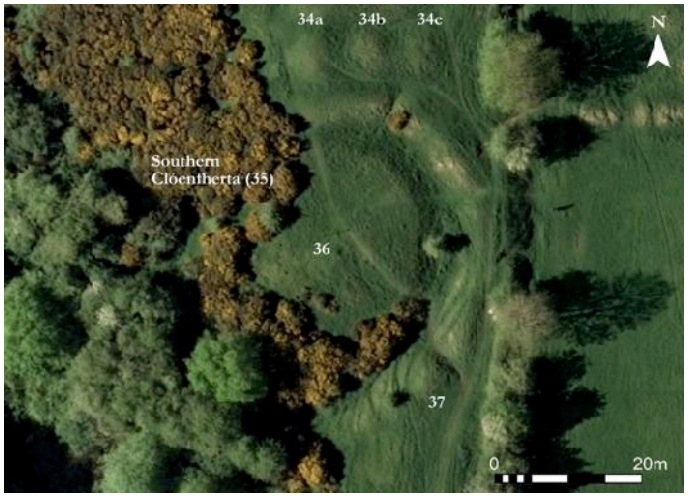
<b>Fig. 75</b> High-resolution 2008 orthophoto of the southern Clóenfhera and adjacent monuments, showing vegetation cover and tracks created by pedestrians and sheep.

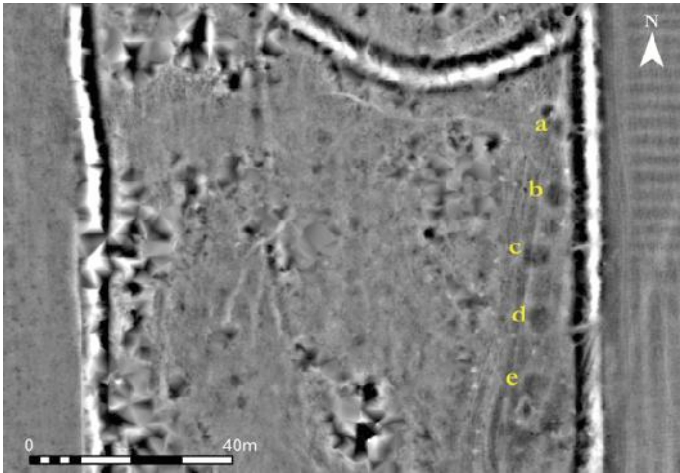
<p><b>Fig. 80</b> Local relief model generated from lidar, showing barrow group to the south of the Clóenfherta. A small circular rise between mounds 'b' and 'c' may be the remains of a sixth mound, and there are possible traces of another between sites 'c' and 'd'. The pedestrian track running N/S across the site is also visible.</p>
<p><b>Maintenance issues</b></p> <p>These monuments are vulnerable to erosion from recreational and animal traffic, as well as disturbance from burrowing animals and the root systems of trees along the adjacent boundary.</p>
