## Rebuilding after Disaster - Engineering Lessons from the 2004 Tsunami

## Project Management lessons from Tsunami Reconstruction Program in Sri Lanka.

Liam McCarton, worked in Sri Lanka from 2005 to 2007 as Project Manager for post tsunami reconstruction programs. In this article he discusses some of the technical and humanitarian challenges involved in managing a reconstruction program in a developing country and presents some of the lessons learnt.

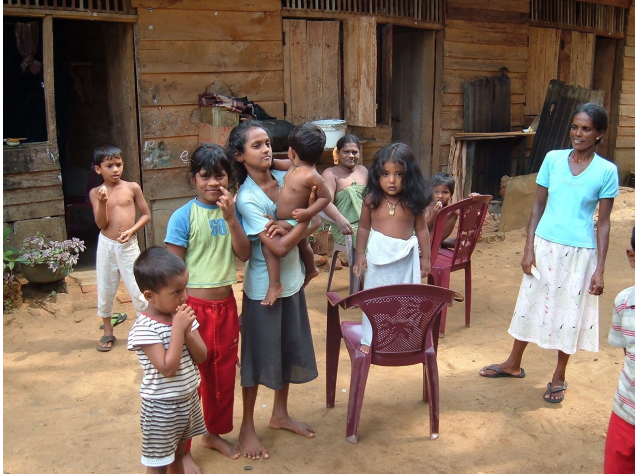
**Fig 2 Families displaced by tsunami living in shelters**

- Over 65,000 temporary shelters were constructed comprising two or three rooms, with 3 foot high walls completed to roof level with timber planks and roofed with corrugated sheets.
- Potable water was provided in accordance with sphere standards at a number of central taps, supplied by water tankers.
- Wastewater treatment typically consisted of squat toilets with pit latrines.
- Temporary shelters were planned as a short to medium term measure with the intention of rehousing people in permanent houses as soon as possible.
- Restoration of transport, water, & communication Infrastructure
- Debris clearance

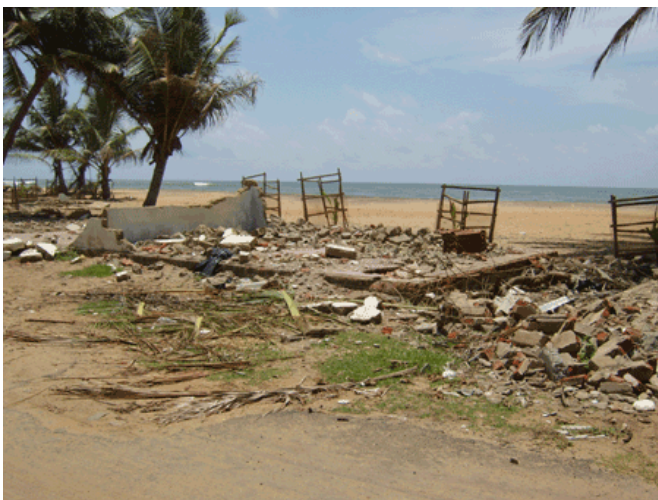
**Fig 3 Total structural failure of blockwork homes within coastal zone**

An assessment of the structures affected by the tsunami waves indicates that the most severely damaged structures were those constructed close to the sea. Although the degree of damage correlates to the magnitude of wave pressure, factors such as structural form, shape of buildings and orientation in relation to the wave direction also had significant bearing on the extent of damage. Building with load-bearing walls, especially those that were perpendicular to the direction of the waves had shown less resistance to the ocean waves and had been completely destroyed, whereas framed structures with reinforced concrete columns and beams as well as load bearing walls that are parallel to the direction of the waves have shown a higher degree of resistance. This review was compiled by a team of local and international engineers and was used to prepare a design manual to assist designers to plan developments to minimise the risk of structural failure in future natural disasters.

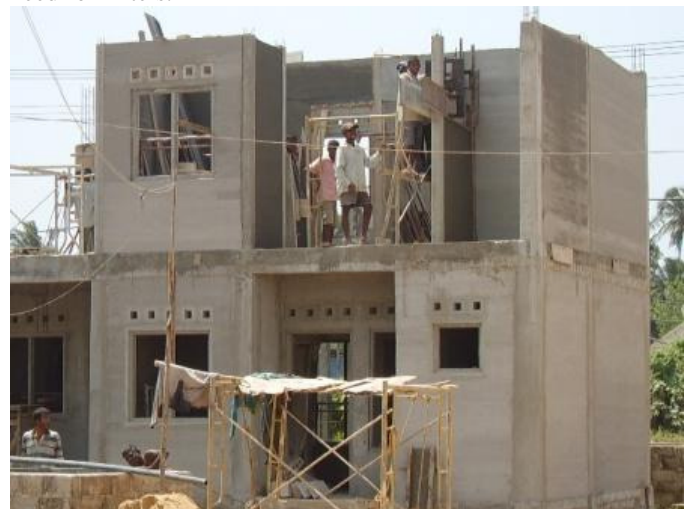
**Fig 4 Shows Slip Form wall construction with team of three unskilled labourers**

This development was designed to minimize the use of scarce resources and skilled labour. The design incorporated plinth beam foundations to minimize excavation by hand and use of stone. Ground floor columns comprised precast prestressed columns on precast pocket foundations. This allowed mass production of the components on site using less skilled labour, less material and by eliminating formwork, the erection program was quicker. The traditional blockwork walls were replaced by slip form walls. These type of walls comprised 1:12 cement and quarry dust / sand mix with 2% coconut coir fibres included in the mix. The walls were constructed using steel shutters in lifts of 3 feet. The high quality finish eliminated the requirements for plastering. All windows and door frames consisted of pre cast concrete frames manufactured by a local NGO. This resulted in a cost saving over imported timber of 70% and eliminated the need for lintels.

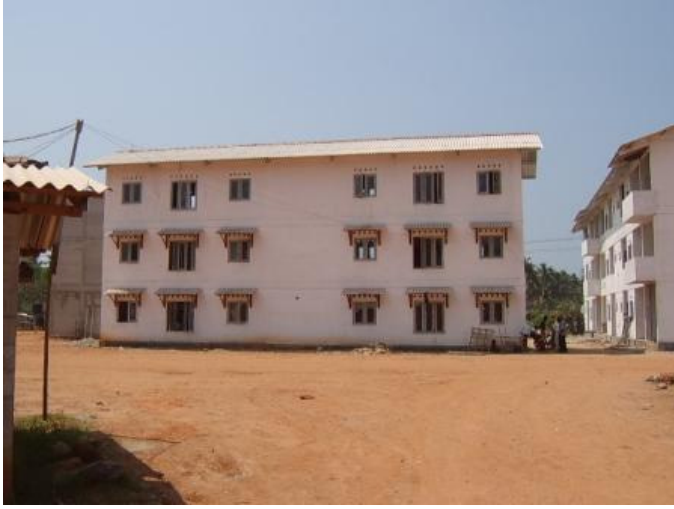
**Fig 5 Finished apartments, Panadura.**

Thimbilli tsunami development in the western coastal town of Panadura is an example of how designers and contractors incorporated new technology (in Sri Lanka) in the tsunami reconstruction program. This development consisted of 120 three storey apartment units in blocks of 6. The traditional Sri Lankan design and construction method for a development of this type would consist of random rubble foundations with insitu columns and beams, insitu rc slabs and blockwork walls.

The floor slabs comprised 2” thick composite slabs with pre-stressed beams. This eliminated the need for formwork and insitu steel and concrete pours. Significant savings on labour and time were effected. The roof comprised a tile roof on precast concrete rafters.

The contract was awarded to one main contractor with ten nominated subcontractors. Each sub contractor was trained in the proposed construction methods using teams of one skilled mason to 9 unskilled labourers. Overall sand savings in the project were from 40% - 70%. Overall resource savings were 40%. Overall cost saving over traditional in-situ apartment projects were up to 40%.
