## Effects of Posttensioning Slippage on 2-Way Spanning Concrete Slabs

# Effects of Posttensioning Slippage on 2-Way Spanning Concrete Slabs

This paper investigates the effect of improper posttensioning of a 2-way spanning concrete slab subject to a central point load. Due to plate slippage alone, the support conditions only offered a 1-way spanning action which could have led to premature failure with dangerous consequences. Posttensioning can strengthen a flat slab against punching shear by controlling deflections and cracking under service loads compared with traditional punching shear reinforcing methods leading to more slender structures and economic solutions for longer spans. However, if the method is not properly applied, these thinner floor plates can fail in a brittle and sudden manner by punching at ultimate limit state and excessive deflection in serviceability. Concrete slabs containing traditional shear reinforcement performed adequately and demonstrated that the critical punching shear perimeter, defined as twice the depth of the slab, was confirmed from measured deflections and crack pattern analysis.

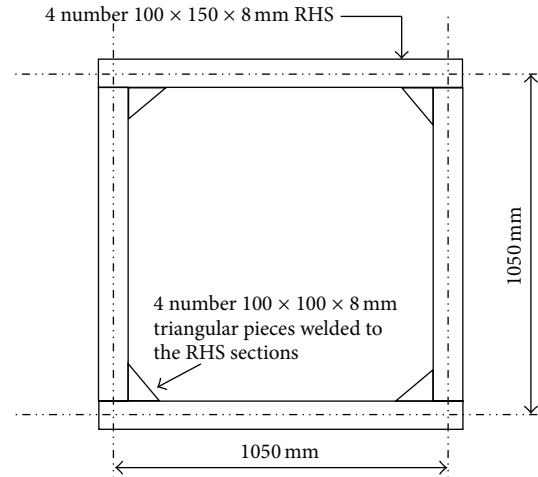
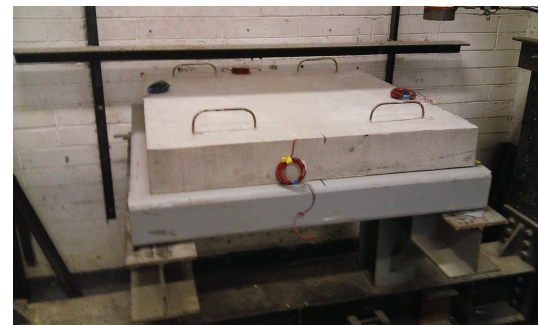
FIGURE 3: RHS frame used to support the concrete slabs.

failure. The support conditions of the test rig were provided a simply supported 2-way spanning arrangement. Figure 3 shows the  $100 \times 150 \times 8$  mm RHS frame used to support the slabs during testing.

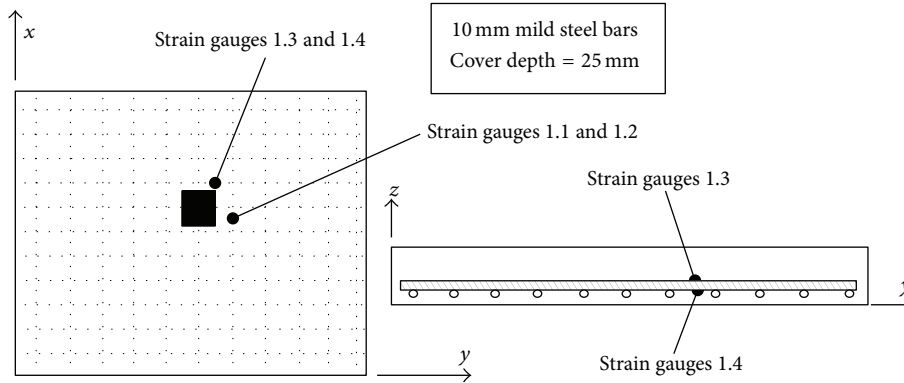
FIGURE 4: Reinforcement details and location of strain gauges 1.1 to 1.4 in slab S1.

**2.6. Reinforcement Details.** Figures 4–6 and Table 2 summarise the strain gauge locations. Longitudinal reinforcement (6 mm diameter) strain gauges were placed on the steel reinforcement just off midspan in both orthogonal

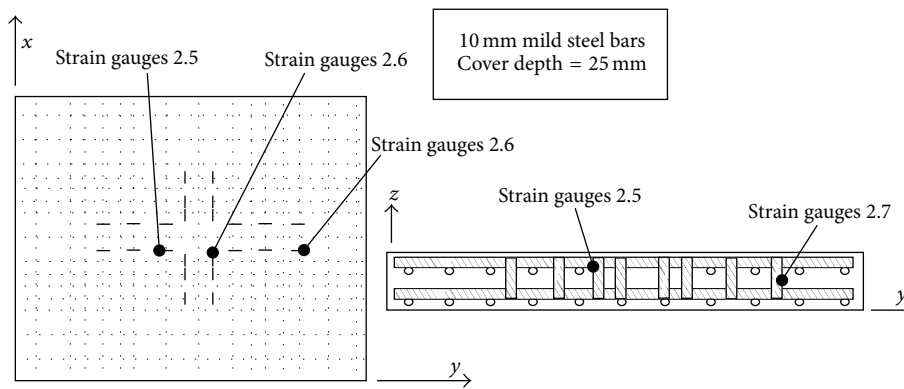
FIGURE 5: Reinforcement details and location of strain gauges 2.5 to 2.7 in slab S2 (gauges 2.1 to 2.4 are identical to 1.1 to 1.4 in slab S1).

Strain gauges were also placed on one shear link leg (6 mm diameter  $\times$  100 mm long) in slab S2 (2.5 and 2.7) on each layer to assess their stress profile during loading. Two extra longitudinal reinforcement strain gauges were placed on a reinforcing bar in the top flexural steel layer of at either

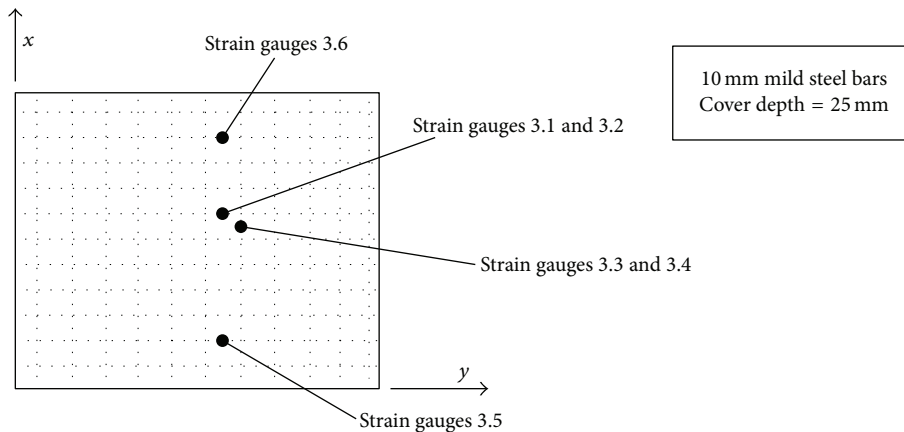
FIGURE 6: Reinforcement details and location of strain gauges 3.1 to 3.6 in slab S3.

end of the posttensioned slab (slab S3) to determine the effect of stressing on the longitudinal reinforcement. The strain gauges were fitted onto the steel by sanding the bars, polishing them using a degreaser and applying using fast drying super glue. Lead wires were soldered to the terminal and multiple layers of protective varnish applied. An example of a prepared strain gauge on the steel is shown in Figure 7.

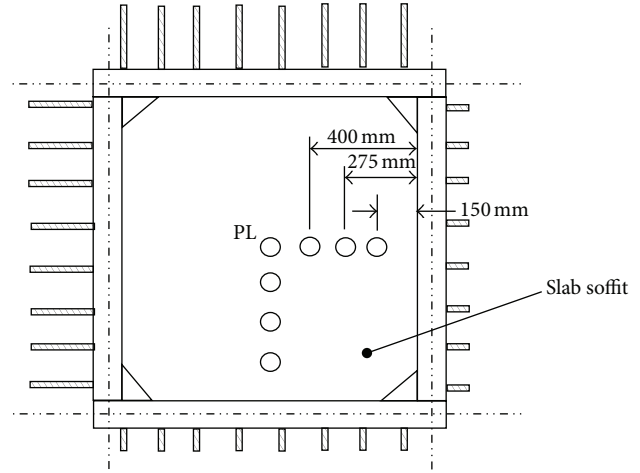
FIGURE 8: LVDT arrangements on the soffit of all slabs.

the deflections during loading and to locate the punching shear perimeter (Figures 8 and 9) [17]. One additional LVDT was placed in the centre of slab S3 (PL) during stressing to record the effect of prestressing on the deflection shows the LVDT arrangement in all three slabs. Figure 10 shows the LVDT arrangements on the top surface of each slab.

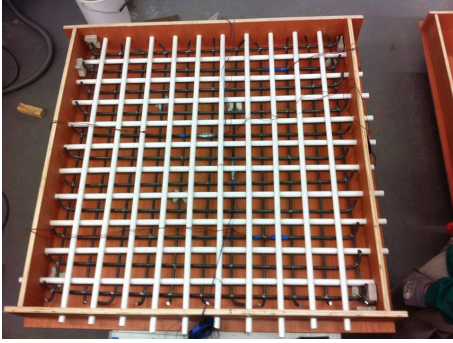
FIGURE 11: PVC duct locations prior to casting.

**2.7. Posttensioning Ducts.** Test specimen S3 was designed and tested as an unbonded posttensioned slab. The strands used for the prestressing procedure were isolated from the concrete during both casting and testing using 20 mm diameter plastic ducting (Figure 11) which was inserted into preformed holes cut into the formwork.

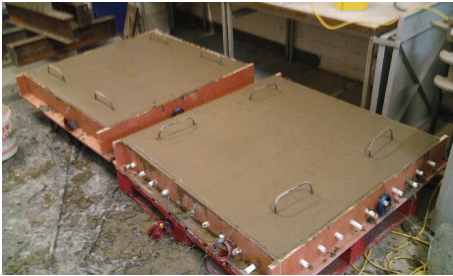
FIGURE 12: Lifting eye positioned during casting.

Each slab was cast with four 8 mm diameter lifting eyes (Figure 12) to aid movement. Each eye was lapped 200 mm under the top layer of flexural reinforcement and protruded 90 mm above the surface of the concrete.

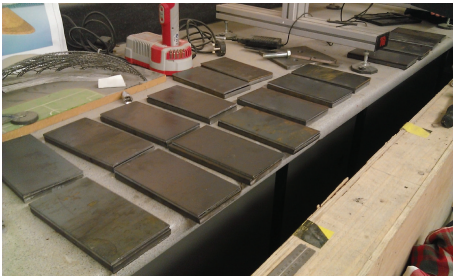
FIGURE 13: Steel bearing plates prior to drilling.

**2.8. Posttensioning Bearing Plates.** To distribute the compressive forces into slab S3 in a safe and controlled manner a composite 17 mm thick steel bearing plate (Figure 13) was prepared with two 12 mm holes to receive the prestressing strands [18, 19].

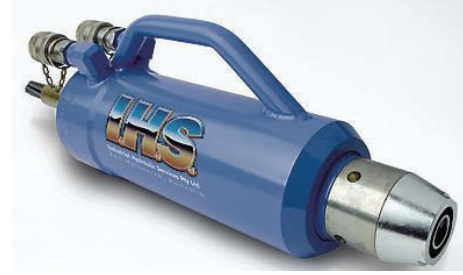
FIGURE 14: 25T hydraulic monostrand jack.

Stressing of the strands was performed using a 25T hydraulic monostrand jack, as shown in Figure 14 calibrated to a pressure of 200 Bar equal to a stressing force of 65.1 kN and a stress of  $1252 \text{ N/mm}^2$  corresponding to 67% of the tensile strength of the strand ( $f_{pk} = 1860 \text{ N/mm}^2$ ). The jack was placed onto the “live” end of the strand (Figures 15 and 16)

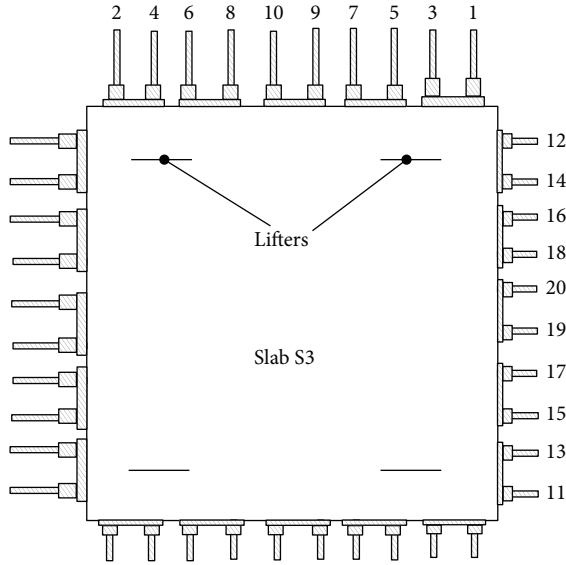
FIGURE 17: Stressing procedure.

As ten 10 strands were to be stressed in both orthogonal directions, a logical stressing plan was employed to account for effects of elastic deformation as the posttension force is applied on the level of prestress transferring into the slab. With multiple strands, stressing the first does not cause any losses as, although the concrete undergoes shortening, the jack is not removed until the specified (calibrated) value of prestress is applied therefore negating any elastic deformation. However, stressing the 2nd strand does cause a loss in force in the former due to concrete shortening. If the stressing procedure took place in a sequential manner the losses in prestress force due to elastic deformation in the strands would range from zero in the final strand stressed to maximum in the first.

Therefore, the strands were stressed in a “skipped” fashion [19, 20] with the second one to be tensioned was furthest from the previous. The next strand prestressed was adjacent to strand 1 and so on until all 20 were stressed. The methodology is shown in Figure 17.

Furthermore, the strands parallel to the  $x$ -axis were tensioned first before those parallel to the  $y$ -axis as these were located at a smaller eccentricity. The readings these strain gauges were used to confirm the effects of the tensioning on the strands in the concrete member.

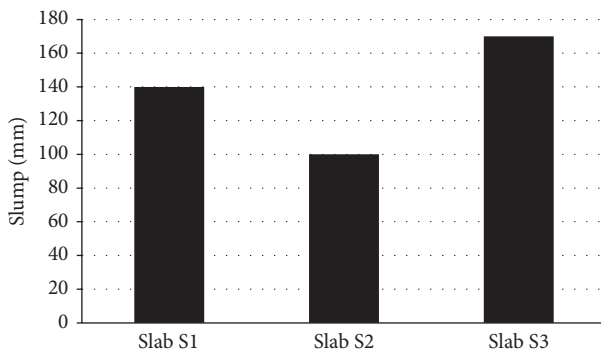
FIGURE 18: Slump values.

3.1. *Workability.* The slump values recorded are shown in Figure 18 which shows the required workability (100–150 mm) was achieved in all the concrete cast. Concrete mix S3 had a slightly higher slump than the others but in conjunction with the compressive and strength results (Figure 18) it is clear that it had no significant effect.

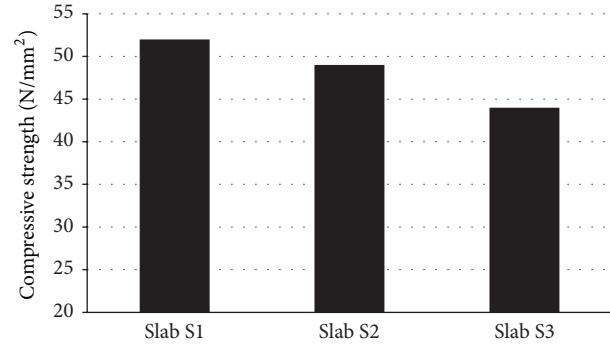
FIGURE 19: Compressive strength results.

3.2. *Compressive Strength.* The compressive strength results are presented in Figure 19. As shown, the entire concrete cast achieved the characteristic strength specified ( $35 \text{ N/mm}^2$ ). There is a slight decrease in strength for slab S3 which corresponds to the higher slump result for that mix (Figure 18) which may indicate excess water added in error. However, as the design strength was achieved the concrete was deemed satisfactory.

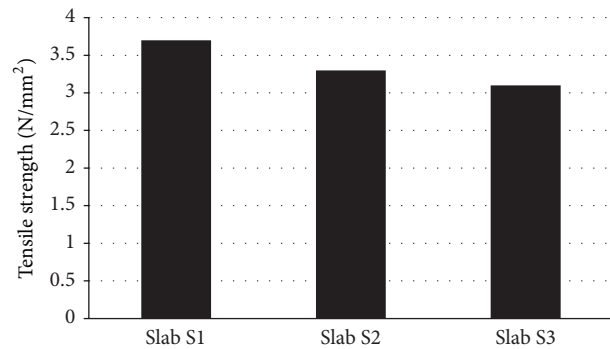
FIGURE 20: Tensile strength results.

3.3. *Tensile Strength.* The tensile strengths are presented in Figure 20. As shown, all concretes achieved a minimum tensile strength of  $3.0 \text{ N/mm}^2$ . As with the compressive

strength, the tensile strength for slab S3 was slightly lower than the others.

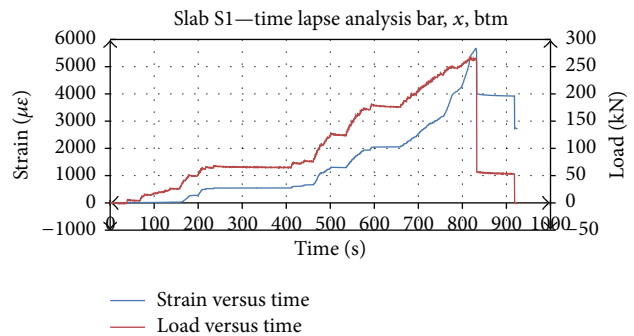
FIGURE 21: Strain time lapse analysis for gauge 1.2, slab S1.

Figure 21 shows the increase in strain in gauge 1.2 with load in the bottom of the flexural reinforcement ( $x$ , btm) indicating the rebar contribution to the load carrying capacity of the slab. At 40 kN, increases in strain in the top bar of the flexural reinforcement ( $y$ , top, parallel to the  $y$ -direction) were observed (Figure 22) and are lower due to

3.4.1. *Strain Analysis.* Failure of slab S1 occurred at a load of 256 kN. The predicted failure load (using [3]) was 201 kN. The strain gauge results are shown in Figures 21–23 with gauge 1.1 braking during testing.

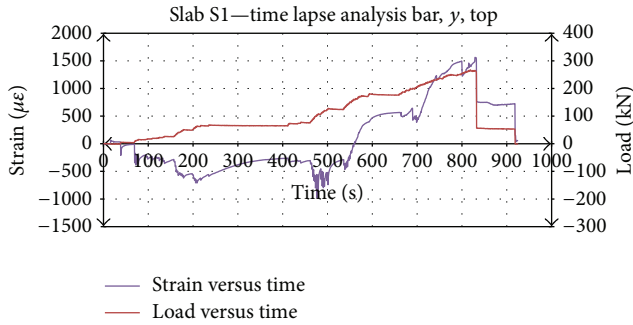
FIGURE 22: Strain time lapse analysis for gauge 1.3, slab S1.

local compression. It is not until 160 kN that a compressive strain is recorded. At 40 kN, the strain in the bar increased linearly until approximately 3200  $\mu\epsilon$  corresponding to a load of 240 kN where the bar began to yield.

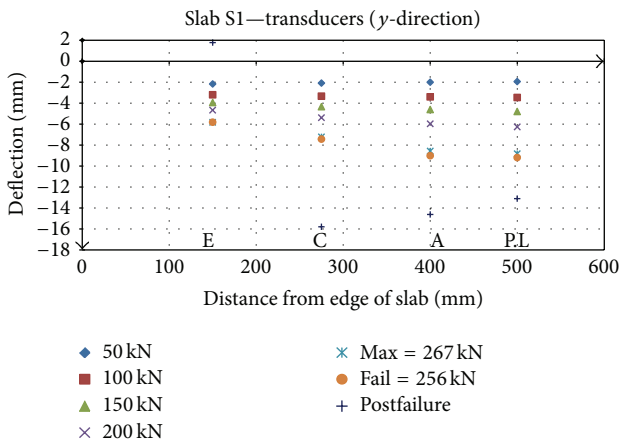
FIGURE 24: Deflection V's distance from support (y-direction).

**3.4.2. Flexurally Reinforced Concrete Slab S1: Deflections.** The deflections at reference points A–F are shown in Figures 24 and 25. At “postfailure,” the instant after failure, the LVDT deformations indicate considerable deflection. However, the deflection at point E has decreased indicating that the punching shear critical perimeter is located between points C

and E. Eurocode recommendations propose that the critical perimeter to be checked at a distance  $2d$  from the loaded area which relates to 210 mm from the loaded area or 240 mm from the supported edge here [21].

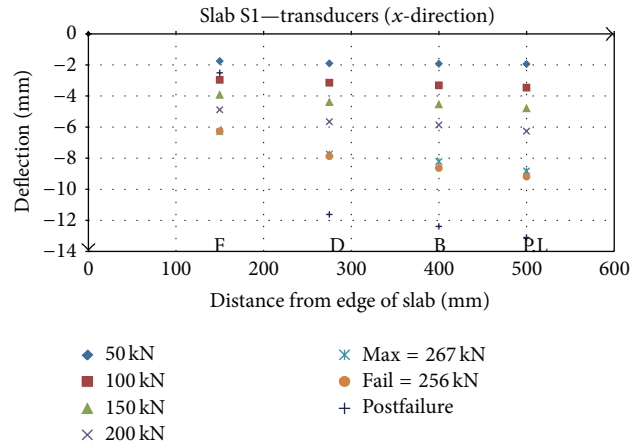
FIGURE 25: Deflection V's distance from support (x-direction).

A similar deflection pattern can be seen in Figure 25. Again, at postfailure, the deflections at B and D increase considerably while at F, it decreases indicating that the critical perimeter for punching is located at a distance between 150 mm to 275 mm. The LVDT readings on the top surface are shown in Figure 26 where negative deflection indicating slab uplift. As may be seen, the results demonstrate an uplift of 3.8 mm at the back right corner of the slab at the failure load (256 kN).

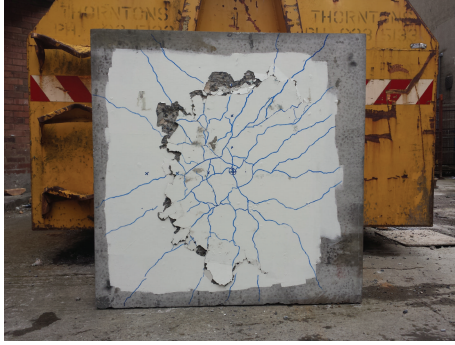
FIGURE 27: Crack pattern on Soffit of slab S1.

**3.4.3. Crack Pattern Analysis.** Figure 27 shows the post failure crack patterns on the underside of the slab. As indicated, a clear well defined punching shear perimeter is visible with the failure perimeter passing between LVDT locations C and E confirming the deformations as seen in Figures 24 and 25.

The exact location of the critical punching shear perimeter is specified as being located a distance of  $2d_{avs}$  from the face of the loaded area. The results here, in terms of both the deflection and crack pattern analysis for slab S1, show that this perimeter is accurate.

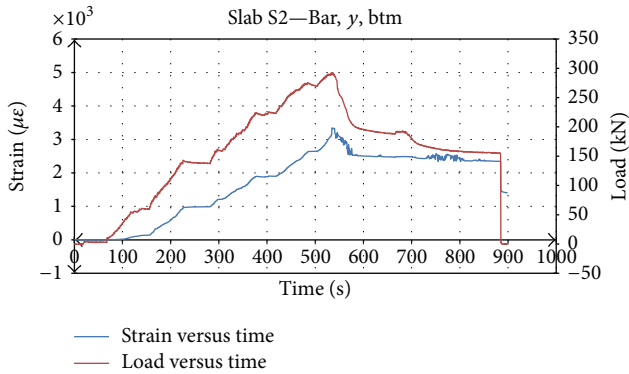
FIGURE 28: Time lapse for gauge 2.2 on Bar, y, btm.

3.5.2. *Strain Gauge Analysis.* The results from strain gauges 2.2–2.4 are shown in Figures 28 and 29. As may be seen, the strain in gauge x (Bar, y) increases with load until the failure load (293 kN) is reached. The trend of strain increases

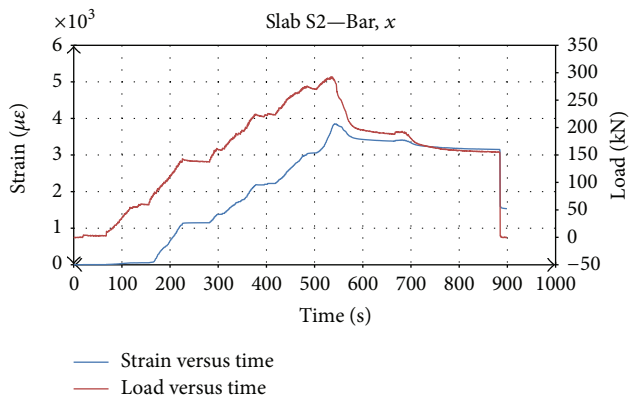
FIGURE 29: Time lapse for gauges on Bar, x.

confirms that the bar passed through the elastic range where strain increases faster than the applied load until approximately 3000  $\mu\epsilon$  where the bar behaves plastically.

Also shown is a change in strain at approximately 80 kN, where the first crack occurred. A linear increase of strain occurs in the bar until approximately 280 kN (3200  $\mu\epsilon$ ) where the reinforcement is assumed to have yielded.

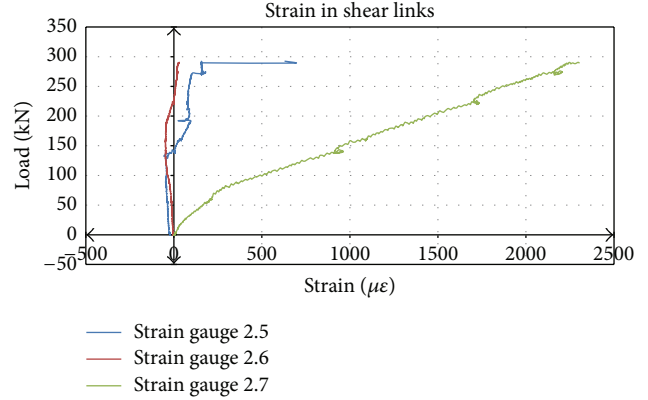
FIGURE 30: Strain readings recorded on shear links.

3.5.3. *Shear Link Strain Gauges.* The strain readings for gauges 2.5 to 2.7 on links L1 to L3, respectively, are shown in Figure 30. As may be seen, a shear force was experienced by the concrete and its tensile capacity was exceeded. Links crossing cracks contributing to the capacity of the section indicating that the links experienced a tensile stress and positive strain. Link L3 experienced the greatest positive strain. Link L2 experienced a negative strain until a load of 225 kN was applied.

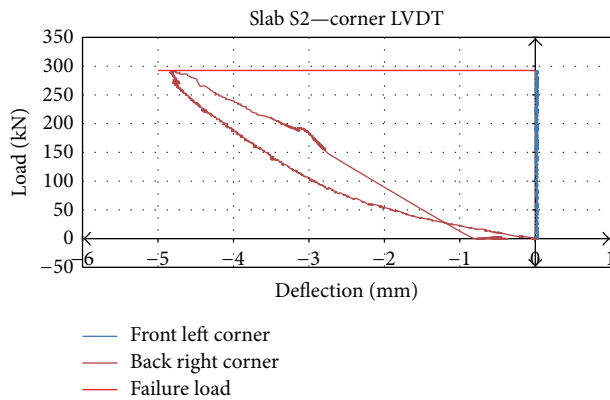
FIGURE 33: Slab S2—load V's corner deflection.

3.5.5. *Deformation Analysis: Top Surface.* Figure 33 shows that the deflections from the top surface are similar to those seen in slab S1 with no uplift at the front left corner.

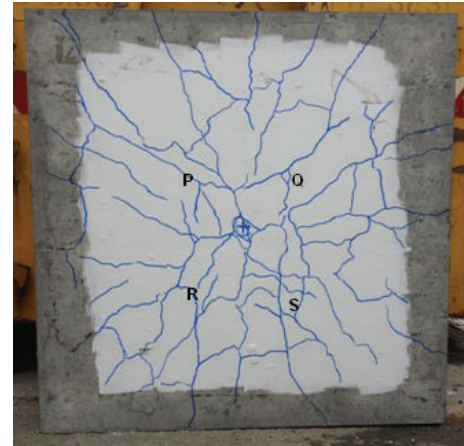
FIGURE 34: Crack pattern on soffit of slab S2.

3.5.6. *Crack Pattern Analysis.* The crack pattern for Slab S2 postfailure is shown in Figure 34. The slabs failing in punching shear within the loaded area (perimeter P, Q, R, S) and the cracks formed part of one long flexural crack. Although cracks were initiated by a flexural mechanism, the capacity of the cracked surface reduced leading to the formation of punching shear cracks.

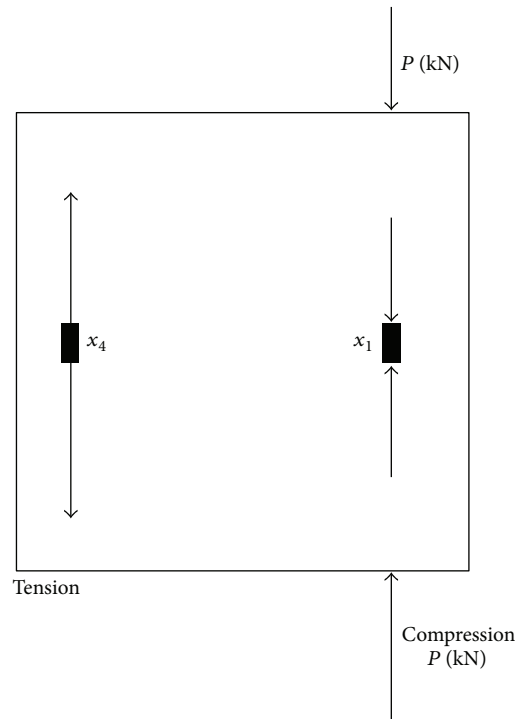
FIGURE 35: Behaviour of slab during Event 1.

3.6.2. *Concrete Strain Gauge Analysis.* The strands parallel to the slabs x-direction were tensioned first (Figure 35) with the effect shown in Figure 36. As expected gauge  $x_1$ ,

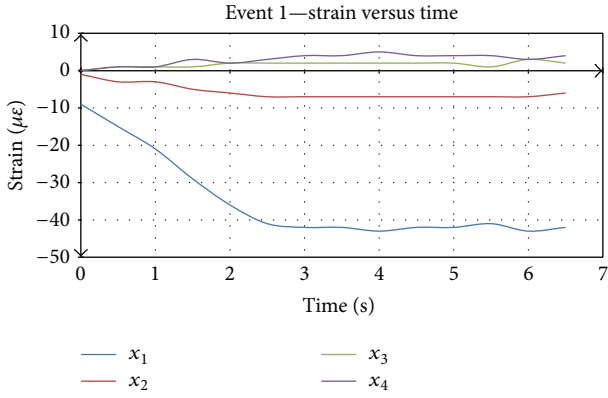
FIGURE 36: Strains parallel to applied axial compression.

located directly above the position of strand 1, experienced the greatest compressive strain as a result of the applied axial load during tensioning of strand one. It appears that gauges  $x_3$  (top) and  $x_4$  (below) experienced a small tensile strain. Therefore, although the slab was in compression in the vicinity located adjacent to the stressed strand, tension was induced on the slab at locations  $x_3$  and  $x_4$  (Figure 36).

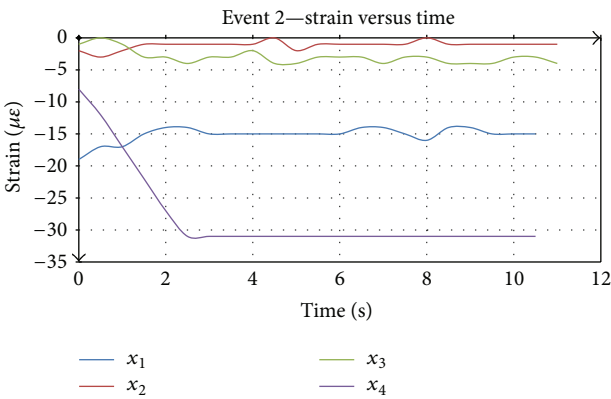
FIGURE 37: Strains parallel to applied axial compression.

The second strand tensioned was directly beneath gauge  $x_4$ . The effects of tensioning on the strains of gauges  $x_1$  to  $x_4$  are shown in Figure 37. As may be seen, the gauge located on top of the strand being tensioned is undergoing increases in compressive strain while the two gauges located furthest away are exhibiting tension. In addition to providing

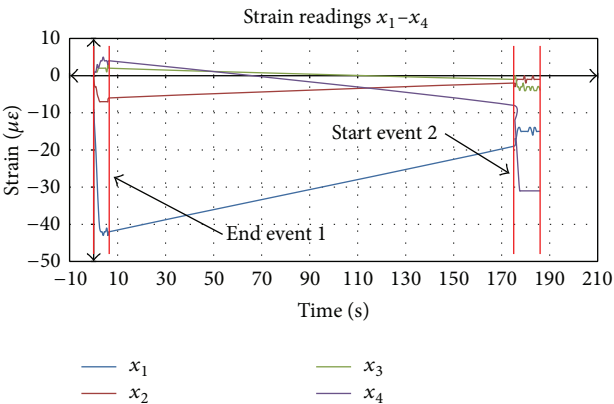
FIGURE 38: Strain reading  $x_1$  to  $x_4$ —end Event 1 to start Event 2.

Immediately following the end of Event 1, strain gauge  $x_1$  reads a compressive strain of  $43 \mu\epsilon$  (Figure 38). By the time

tensioning of strand two took place, that is, the start time of Event 2, this compressive strain decreased to  $19 \mu\epsilon$ . This suggests that the concrete surrounding strand 1 is experiencing a smaller compressive stress at the time of stressing strand two than at the end of Event 1. There has been a significant loss in prestress force from the end of Event 1 until the stressing of strand two takes place. The most likely cause of this loss in prestress force is as a result of anchorage draw-in losses which have been discussed previously.

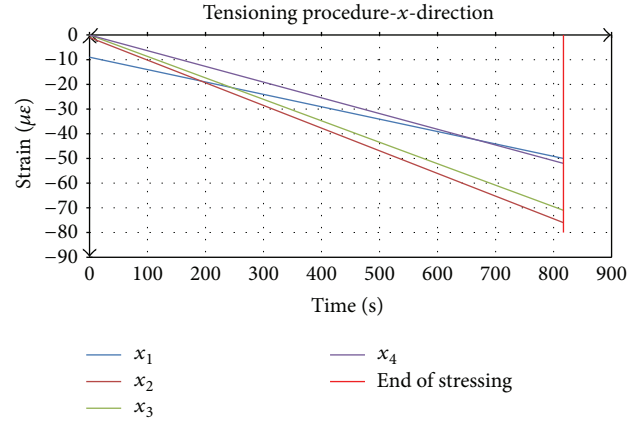
FIGURE 39: Total increase in strain in direction  $x$ .

Figure 39 shows the total increase in strain on gauges  $x_1$  to  $x_4$  over the time taken to tension all ten strands in the  $x$ -direction. As may be seen, the highest compressive strains occurred at locations  $x_2$  and  $x_3$  which was expected due to the sequence of tensioning undertaken.

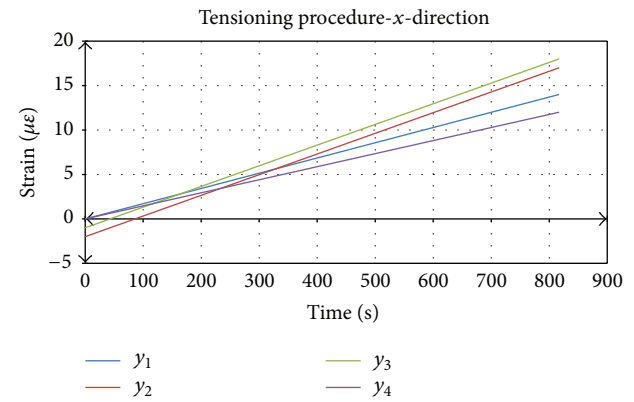
FIGURE 40: Total increase in strain in direction  $y$ .

Four gauges were located perpendicular to the direction of stressing during Events 1–10. The strains recorded in Figure 40 show tensile strains occur in gauges  $y_1$  to  $y_4$  with the maximum occurring in gauges  $y_2$  and  $y_3$ . By applying the compressive force in the  $x$ -direction the axial shortening in the direction of stressing is accompanied by a lateral elongation, that is, expansion normal to the applied load. Assuming the concrete slab was acting as an uncracked section, the magnitude of this lateral expansion can be attributed to Poisson's ratio.

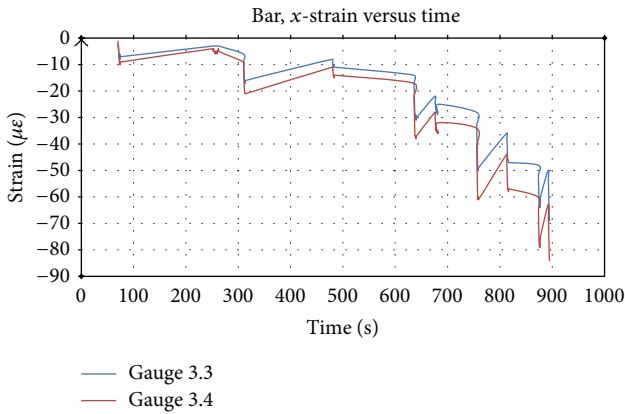
FIGURE 41: Bar,  $x$  strain in gauges 3.3 and 3.4.

3.6.3. *Steel Strain Gauges.* The strains in the four flexural reinforcement bars within slab S3 are shown in Figure 41. As shown, there is a clear loss in strain within the bars during the changeover period between tensioning the strands indicating a loss in prestressing force and in the compression force applied to the slab.

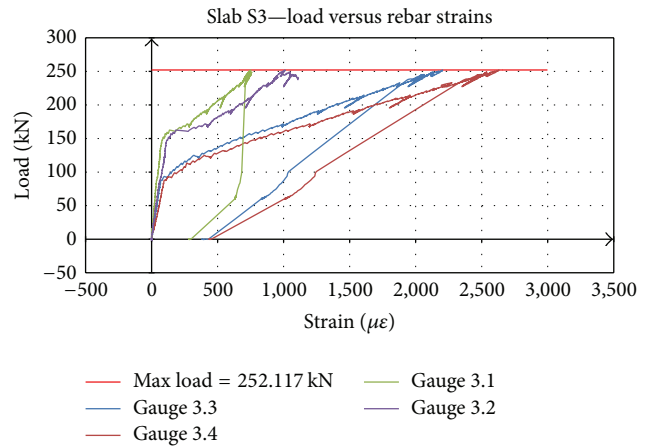
FIGURE 43: Load  $V$ 's strain (gauges 3.1–3.4).

3.6.5. *Strain Gauge Analysis.* Strain Gauges 3.3 and 3.4 located on Bar,  $y$  exhibit much larger strains than those on Bar,  $x$  (3.1 and 3.2) as shown in Figure 43. First cracking occurred parallel to the slabs  $x$ -direction at a load of 90 kN. The first crack passed the steel reinforcement at a load of 150 kN. However, upon reaching failure, the strains in Bar,  $y$  are three times greater than those in Bar,  $x$ . Figures 43 and 44 both indicate that neither bar had yielded which is unexpected considering that once the maximum load had been reached, the slab was unable to sustain any increase in load.

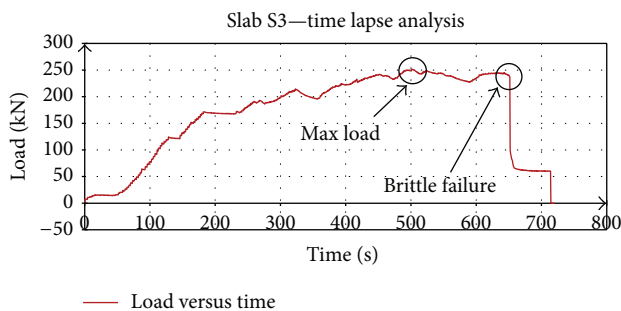
FIGURE 42: Load  $V$ 's time slab S3.

3.6.4. *Failure Load Analysis.* The failure load of Slab S3 was 252 kN (Figure 42). Upon reaching this load, the slab failed in a brittle manner.

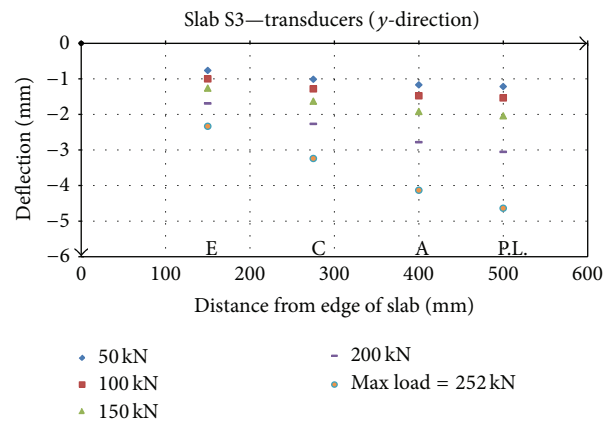
FIGURE 45: Transducer displacements (P.L., A, C, E).

3.6.6. *Deformation Analysis: Deformation Results—Soffit of Slab.* Figures 45 and 46 show the deflections in the  $y$ - and  $x$ -directions, respectively. As may be seen, the deflections in the two directions are not consistent with what would be expected for a 2-way spanning slab. Comparing the various

LVDTs along the two orthogonal directions there noticeable differences between the magnitude of deflection. The vertical deflection recorded decreases from a maximum underneath the point of application to the slabs. The deflections along the  $x$ -direction indicate the slab was deflecting as one-way spanning. This suggests that slab S3 during testing following

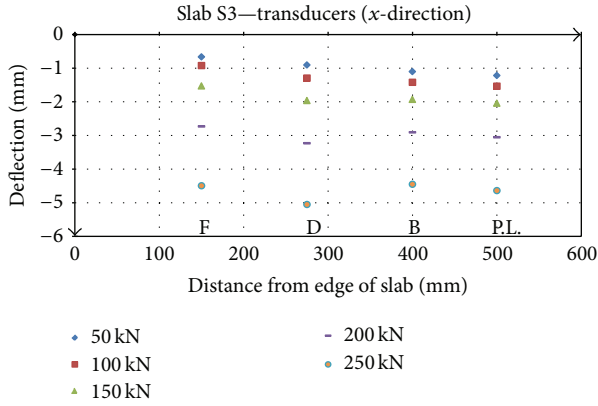
FIGURE 46: Transducer displacements (P.L., B, D, F).

posttensioning had marginally less support along the slabs *y*-direction.

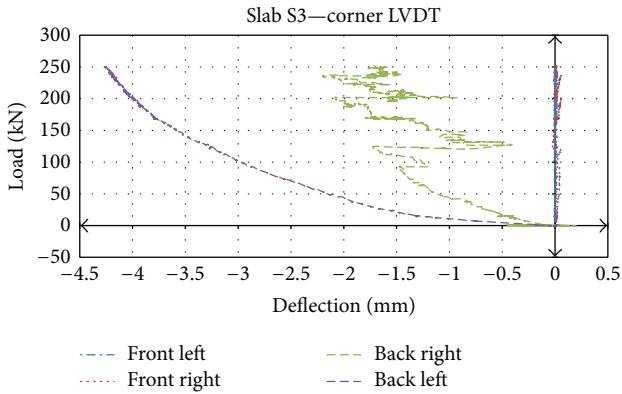
FIGURE 47: Slab S3—load V's corner deflection.

**3.6.7. Deformation Analysis: Top Surface.** Figure 47 indicates that there was no uplift in both the front left and front right corners with uplift occurring in the back left and, to a lesser extent, at the back right corner.
