Investigation of Electrical Defects arising from Excessive Sidewall Force and Excessive Tensile Strain on Power Cables

McConnon, D., Kearney, J., Looby, T. & O'Shaughnessy, J. (2017) Investigation of Electrical Defects arising from Excessive Sidewall Force and Excessive Tensile Strain on Power Cables, *52nd International Universities Power Engineering Conference (UPEC)*, Crete, 2017.

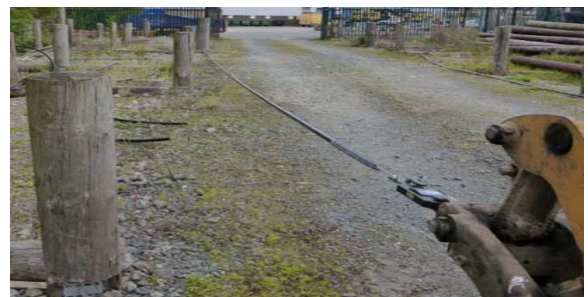
Fig. 1. Tensile Strain Test - Three cable samples were pulled to different tensile strains i.e. 700 kg, 1500 kg and 2000 kg

Tensile stress was applied to cable samples in the ESB Networks test facility through a simplistic method. The aim was to minimise the effect of sidewall loading so no bends or steel ropes were included in the design. One end of the cable sample was anchored to a stationary wooden pole stub using pole slings, shackles and a pulling stocking, and the cable was subjected to a straight pulling operation through the use of a JCB digger.

For each of the three tensile pulling forces applied (700 kg, 1500 kg and 2000 kg), there was 0 mm, 10 mm and 20 mm cable extension measured respectively during the pulling operation. It should be noted that a period of approx. 2 hours was left prior to terminating each cable sample.

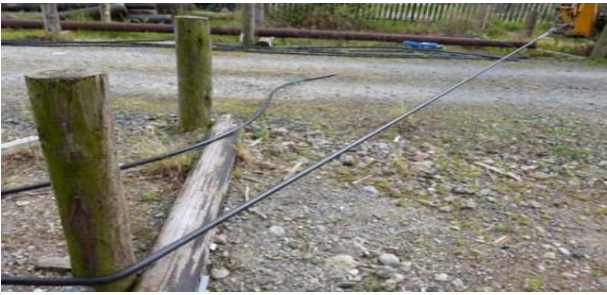
Fig. 2. Sidewall Loading Test - Cable sample is experiencing a tensile strain and sidewall force at the 75° bend angle

A test method was designed to subject cable samples to sidewall force. The aim of this test was to simulate a trench pulling operation over rollers, with an additional wooden pole stub acting as rollers at a bend in a trench. It can be difficult to isolate the cause of a cable failure, whether that be tensile or sidewall force, when conducting this type of test. However, this arrangement provides for an assessment of how both forces combine to result in the severe strain experienced by a cable in a typical cable pull. In this test arrangement, 700 kg, 1500 kg and 2000 kg were applied to three different cable samples at a bend angle of 75° for each test, with a contact surface with the pole stub of 110 mm, 130 mm and 130 mm, respectively.

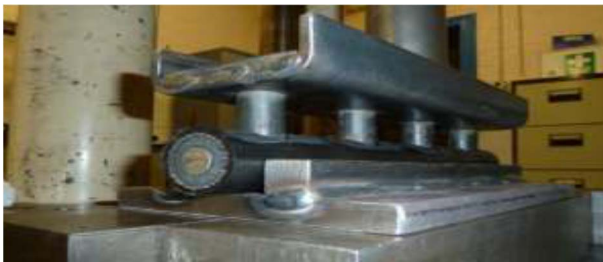
Fig. 3. Compressive Force Test - Rig designed so all force transmitted to the conductor via vertical prongs having drilled the cable at intervals

A compressive force test was designed and performed in the Dublin Institute of Technology (DIT) Bolton Street campus, Dublin, Ireland. Initially, two steel rectangular blocks were placed on either side of the longitudinal section of the each cable sample and the cable was compressed. Two different cable samples were tested, one at a force of 1500 kg/m and the other at a force of 3000 kg/m [4], which were then to be terminated and tested at high voltage.

A rig was also designed that equally distributed the radial compressive force applied. In this arrangement, there was no squashing outward of the cable, because it was held inwards, and all of the force was transmitted to the

conductor via vertical prongs that rested on the conductor, having drilled the cable at intervals to receive them.

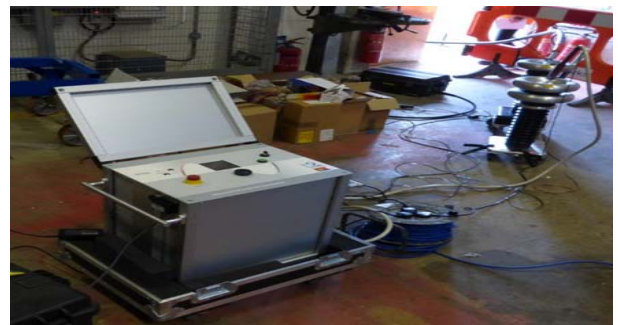
Fig. 4. Partial Discharge and Tan δ Test - Mechanically stressed cables undergo high voltage defects diagnostic tests

The IEC 60270 standard outlines the Conventional PD detection method [7], which was employed in this study of partial discharge. The presence of partial discharge causes voltage or current pulses in the power cable and the working principle of the detection method is thus to measure the charge displacement q produced by the voltage or current pulses. This method employs the use of a coupling device, a transmission system and a measuring instrument in order to detect PD presence in the power cable. The noise blocking filter reduces background noise from the HV supply.

A high voltage (HV) very low frequency (VLF) system provided by b2 electronics operating at 0.1 Hz was used to complete the measurements in ESB Networks, Leopardstown. Three different levels of voltage were applied to the cable, with measurements completed at 11.5 kV, 23 kV, and finally

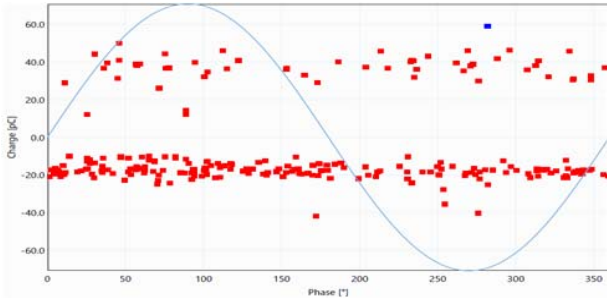
Fig. 5. Partial Discharge Pattern - Noise Floor of 50 pC observed during the combined partial discharge and $\tan \delta$ tests in ESB Leopardstown

$3 \times U_o$ (34.5 kV) root-mean-square (RMS). The final test voltage was three times the nominal voltage (U_o) of the 20 kV MV power cable under test. However, despite further analysis of the results of the tests, no partial discharge above the noise floor of 50 pC was detected. By removing a section of the outer sheath, it was observed that the excessive pulling and sidewall loading had failed to damage the cable in so far as embedding the screen wires in the outer semi-conductive layer.

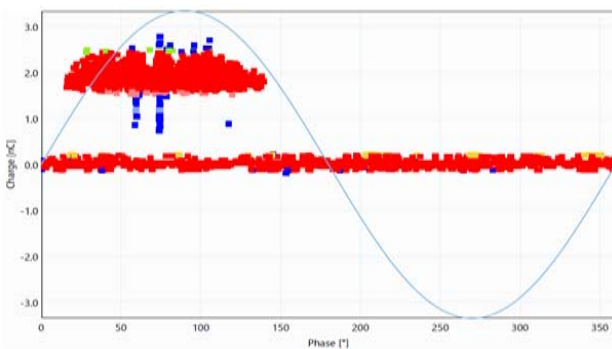
Fig. 6. Corona Discharge Observed on Positive Half Cycle - Corona Discharge eliminated through fitting of corona shield

Despite no detection of partial discharge, there was significant corona noise at the far end of the cable, which was affecting results, but this was resolved by fitting a corona shield. An interesting observation was that the corona discharge was only present near the peak of the positive half cycle. However, following the fitting of the corona shield, there was no evidence of corona discharge.

Corona discharge on the other hand only occurs when the electric field surrounding the live conductor attracts the free electrons in the air during the positive half cycle and when the electric field increases to such a level that local ionisation can occur. Therefore, the voltage needs to exceed a certain threshold for corona discharge to occur and the inherently negative free electrons in the air are only attracted to the live conductor during the positive half cycle.

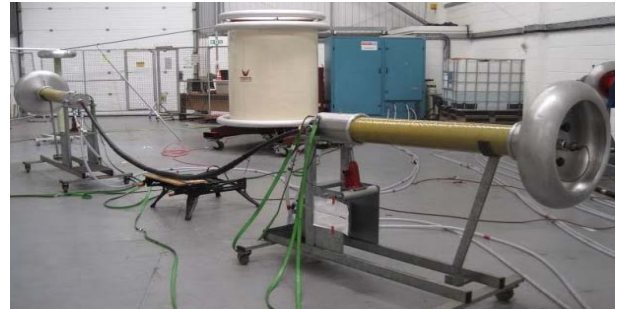
Fig. 7. Test arrangement in PowerCSL - Four times the nominal voltage applied to cable samples for four hours during Noise Free PD test

The cable samples subjected to excessive tensile strain and sidewall loading, including the samples tested using the compressive force test arrangement, were subsequently tested in PowerCSL test facilities, Kent, UK. In this test facility, high voltage can be applied in a noise free environment. Four times the nominal voltage was applied for a period of four hours to each cable sample ($4 \times U_o$ for 4 hours).

The noise floor was 2 pC, as opposed to 50 pC encountered during the combined partial discharge and $\tan \delta$ testing completed in ESB Networks, Leopardstown. There was a

constant partial discharge level for each of the cable samples tested with constant applied voltage of 46 kV ($4 \times U_o$).

For example, there was a PD level of 10 pC at 48 kV for the cable sample with 3000 kg/m applied during the compressive force test. However, there was no significant partial discharge observed that would indicate cable failure despite the increase in voltage and application time in PowerCSL test facilities, thus the cable samples passed the various tests.

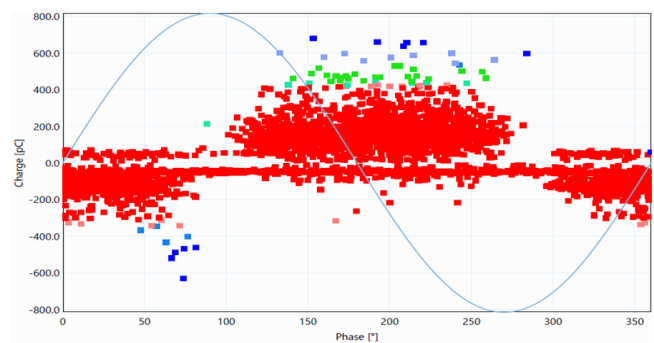
Fig. 8. Partial Discharge Observed - Screen Wires protruded into insulation to mimic effects due to excessive strain

The screen wires were deliberately protruded into the insulation of the cable sample that had been subjected to a pulling force of 1500 kg and sidewall loading. This was completed as an attempt to mimic a condition that could occur in a real world scenario where the cable experienced excessive tensile strain and sidewall loading during installation and was then subjected to normal operating conditions over years in service. An electrode was effectively created by protruding the screen wires slightly into the cable insulation. With the cable in this condition, there was significant partial discharge observed.

Partial discharge is capacitive in nature so as was expected, the partial discharge occurred near the zero crossings and where the voltage was undergoing most change, as the partial discharge was out of phase with the voltage. However, since many capacitive-like characteristics occur together, there is a complex phasor sum phenomenon and a stream of partial discharge is observed across the voltage waveform either side of the zero crossing.

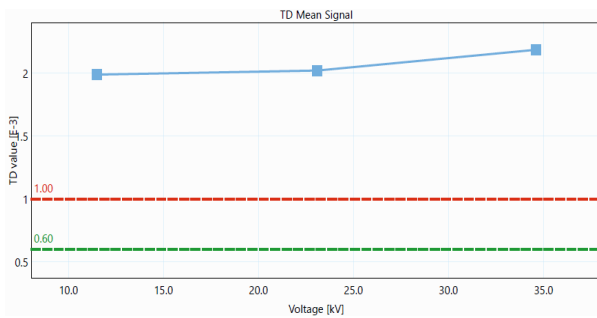
Fig. 9. Dissipation Factor ($\tan \delta$) Test - the $\tan \delta$ value was observed to have increased with an increase in voltage and the occurrence of PD

The $\tan \delta$ test was simultaneously completed on the cable sample subjected to a pulling force of 1500 kg and sidewall loading. The loss angle was observed to have increased with when partial discharge was occurring. For paper insulated cables, the tangent of the loss angle could be as high as 30, but is a lot lower for XLPE insulated cables, as observed in this test completed in ESB Networks, Leopardstown with a $\tan \delta$ value between 0.00195 and 0.00225.

The value is observed to increase as the capacitance of the cable deviates due to surface discharges, voids etc. which are resistive in nature. Also illustrated is that the susceptibility of a cable to partial discharge, and similarly the $\tan \delta$ value, increase with voltage.
