## Monkstown Enerphit and Passive House Extension

# Monkstown Enerphi t Extensi on and Refurbi shment

## Sets Deep Retrofit Example

PUBLISHED IN PASSIVHOUSE+ MAGAZINE,  
FEB/MARCH 2013, ISSUE 2, VOL 1

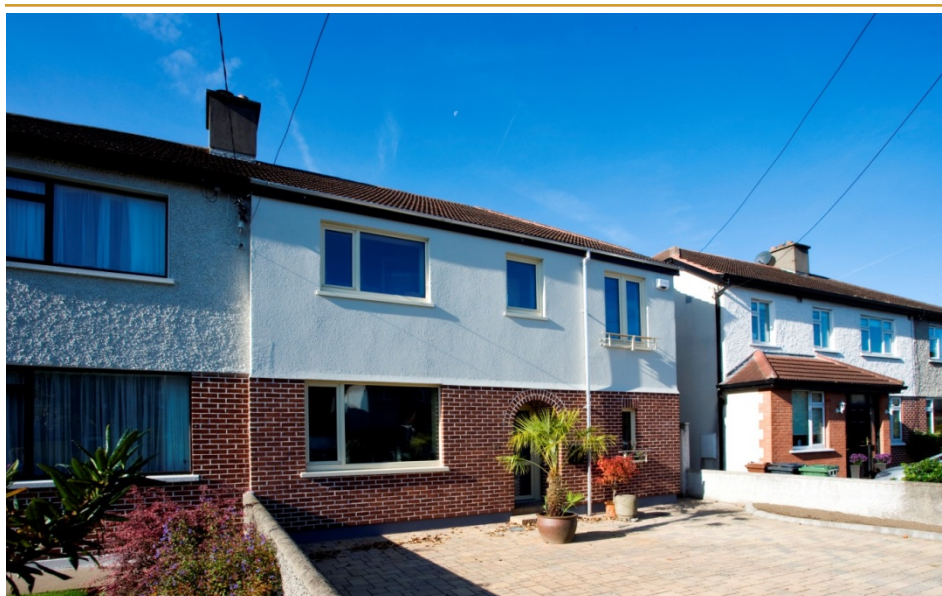
FIGURE 1

view of front elevation after retrofit  
(2-storey extension is on right side of  
downpipe)

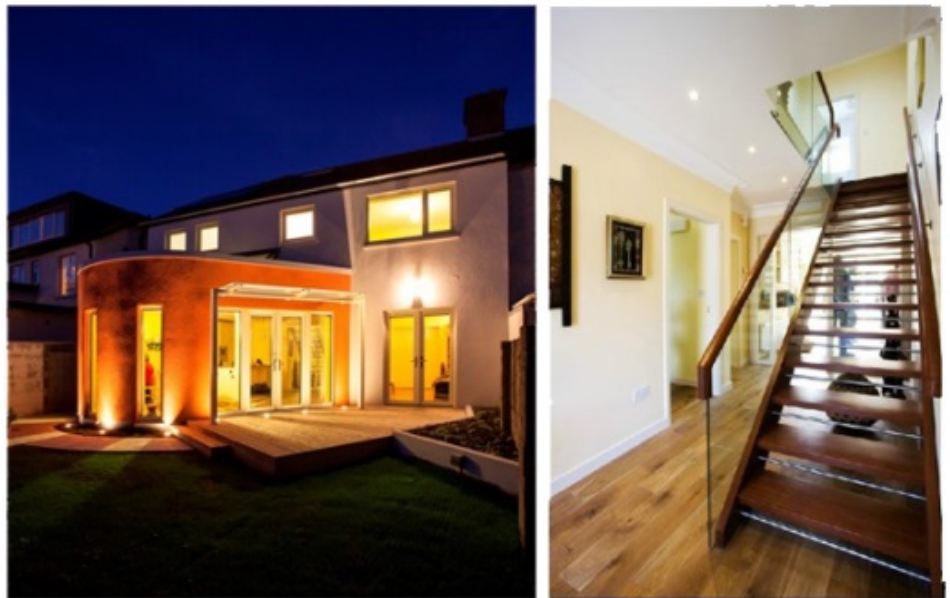
FIGURE 2

rear elevation and internal hallway  
after retrofit

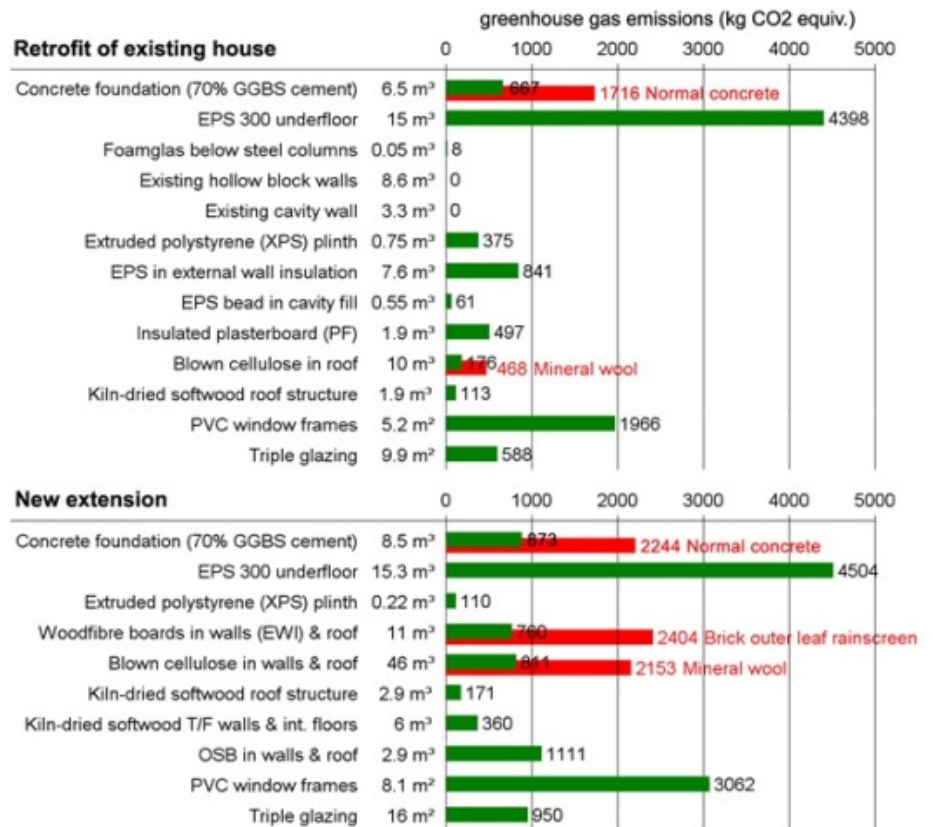
FIGURE 3

embodied carbon in materials used<sup>8</sup>

<sup>8</sup> Green bars show materials used, red bars show materials and emissions avoided. Concrete values came from Ecocem Ireland Ltd, woodfibre values came from Natural Building Technologies. All other values taken from *Ökobilanzdaten im Baubereich 2009/1* jointly researched and published in Switzerland by KBOB, Eco Bau and IPB: [www.kbob.ch](http://www.kbob.ch)

because of this decision: we knew the use of low carbon concrete, woodfibre and recycled products would be in our favour but it is striking to see in Figure 3 that the EPS300 slab insulation had a far greater carbon impact than expected. Its higher density results in greater amounts of EPS and therefore embodied carbon: we would like to see if there are lower carbon alternatives in future projects. The embodied carbon of the uPVC window frames are also worthy of note.

Figure 1 should only be considered a rough, incomplete estimate of associated CO<sub>2</sub> (eq.) emissions: the impact of the timber frame, membranes, renders and finishes, for example, are omitted. We deliberately show a few alternatives (such as mineral wool in the attic or brick rainscreen) to illustrate how a low carbon focus and specification can allow an equal or better performance. We look forward to the publication of SEAI's 'Embodied Energy

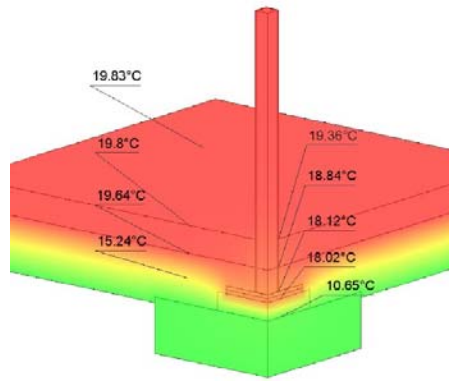
FIGURE 5

point thermal bridge analysis of column base plate.  $\chi$ -value = 0.041 W/K  
 Note: air temp 20°C, ambient ground 10°C

concrete pad. Figure 5 shows an output from a point thermal bridge evaluation using the newly translated Psi-Therm software. Note the temperature at the junction of floor and column (19.36 °C) is only 0.5 K cooler than the floor elsewhere.

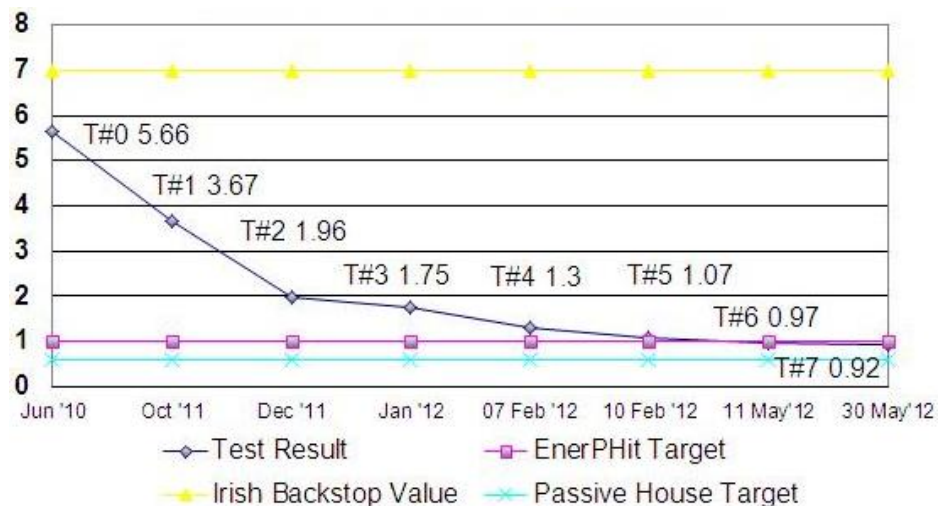
FIGURE 6

the progress of airtightness tests

At the first construction stage airtightness test (3.67 ACH@50Pa) it was clear that Bourke Builders had started to move ahead, slabbing insulated plasterboard at the party wall thermal bridges and first fixing. We instructed them to stop until the design airtightness value was reached. If it's not reached at this stage, when the layers of buildups and number of penetrations are relatively few and easily accessed, *it never will be*: later tests are to ensure the value is *maintained*. There was clearly a learning curve on the specific difficulties of airtightness in retrofits. Diagnostic airtightness tests were crucial in helping us learn where under-performance was
